# **Fire Risk Assessment**

## **Beaconview House**

**Beaconview Road, West Bromwich,  
B71 3PL**

**Date Completed: 13/02/2025**

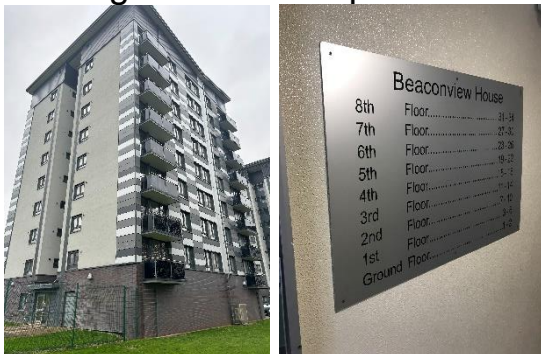
The High-rise residential block was constructed in 1964 out of a concrete brick construction and was last refurbished in 2015 with the installation of an external wall system. The block consists of 9 stories inclusive of the ground floor with each floor containing 4 number dwellings coming off the lift lobby with the ground floor containing only 2 dwellings and office space containing a server room.

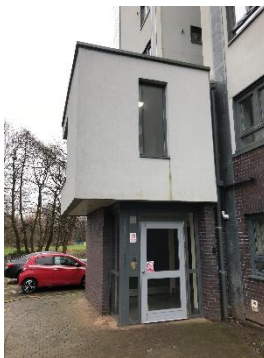
(Left side MAP)

There is an entrance/ exit to the left side elevation to the block with an additional entrance/exit to the right-side elevation (from the main road). The left side elevations entrance acts as the main access point to the block.

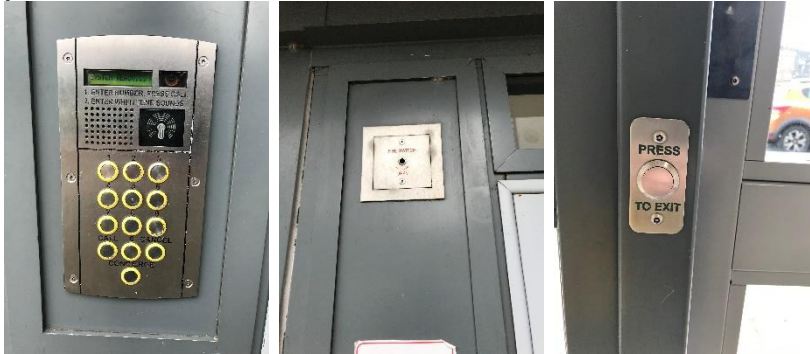
Both entrances utilise fob access in order to gain entry to the block with the main access point also having access to a firefighters override system in the form of a drop latch switch. Both entry/exit points use a push to exit button.

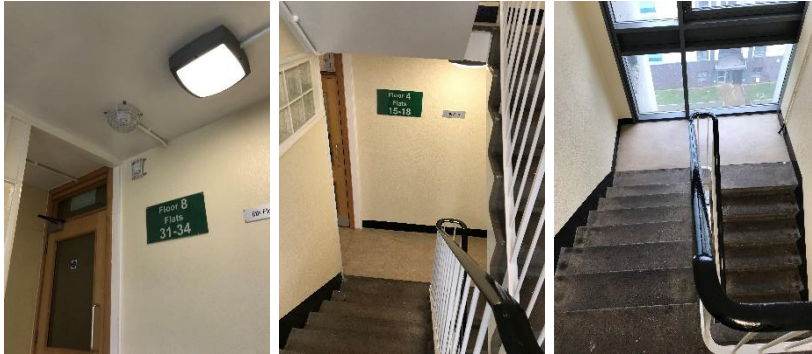
The block has a single protected staircase serving all floors of the block with floor identification numbers (wayfinding) on the wall of each floor. The staircase is protected using nominal 44mm FD30s doors with combined intumescent and smoke seals.

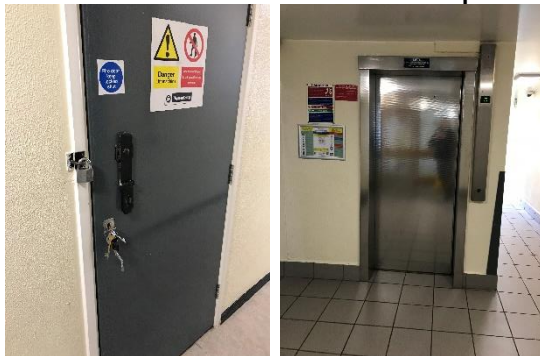
The block has lift access that serves from the ground to the 7<sup>th</sup> floor with the lift motor room being accessed via a full height nominal timber 54mm FD60s door secured with a pad lock and a suited lock.

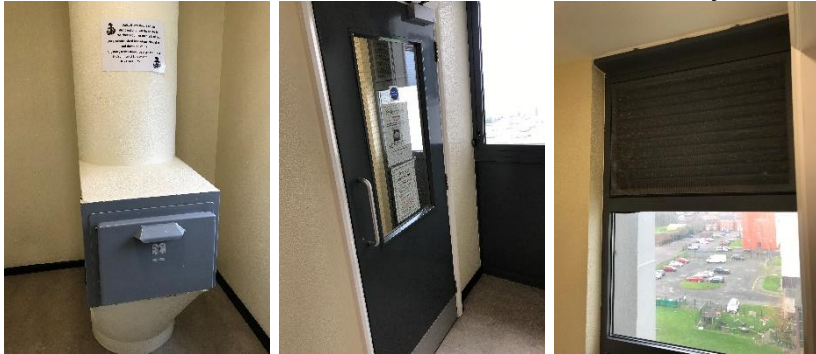
Residents have access to a bin chute system that serves every floor of the block secured behind nominal 44mm FD30s doors with combined intumescent and smoke seals and is naturally ventilated.

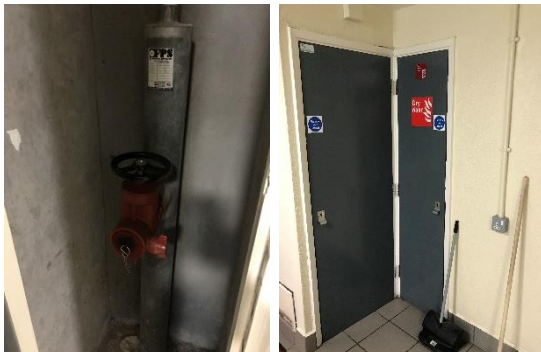
There is a dry riser that serves all floors of the block with a dry riser inlet cupboard located on the ground floor door that is adequately signed and secured, each floor of the block contains a dry riser protected via nominal 44mm FD30s doors with combined intumescent strip and smoke seals.

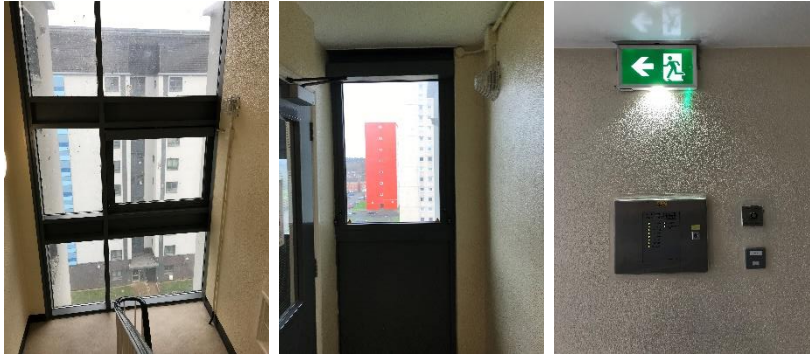
AOV's are in operation on all floors within the corridor nearest the bin chute and within the protected staircase with the control panel on the ground floor nearest the main entrance.

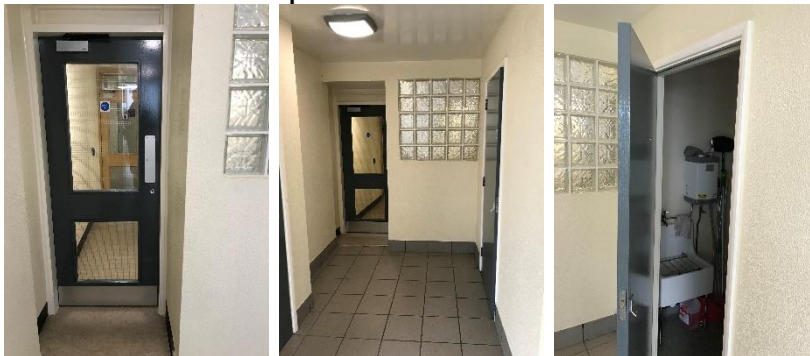
There is a “viewing pod” located on the 1<sup>st</sup> for acts as a viewing pod/ waiting room, this is secured with the use of nominal 44mm timber FD30s doors secured with a suited 138 key. This area also holds the cleaners store cupboard.

- 14) Communal viewing pod located on the first floor secured with a 44mm timber nominal door with intumescent strips, cold smoke seals and vision panels is secured with a type 34 mortice lock that residents have access to this room remains relatively sterile with the cleaners cupboard also being within this area noted the cleaners cupboard is missing the addition of combined intumescent strips and smoke seals as this is a nominal door and the area being regularly accessed by cleaning / caretaking teams the element of risk is tolerable however with future improvements to the block it should be considered that this door is upgraded to a FD30s.

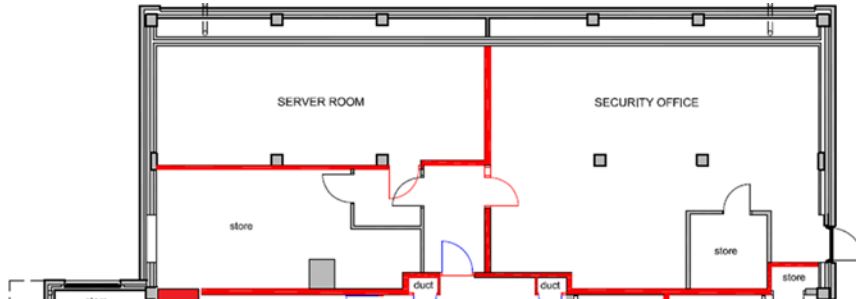
The ground floor consists of 2 flats and an office space. The office spaces contain stores, server room and main office area, there is an exit door located at the rear of the main office leading to the rear car park provided 2-way travel in this area. This area also contains a kitchenette.

- 6) Noted that no detection was present within the main office area and the small office/ storeroom. Due to the occupancy/use, multiple escape routes and items stored within this is a trivial risk however when upgrades take place at the block consideration should be made to introduce fire detection within these areas.

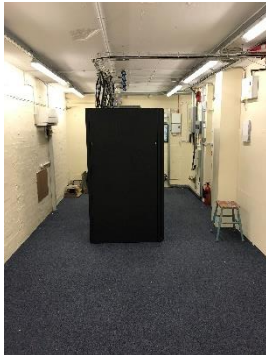
The server room is located to the left-hand side of the office spaces through a standard door and a nominal door secured with a mag lock and can be accessed with the use of a drop latch key with a push to exit button on the inside. This area benefits from a fire detection system.

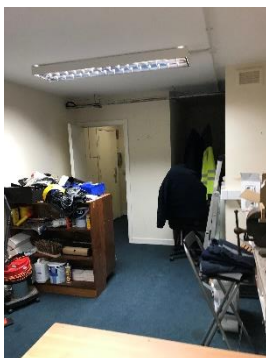
Smaller office used as a storeroom also located to the left-hand side of the office area through the same standardised door as the server room following on to another separate nominal fire door that separates the two spaces.

- 16) Noted that the door leading to the area within the office space where the small office/stoarge area and server room is located is not a fire door however the doors beyond this point are nominal doors and are deemed tolerable despite the door to the small office/storage space not having an intumecent strip and cold smoke seals due to other doors protecting the communal areas and the secondary escape route available to emplooyees from the main office area. With future upgrades to the premise it should be considered that all doors within this area are upgraded to fully certified FD30s doors.

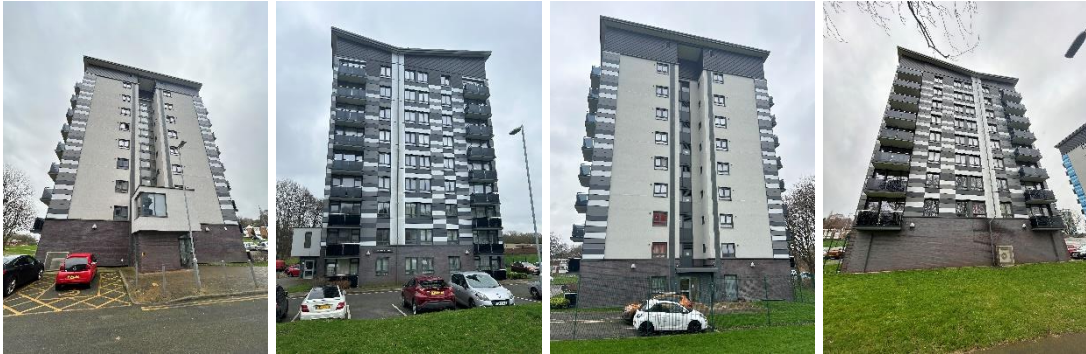
- 1) The block was constructed of concrete frame with masonry infill (Wates) last refurbished in 2015 with the addition of an external wall system the external facade consists of high-density laminate board with rockwool insulation (A1), and rockwool insulated render.

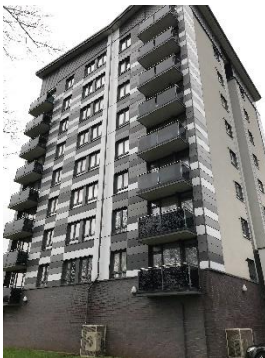
- 7) Aluminium faced timber composite windows to resident's flat windows/balcony doors and communal windows.

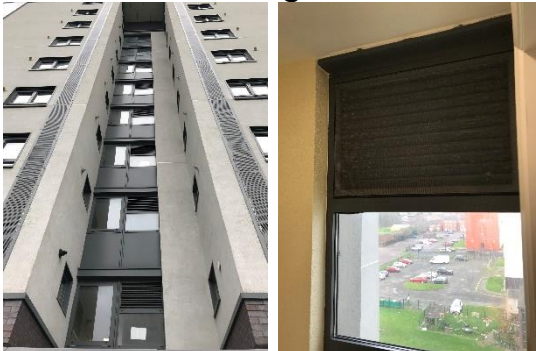
- 8) Natural ventilating to the bin chutes in the form of louver vents.

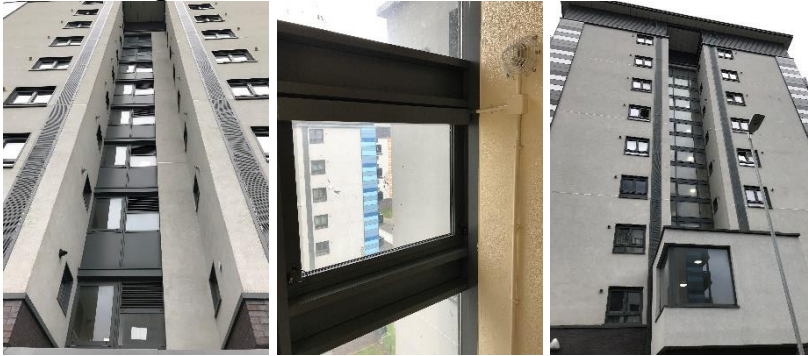
- 9) AOV's serving all floors run along the side elevations of the building.

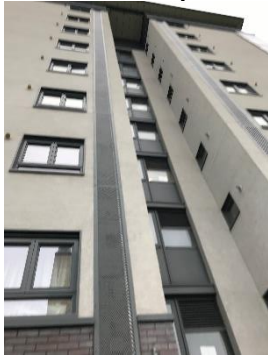
- 10) Gas pipe is located on the external wall, secured behind perforated panelling, with gas isolation points located on the orientation plan.

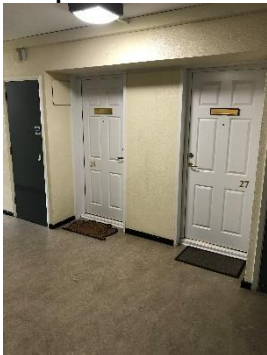
- 2) From Flats sampled, Individual flat doors are predominantly Certified 44mm FD30s composite fire door sets with intumescent strips and cold smoke seals.

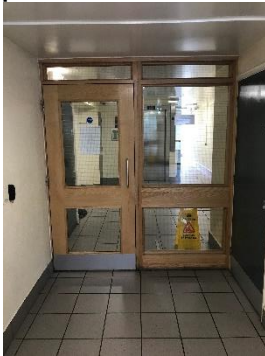
- 4) The lift lobby, communal landing, and staircase are protected by use of upgraded nominal timber 44mm FD30s fire doors with vision panels.

Some nominal communal landing doors are starting to show signs of general wear and tear due to age. Consideration should be given to upgrading with certified FD30s door sets & combination frames with future improvement works.

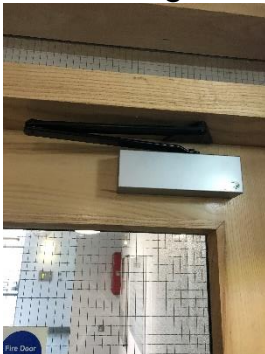
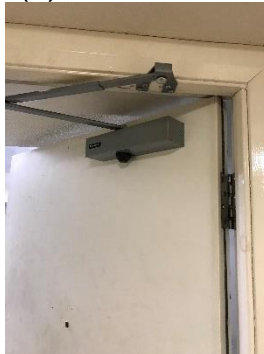
- 5) All communal doors are fitted with automatic closing devices that are checked on a regular basis by Caretaking Teams as part of their checks. Defective closing devices are replaced either by the Caretaking Team(s) or the in-house repairs team(s).

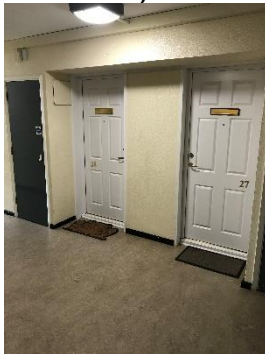
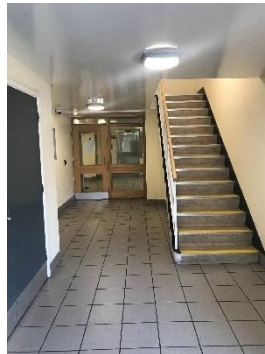
- 6) All corridors & Lobby areas are of adequate width (at least 1050mm) and will be maintained clear to that width as a minimum.

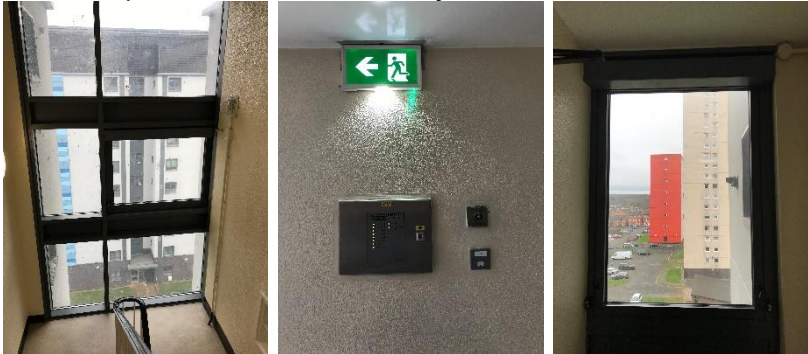
- 8) Automatic smoke ventilation is employed within the protected stair and flat lobby area. This is tested, inspected and maintained by a competent procured contractor in accordance with BS7346. The frequency for the maintenance checks is twice per year (April and October) of each calendar year.

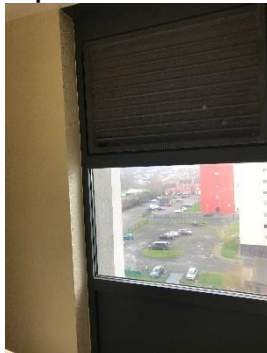
- 9) The chute room has natural louvre vent / screen allowing ventilation to the chute rooms. These areas are secured behind a 44mm nominal FD30s timber door with vision panels intumescent strips and cold smoke seals.

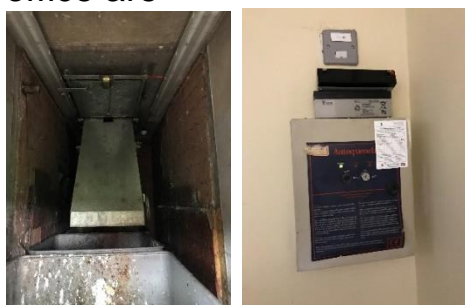
- 3) There is no effective means for detecting an outbreak of fire to communal areas other than the server room/office spaces that is used by staff only. The reason for this is:
  - I. Such systems may get vandalised.
  - II. False alarms would occur.
  - III. A Stay Put - Unless policy is in place
- 4) A sprinkler or deluge system is provided to the refuse chute bin store. An approved contractor maintains the system. The frequency for the maintenance checks is twice per year (April and October) of each calendar year. The control panel can be found in the main office are

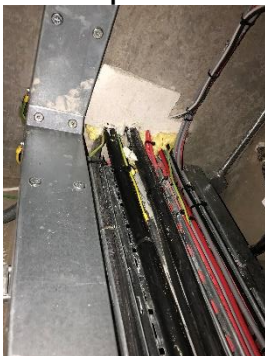
- 13) Noted the use of expanding foam was present within the communal cupboards around cabling as part of the fire stopping knowing that intumescent pads and a concrete slab is present and this foam is only used as an enhancement it is deemed acceptable. This should be enhanced as part of future works to the building and replaced with intumescent mastic to improve fire stopping.

The use of expanding foam was present within the communal cupboards around cabling as part of the fire stopping, knowing that intumecent pads and a concrete slab is present and this foam is only used as a enhancment it is deemed tolerable. This should be enhanced as part of future works to the building and replaced with intumecent mastic to imporve fire stopping. Noted that no detection was present within the main office area and the small office/ storeroom. Due to the occupancy/use, multiple escape routes and items stored within this is a tolerable risk however when upgrades take place at the block consideration should be made to introduce fire detection within these areas.

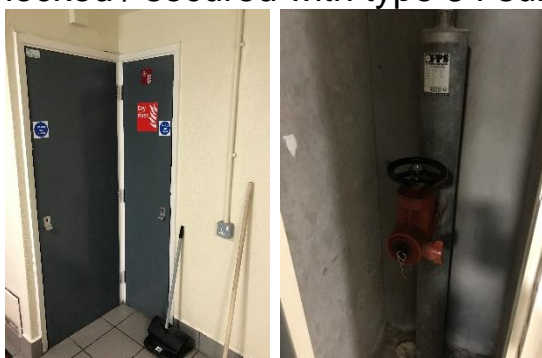
- 1) The dry riser inlet cupboard is in the ground floor lift lobby and is appropriately signed. Dry riser cupboard doors are timber 44mm nominal FD30s with intumescent strips and cold smoke seals, kept locked / secured with type 54 suited mortice lock(s).

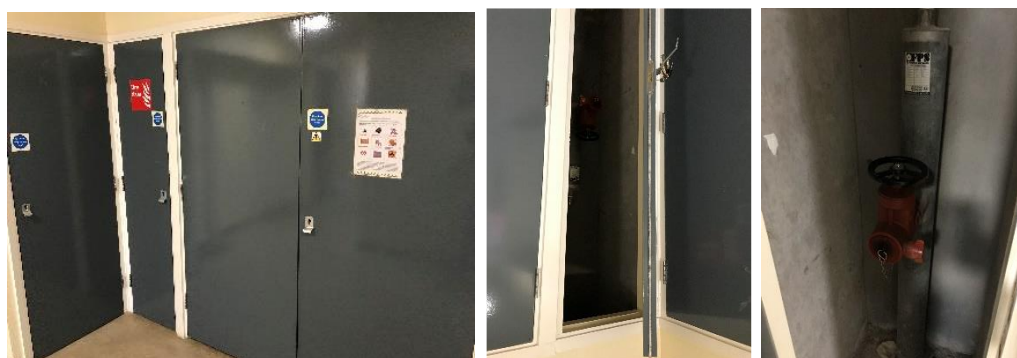
- 2) The riser outlets are available on each floor lobby (ground – 8<sup>th</sup>) these are protected via nominal 44mm 30-minute fire doors secured by suited 54 key & mortice locks.

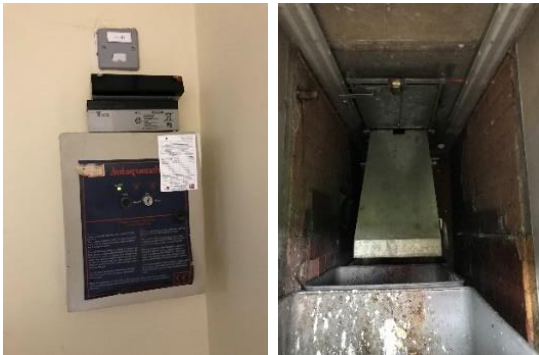
- 6) Bin room is protected by Deluge/sprinkler system and serviced 6-monthly, the control panel is stored within the ground floor office area.

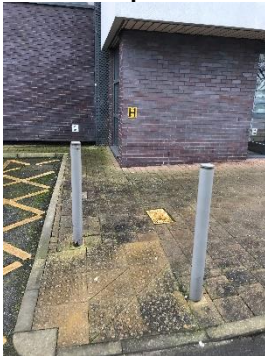
- 7) Fire hydrant can be located at the side elevation nearest the main access point to the building

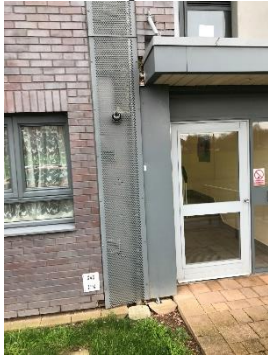
- 8) Gas appliances and pipework (where installed) are subject to annual testing and certification. This cyclical contract is managed by the in-house Gas Team. **Gas supplies are external secured behind perforated panels.**

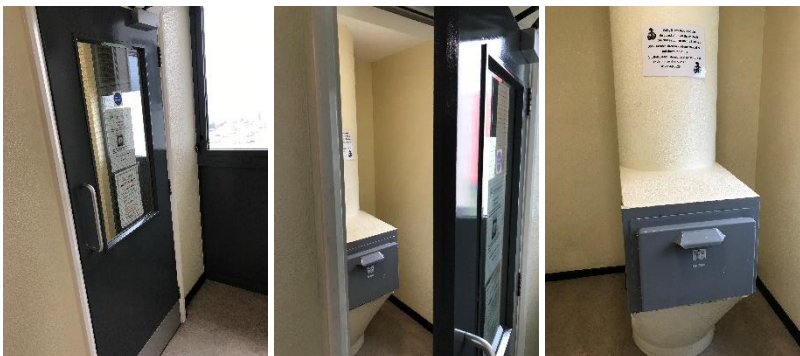
- 2) Refuse hoppers are accessed on each floor secured behind its own dedicated nominal 44mm 30-minute door with combined intumescent and cold smoke seals.

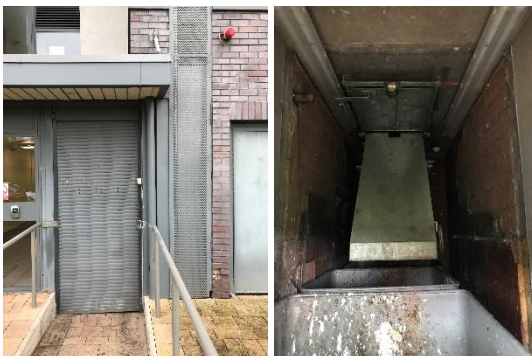
- 3) Refuse containers regularly emptied, bin store located at the side elevation near the additional exit/entrance to the building.

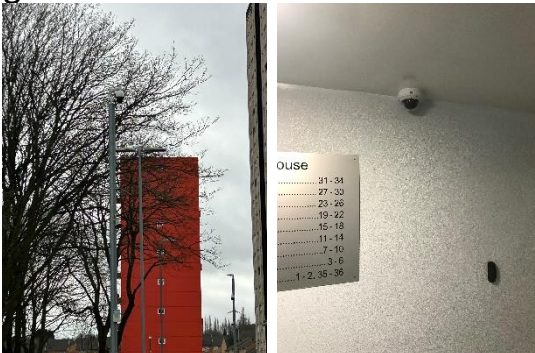
- 3) There is CCTV system in place that covers the external perimeter, ground floor and lift car
