Fire Risk Assessment

Broome House

**Beaconview Road, West Bromwich,
B71 3PN**

Date Completed: 13/02/2026

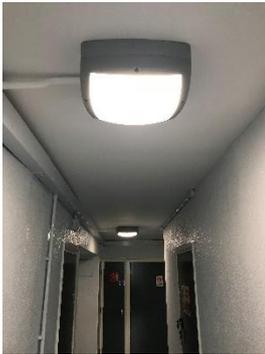
- 1) The premises has a sufficient emergency lighting in accordance with BS 5266 and has test points strategically located.
- 2) The units are provided to the communal landings, stairs and lift motor room.

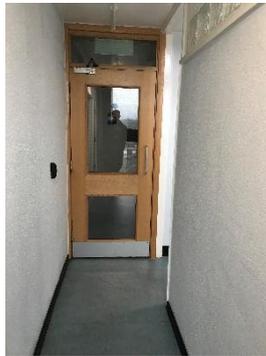
- 7) Any remedial works arising from the fire stopping / compartmentation check(s) will be actioned immediately by the Fire Safety Rapid Response Team.
- 8) A variety of methods / materials have been used to achieve fire-stopping including Rockwool, fire rated sponge and intumescent pillows.
- 9) Individual flat doors are a combination of 44mm nominal FD30s composite/timber fire door construction.
- 10) Corridors / staircases are protected by use of FD30s fire doors with vision panels.

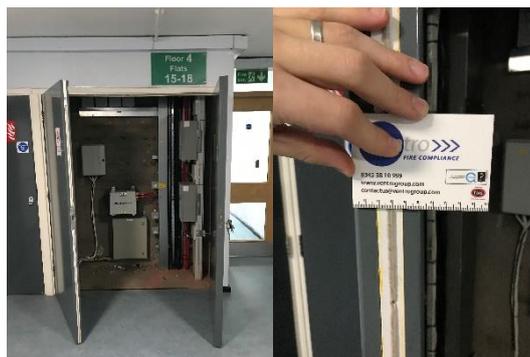
- 11) Cupboard doors within the communal areas such as residents meter cupboards/ electrical risers' cupboards are nominal 54mm FD60 timber fire door sets with intumescent strips, cold smoke seals.

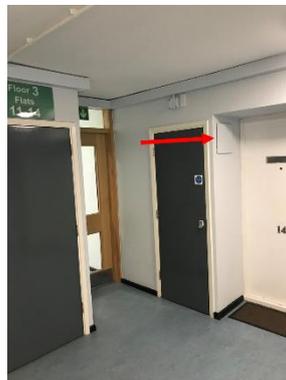
- 12) Access panels to stop taps are fixed to masonry and bedded on Intumescent material.

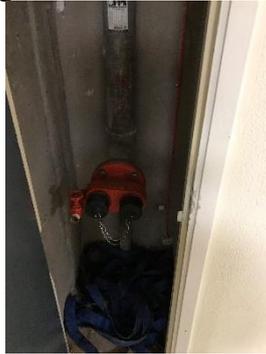
- 1) The dry riser inlet cupboard is located in the ground floor lift lobby and is appropriately signed

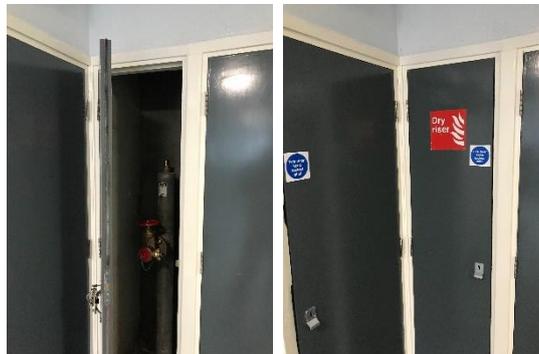
- 2) The riser outlets are available on each floor lobby (ground – 8th) these are protected via nominal 44mm 30-minute fire doors secured by suited 54 key & mortice locks.

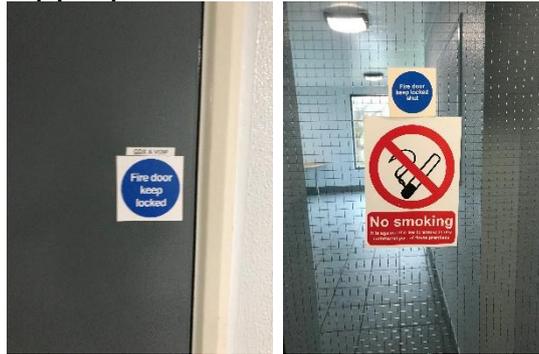
- 1) All fire doors display “Fire Door Keep Shut” or “Fire Door Keep Locked where appropriate.

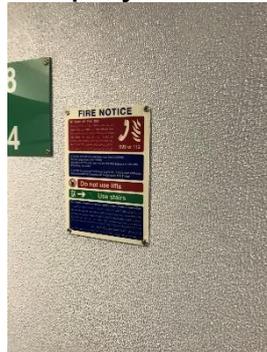
- 2) Fire Action Notices are displayed throughout the building.

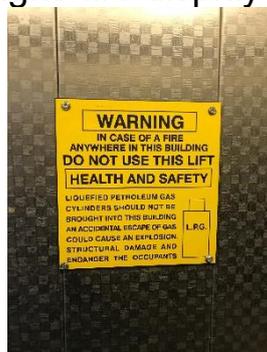
- 3) Yellow LPG warning signs are displayed within the lift car.

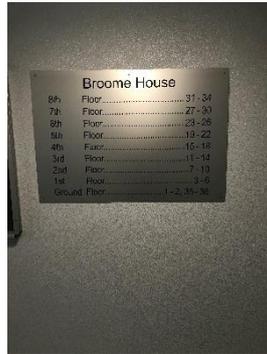
- 5) Wayfinding Signage depicting floor level and flat numbers are fitted to the wall adjacent to lift. They meet the requirements set out in the Fire Safety (England) Regulations 2022

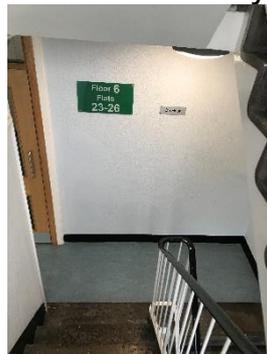
- 7) The fire escape routes use directional fire signage

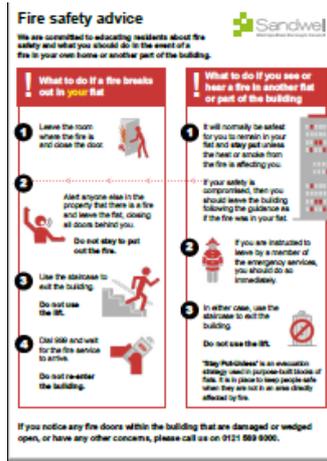
9) Information regarding building safety is contained within a Building Safety Notice. This is affixed to the wall on the ground floor lift lobby of high-rise blocks.

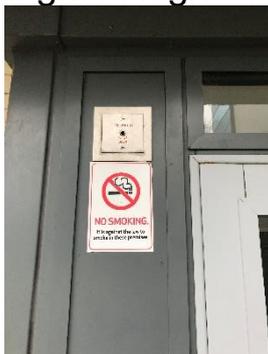
- 1) Smoking is prohibited within any communal parts of the building in line with Smoke Free England legislation.

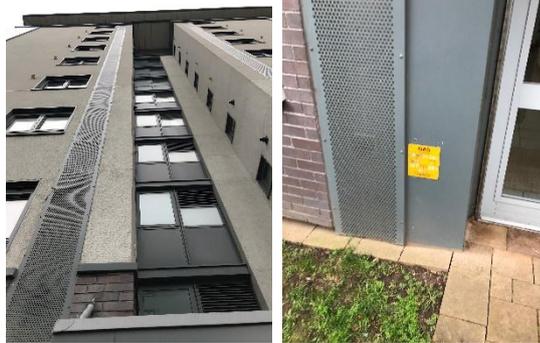
- 8) Gas appliances and pipework (where installed) are subject to annual testing and certification. This cyclical contract is managed by the in-house Gas Team. Gas supplies are external secured behind corrugated panels.

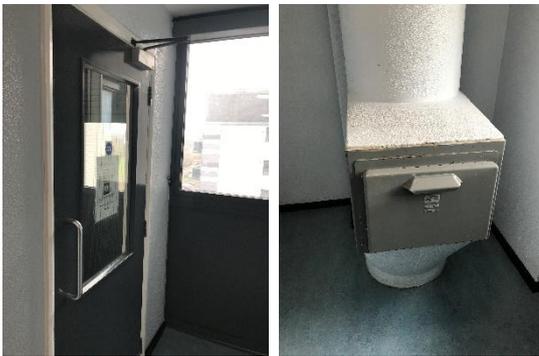
- 1) There is a regular Cleaning Service to the premises.
- 2) Refuse hoppers are accessed on each floor secured behind its own dedicated nominal 44mm 30-minute door with combined intumescent and cold smoke seals.

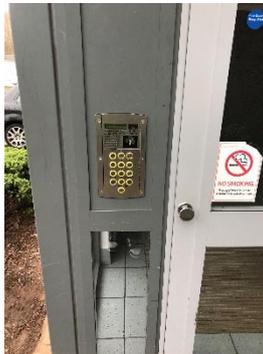
- 1) Regular checks are undertaken by Caretakers / Cleaning Team(s) 365 days per year which helps reduce the risk of arson.
- 2) Restricted access to the premises by means of a door entry system.

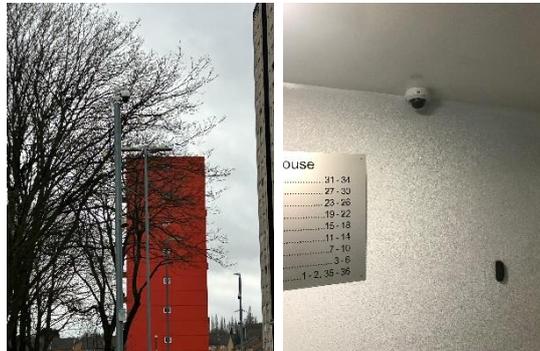
- 3) There is CCTV system in place that covers the external perimeter, ground floor and lift car
