# Fire Risk Assessment

## Bowater House

Moor Street, West Bromwich,  
B70 7AZ

**Date Completed:** 20<sup>th</sup> January 2026

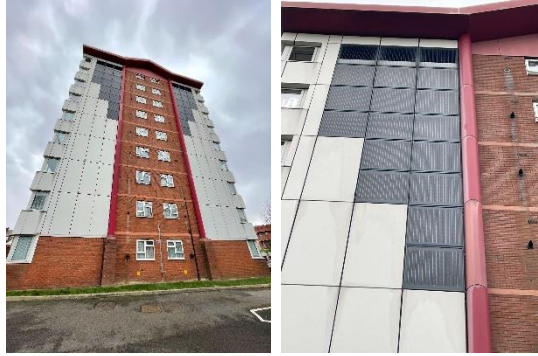
- 5) Insulation to the masonry cavity has been identified as 30mm foil faced PUR tongue & groove boards manufactured by Nestaan. This detail is recorded on an architect drawing.

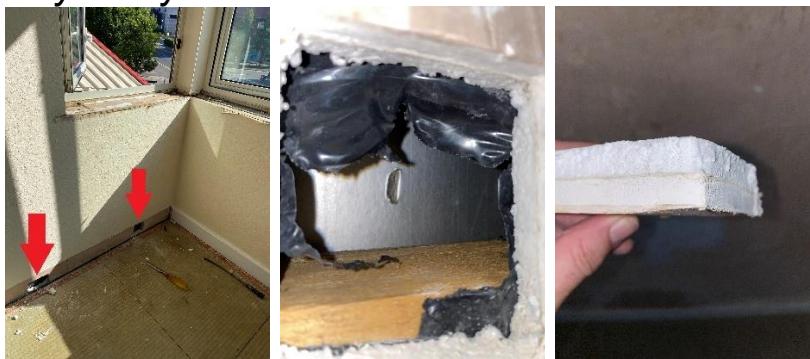
- 9.5mm gypsum plasterboard with a 10mm polystyrene layer bonded to the rear for basic thermal insulation.
- Damp proof membrane (polythene sheet).
- Timber studwork.
- PUR board.,

*The borescope could not access beneath or behind the PUR boards or the area where the cavity within the balcony meets the masonry or masonry cavity.*

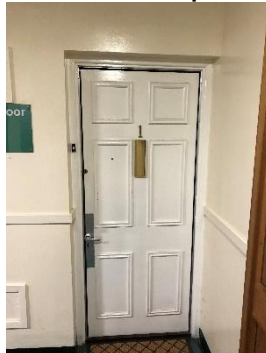
- 1) Individual flat doors are predominantly nominal self-closing 30-minute timber fire door sets with intumescent strips, cold smoke seals. Flat 18 has a replacement FD30s composite, not all doors have an intumescent lined letterbox which is acceptable because the doors were installed at a time prior to current standards.

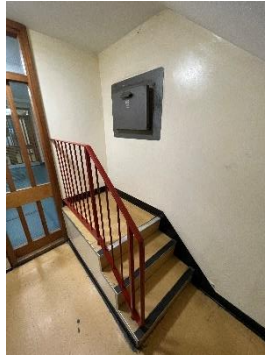
- 15) The refuse hopper to the ground floor is wall mounted beneath the ground to 1<sup>st</sup> floor rear stairs. This is deemed an acceptable location because the hopper is 1.5 hrs fire rated and tested to BS 7386: 1990 for smoke containment.

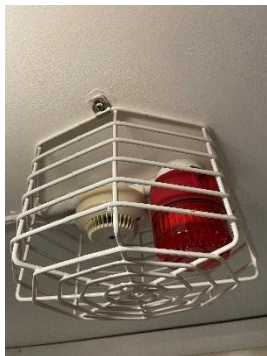
- 4) The communal fire alarm system shall remain as a temporary measure until the results of the FRAEW from the specialist contractor have been received, and any identified remedials have been satisfactorily completed to lower any identified risks. The system shall then be decommissioned.
- 5) The system is addressable so will identify the floor number with the relevant zone number and will state landing / stairs in text on the display.
- 6) The system provides detection to the communal areas which includes stairs, landings, mains cupboards, lift shaft, internal roof space and is also linked to heat detectors within resident's hallways.

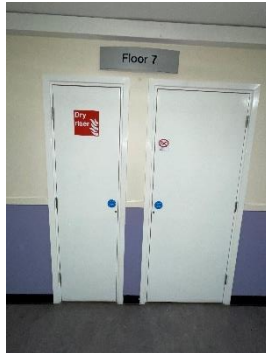
- 5) Service cupboards are secured by use of locked nominal FD30s timber doors.

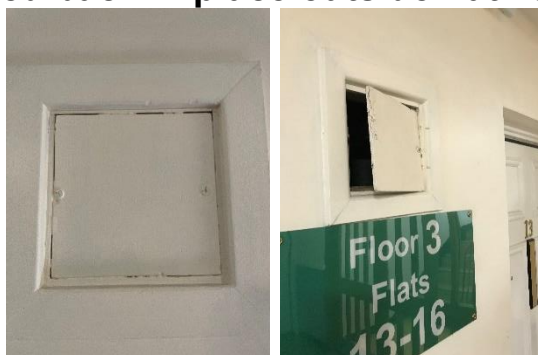
- 11) The fire stopping / compartmentation is subject to a 12-week check by the Fire Safety Rapid Response Team.
- 12) Any remedial works arising from the fire stopping / compartmentation check(s) will be actioned immediately by the Fire Safety Rapid Response Team.
- 13) A variety of methods / materials have been used to achieve fire-stopping including intumescent coated slabs & fire rated sponge.
- 14) Access panels to stop taps are fire resistant board and are fixed to a timber rebated frame on intumescent material. **Cover to stop taps to be fixed back in place outside flat 13.**

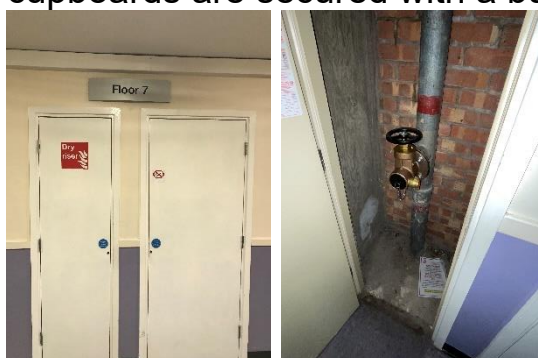
- 2) Dry riser outlets are in cupboards on the communal landing of each floor. All cupboards are secured with a budget lock / key.

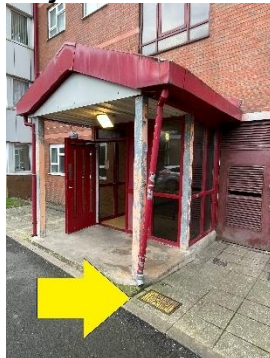
- 8) There is a fire hydrant adjacent the rear entrance.

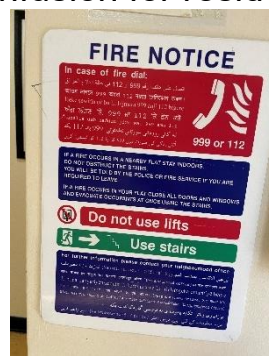
- 2) Fire Action Notices are displayed throughout the building. However, there is no instruction or reference to “on hearing the fire alarm”. During the previous FRA, a discussion with the (now former) Head of Building Safety and Compliance, RH has concluded that the Stay Put - Unless evacuation strategy shall remain in place. The communal fire alarm system shall also remain and continue to be maintained as a temporary measure until the results of the FRAEW from the specialist contractor have been received, and any identified remedials have been satisfactorily completed to lower any identified risks. The communal fire alarm will then be decommissioned to align with the stay put strategy and avoid any potential confusion for residents.
