Fire Risk Assessment

Bowater House

**Moor Street, West Bromwich,
B70 7AZ**

Date Completed: 20th January 2026

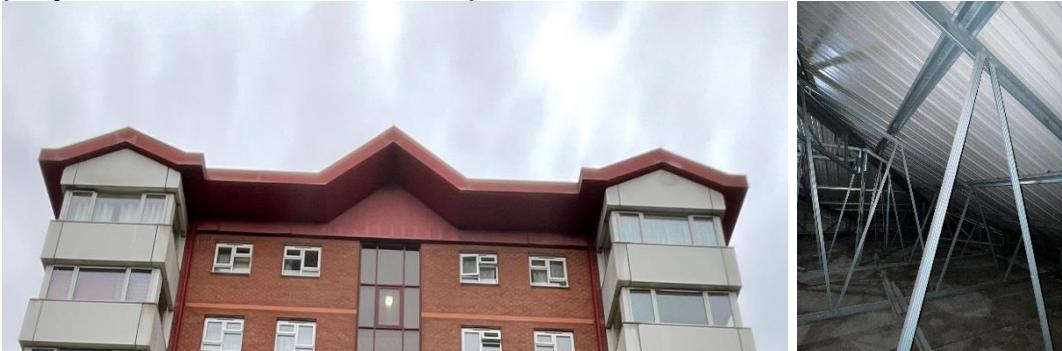
- 1) The exterior of the pitched roof consists profiled aluminium standing seam mineral wool core composite panels and 14-gauge polyester coated aluminium panels to the soffits and fascia's.

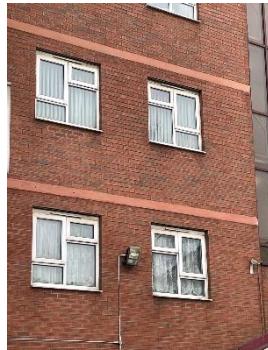
- 2) Marshalls Airedale Armitage multi cut brick work covering approximately 43% of the external walls surface area.

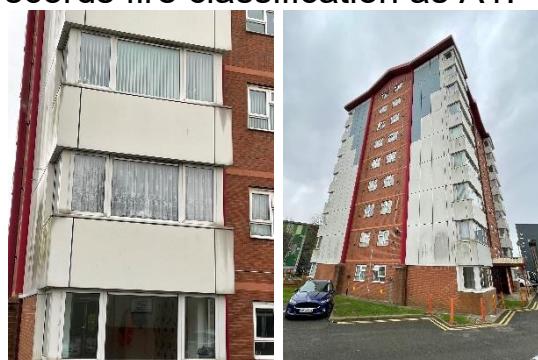
- 3) 3mm solid aluminium panels clad approximately 32% of the external walls to include the enclosure of the former balconies. Information available at the time of the risk assessment (delta submission) records fire classification as A1.

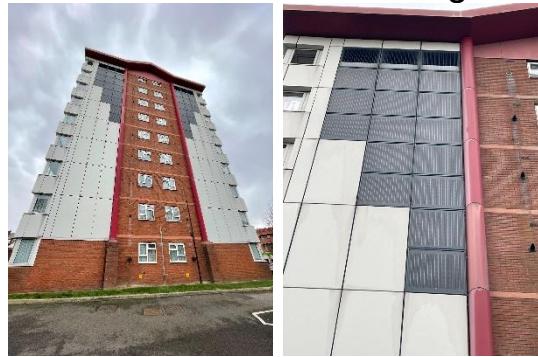
4) Solar PV panels clad the southwest facing side elevation.

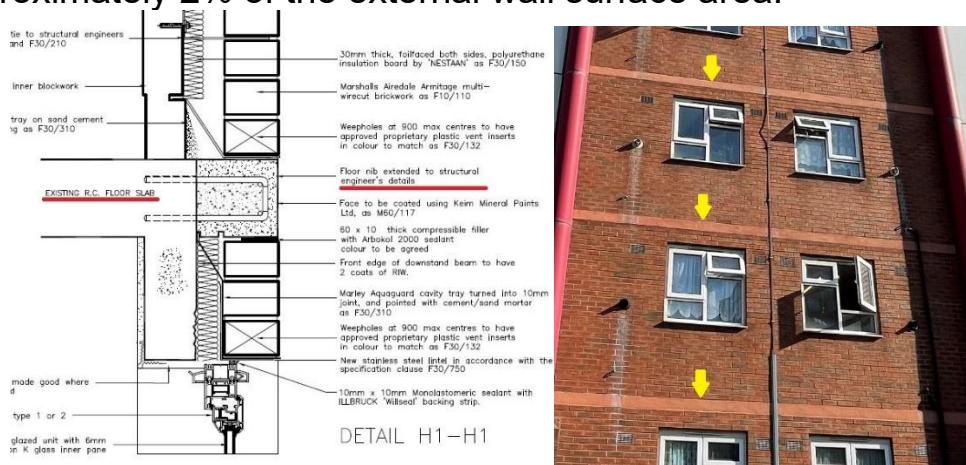
6) The original concrete floor slab was extended and now forms approximately 2% of the external wall surface area.

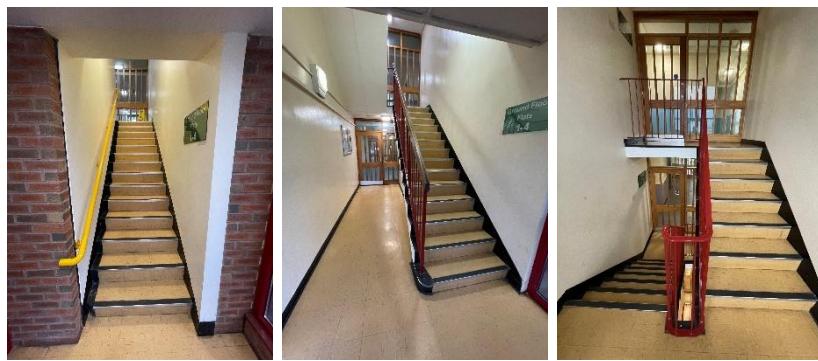
13) The site has two staircases which provide an adequate means of escape. Both of which are 1000mm in width. The maximum travel distance from the furthest flats to the protected stair is 3 metres.

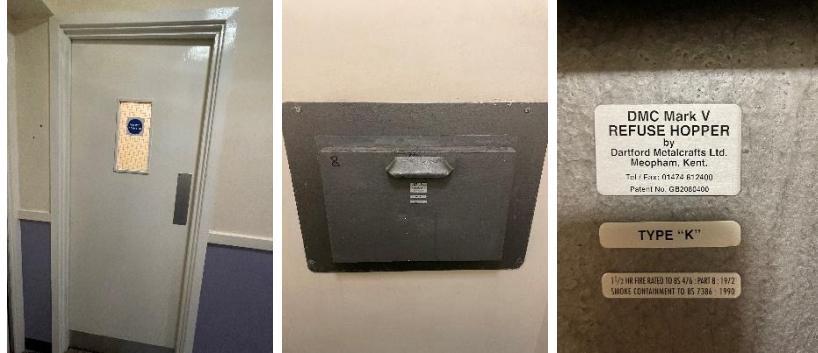
14) There is a chute room with a nominal FD30s timber door with vision panel (Georgian wired) on each floor lobby from 1st to 8th. All refuse hoppers are 1.5 hrs fire rated to BS 476 : 8 – 1972.

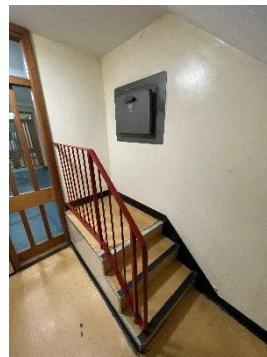
15) The refuse hopper to the ground floor is wall mounted beneath the ground to 1st floor rear stairs. This is deemed an acceptable location because the hopper is 1.5 hrs fire rated and tested to BS 7386: 1990 for smoke containment.

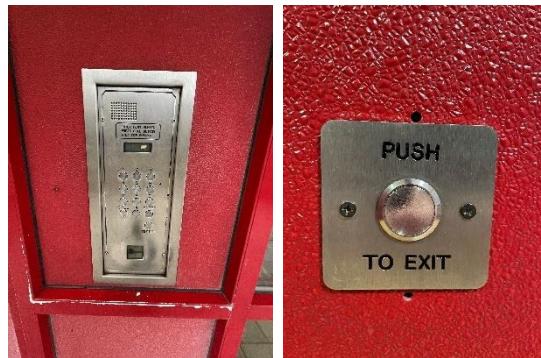
16) The final exit doors have door entry systems installed. These systems are designed to fail safe i.e. door unlocked in the event of a power failure. This prevents residents being locked in or out of the building.

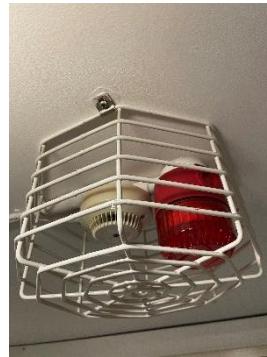
- 4) The communal fire alarm system shall remain as a temporary measure until the results of the FRAEW from the specialist contractor have been received, and any identified remedials have been satisfactorily completed to lower any identified risks. The system shall then be decommissioned.
- 5) The system is addressable so will identify the floor number with the relevant zone number and will state landing / stairs in text on the display.
- 6) The system provides detection to the communal areas which includes stairs, landings, mains cupboards, lift shaft, internal roof space and is also linked to heat detectors within resident's hallways.

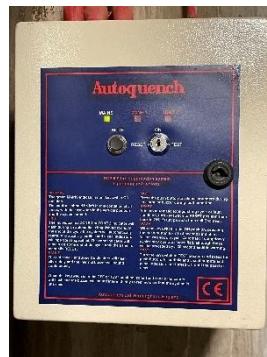
- 7) A deluge system is provided to the refuse chute bin store. An approved contractor maintains the system. The frequency for the maintenance checks are twice per year (April and October) of each calendar year.

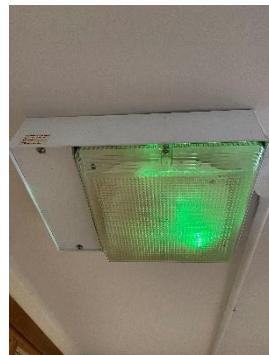
- 1) The premises has a sufficient emergency / escape lighting system in accordance with BS 5266 and has test points strategically located.

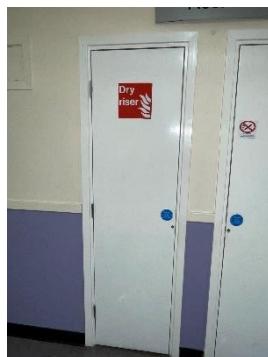
- 4) Dry riser cupboards are secured by use of locked nominal FD30s timber doors.

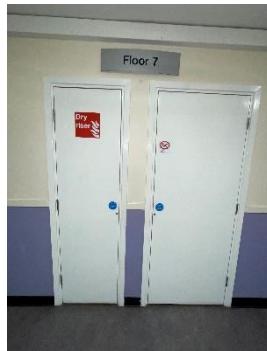
- 5) Service cupboards are secured by use of locked nominal FD30s timber doors.

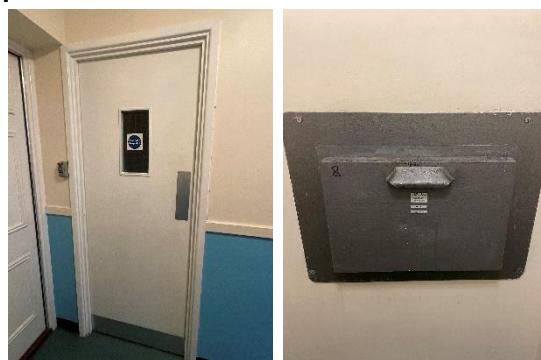
- 6) Chute rooms have nominal FD30s timber doors with Georgian wired vision panel. All refuse hoppers are 1.5 hrs fire rated to BS 476: 8 – 1972.

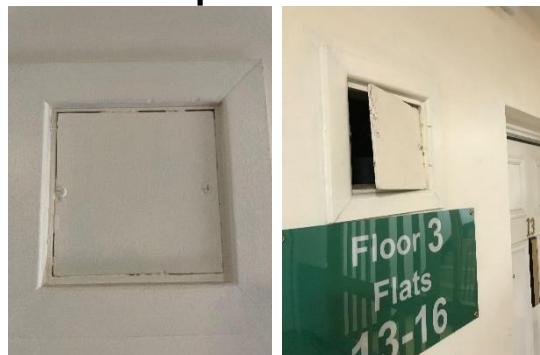
- 11) The fire stopping / compartmentation is subject to a 12-week check by the Fire Safety Rapid Response Team.
- 12) Any remedial works arising from the fire stopping / compartmentation check(s) will be actioned immediately by the Fire Safety Rapid Response Team.
- 13) A variety of methods / materials have been used to achieve fire-stopping including intumescent coated slabs & fire rated sponge.
- 14) Access panels to stop taps are fire resistant board and are fixed to a timber rebated frame on intumescent material. **Cover to stop taps to be fixed back in place outside flat 13.**

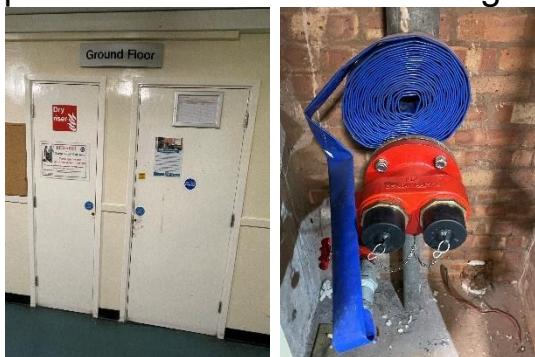
- 1) The dry riser inlet is located in the ground floor lobby opposite the lift car. The cupboard is secured with a budget lock / key.

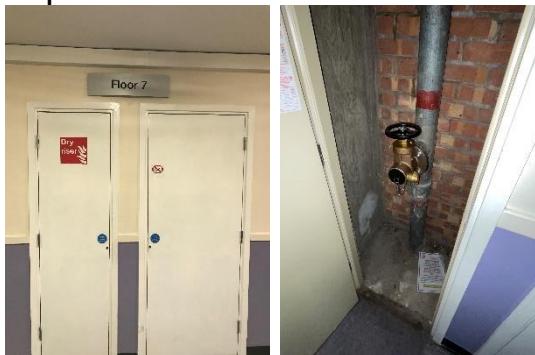
- 2) Dry riser outlets are in cupboards on the communal landing of each floor. All cupboards are secured with a budget lock / key.

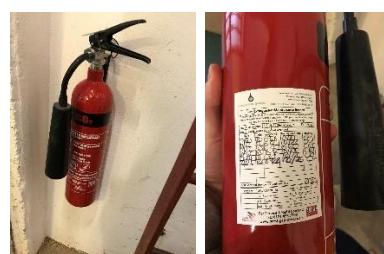
- 3) The dry riser is checked regularly as part of the Caretakers duties.
- 4) Maintenance contracts in place to service the valves twice per year (April and October) with a hydraulic test undertaken annually (October) to comply with the requirements of BS9990.
- 5) Portable fire extinguisher (CO2) is provided to the lift motor room. Service contracts are in place for maintenance of the extinguisher. The frequency for the maintenance checks are once (October) of each calendar year.

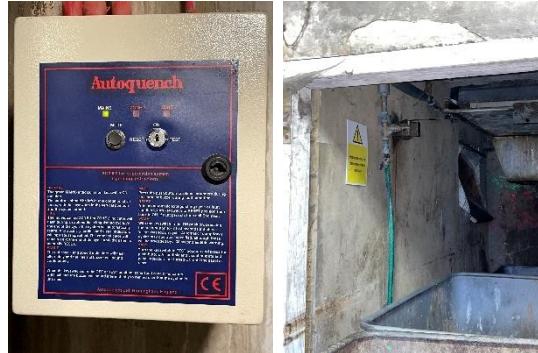
6) Bin room is protected by Deluge/sprinkler system and serviced 6-monthly. The control panel is in the ground floor service cupboard opposite the lift car.

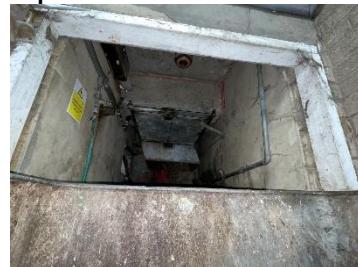
7) There is also a closer plate with fusible link to the bin store chute.

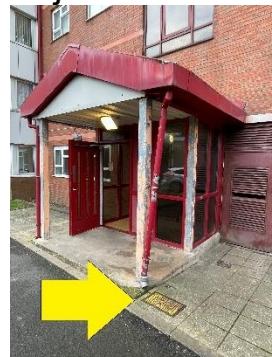
8) There is a fire hydrant adjacent the rear entrance.

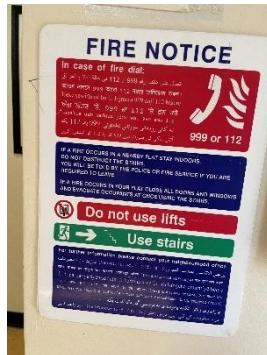
- 2) Fire Action Notices are displayed throughout the building. However, there is no instruction or reference to "on hearing the fire alarm". During the previous FRA, a discussion with the (now former) Head of Building Safety and Compliance, RH has concluded that the Stay Put - Unless evacuation strategy shall remain in place. The communal fire alarm system shall also remain and continue to be maintained as a temporary measure until the results of the FRAEW from the specialist contractor have been received, and any identified remedials have been satisfactorily completed to lower any identified risks. The communal fire alarm will then be decommissioned to align with the stay put strategy and avoid any potential confusion for residents.

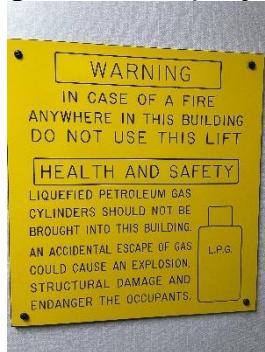
3) Yellow LPG warning signs are displayed within the lift cars.

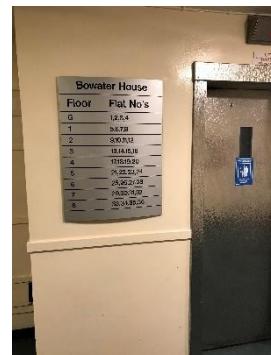
4) Signage depicting the floor location of each flat is fitted to the ground floor lobby wall.

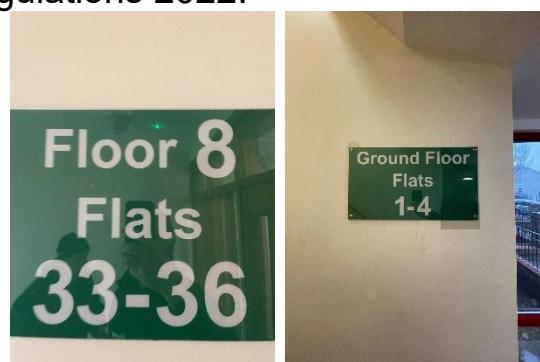
5) Photoluminescent wayfinding signage depicting floor level and flat numbers are fitted to the walls on all floors adjacent the lift car's and to the wall of each landing on the communal staircase. Signage that meets the requirement of ADB and Fire Safety (England) Regulations 2022.

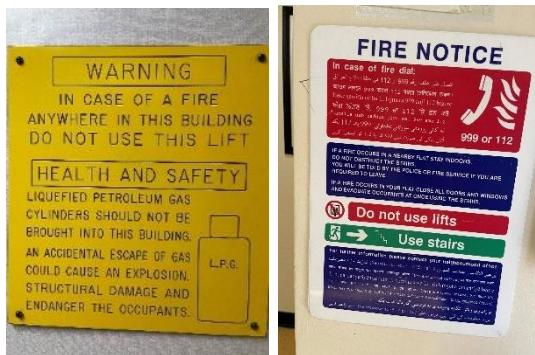
- 1) All Caretaking / Cleaning Employees have undertaken fire safety training. This includes use of bespoke 'Fire Safety in High / Low Rise Flatted Accommodation' Video.
- 2) All employees are encouraged to complete 'In the line of fire' training on an annual basis.
- 3) Caretaking Teams are not currently trained in the effective use of fire extinguishers. The only extinguisher is located within the lift motor room. Caretaking Teams are not expected to tackle fires in this area.
- 4) Staff undertaking fire risk assessments are qualified to Level 4 Diploma in Fire Risk Assessment.
- 5) Fire safety information has been provided as part of tenancy pack.
- 6) Building safety and evacuation notices are displayed in common areas and lift cars.

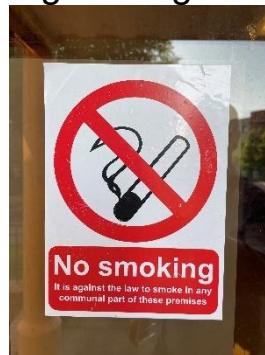
- 1) Smoking is prohibited within any communal parts of the building in line with Smoke Free England legislation.

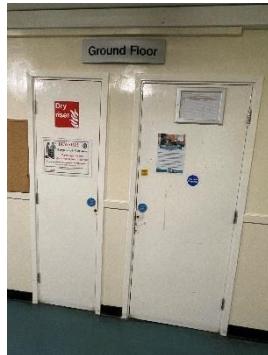
- 5) The electrical installation i.e. risers are contained within dedicated service cupboards that are secure and protected by means of a nominal FD30S door.

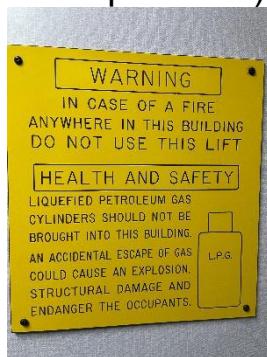
- 1) Residents instructed not to bring L.P.G cylinders into block.
(Notice displayed in lifts see point 9-3)
