# Fire Risk Assessment

## Bowater House

Moor Street, West Bromwich,  
B70 7AZ

**Date Completed:** 20<sup>th</sup> January 2026

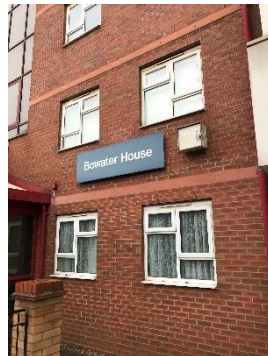
There is a firefighter's white box externally to the right-hand side of the main entrance to the front of the building. The box contains keys for the building and is secured with a bridge-door padlock. Keys stored will be relocated to the PIB box once confirmed with WMFS.

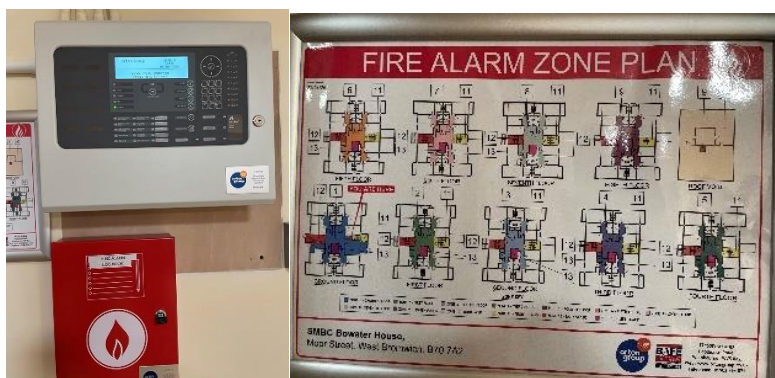
5<sup>th</sup> to 8<sup>th</sup> May 2026 the communal fire alarm was replaced with a new L1 system. Work is ongoing to connect the new fire alarm system to an alarm receiving centre at SMBC CCTV control room. The new system includes the same functions as the previous with additional smoke detectors outside the chute room door on each floor, a lift interface that will send the lift to ground floor upon alarm activation and the removal of the sounder silence function within all flats. For clarity all detector heads have been replaced including, those linked heat detector heads within the hallway of each flat, lift shaft and roof void. The AOV's in each staircase will operate upon detection of smoke in each respective stairwell. The AOV override switch in each stairwell has not been affected by the new fire alarm installation and works as designed too.

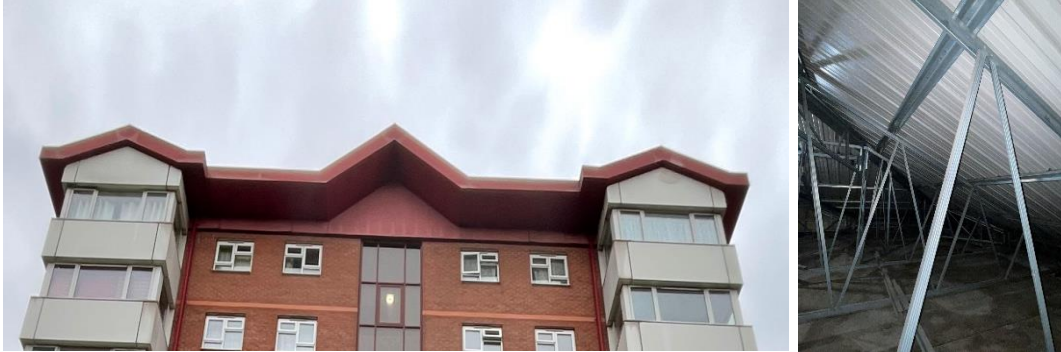
- 1) The exterior of the pitched roof consists of profiled aluminium standing seam mineral wool core composite panels and 14-gauge polyester coated aluminium panels to the soffits and fascia's.

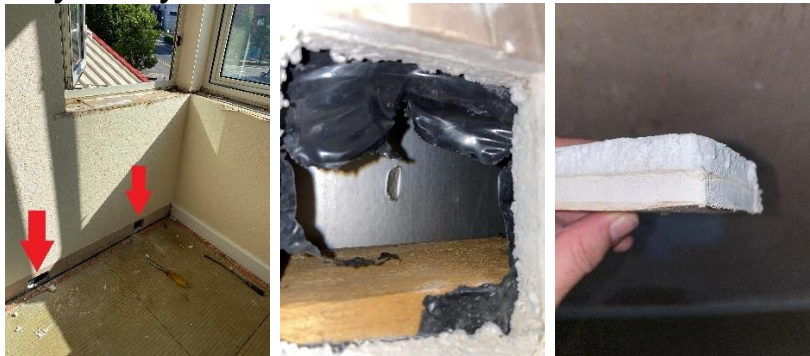
*The borescope could not access beneath or behind the PUR boards or the area where the cavity within the balcony meets the masonry or masonry cavity.*

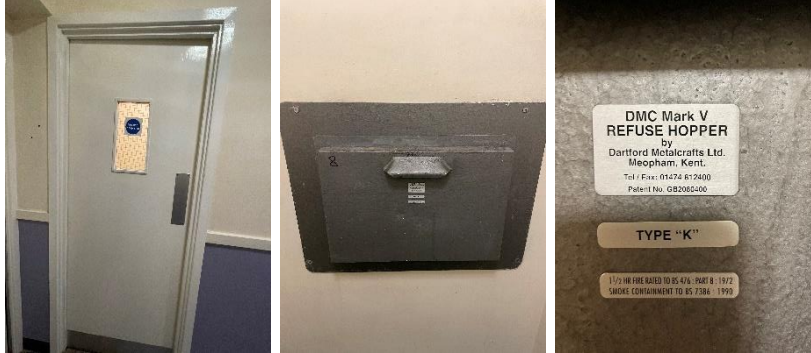
- 13) There is a chute room with a nominal FD30s timber door with vision panel (Georgian wired) on each floor lobby from 1<sup>st</sup> to 8<sup>th</sup>. All refuse hoppers are 1.5 hrs fire rated to BS 476 : 8 – 1972.

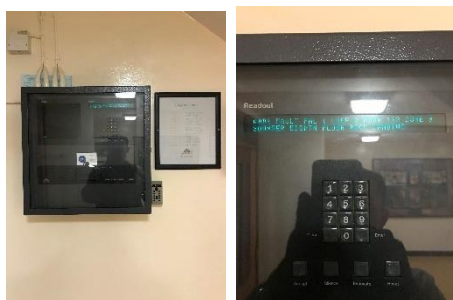
5th to 8th May 2026 the communal fire alarm was replaced with a new L1 system. Work is ongoing to connect the new fire alarm system to an alarm receiving centre at SMBC CCTV control room. The new system includes the same functions as the previous with additional smoke detectors outside the chute room door on each floor, a lift interface that will send the lift to ground floor upon alarm activation and the removal of the sounder silence function within all flats. For clarity all detector heads have been replaced including, those linked heat detector heads within the hallway of each flat, lift shaft and roof void. The AOV's in each staircase will operate upon detection of smoke in each respective stairwell. The AOV override switch in each stairwell has not been affected by the new fire alarm installation and works as originally designed to do.

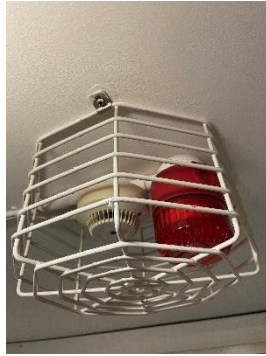
7) A deluge system is provided to the refuse chute bin store. An approved contractor maintains the system. The frequency for the maintenance checks are twice per year (April and October) of each calendar year.

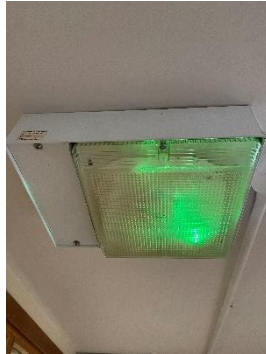
- 1) The premises has a sufficient emergency / escape lighting system in accordance with BS 5266 and has test points strategically located.

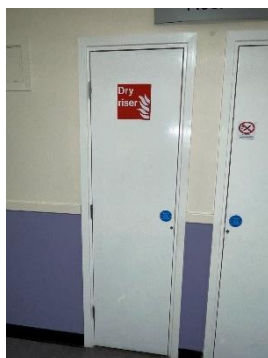
- 4) Dry riser cupboards are secured by use of locked nominal FD30s timber doors.

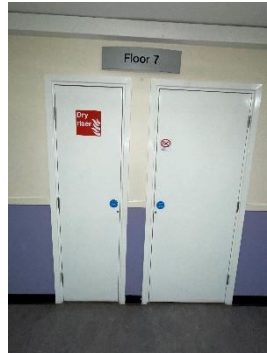
- 5) Service cupboards are secured by use of locked nominal FD30s timber doors.

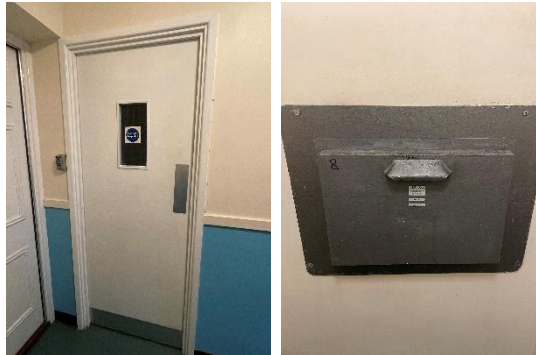
- 6) Chute rooms have nominal FD30s timber doors with Georgian wired vision panel. All refuse hoppers are 1.5 hrs fire rated to BS 476: 8 – 1972.

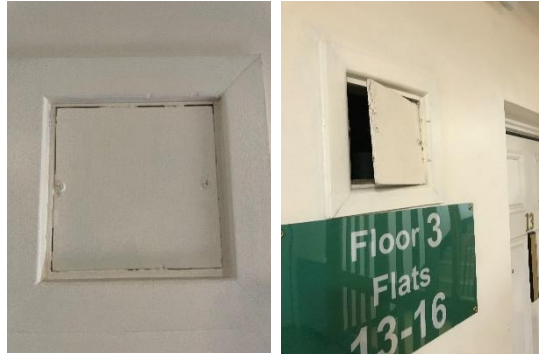
- 11) The fire stopping / compartmentation is subject to a 12-week check by the Fire Safety Rapid Response Team.
  - 12) Any remedial works arising from the fire stopping / compartmentation check(s) will be actioned immediately by the Fire Safety Rapid Response Team.
  - 13) A variety of methods / materials have been used to achieve fire-stopping including intumescent coated slabs & fire rated sponge.
  - 14) Access panels to stop taps are fire resistant board and are fixed to a timber rebated frame on intumescent material. **Cover to stop taps to be fixed back in place outside flat 13.**
-

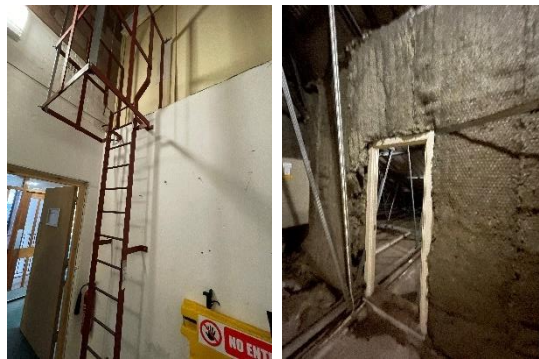
15) The enclosed roof space is compartmentalised by fire curtains and doors. The roof space is accessed via a fixed steel ladder within the lift motor room.

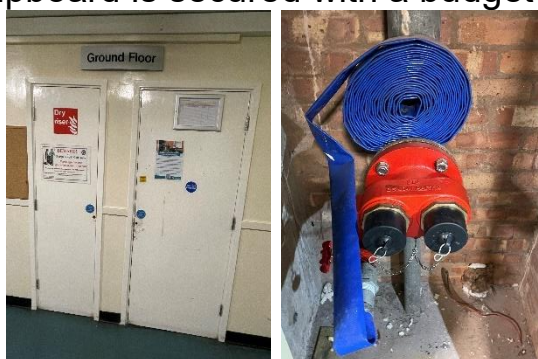
- 1) The dry riser inlet is located in the ground floor lobby opposite the lift car. The cupboard is secured with a budget lock / key.

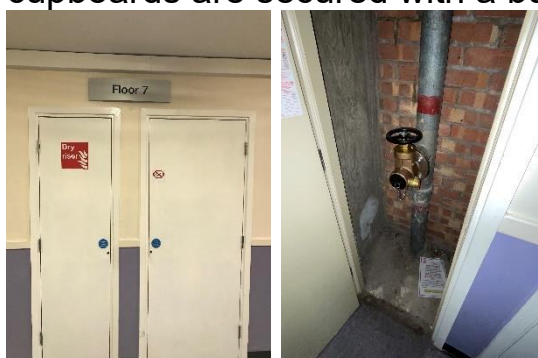
- 2) Dry riser outlets are in cupboards on the communal landing of each floor. All cupboards are secured with a budget lock / key.

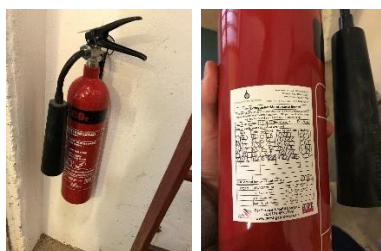
- 3) The dry riser is checked regularly as part of the Caretakers duties.
- 4) Maintenance contracts in place to service the valves twice per year (April and October) with a hydraulic test undertaken annually (October) to comply with the requirements of BS9990.
- 5) Portable fire extinguisher (CO2) is provided to the lift motor room. Service contracts are in place for maintenance of the extinguisher. The frequency for the maintenance checks are once (October) of each calendar year.

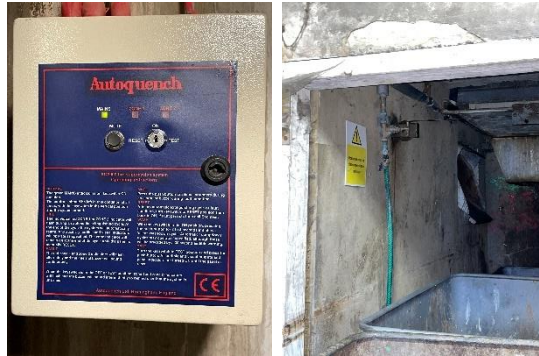
- 6) Bin room is protected by Deluge/sprinkler system and serviced 6-monthly. The control panel is in the ground floor service cupboard opposite the lift car.

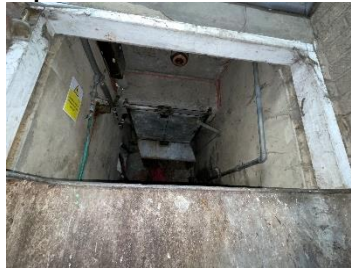
- 7) There is also a closer plate with fusible link to the bin store chute.

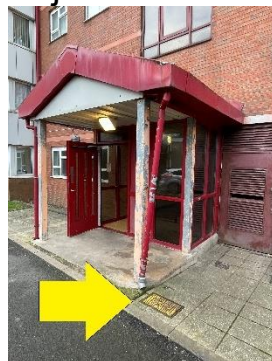
- 8) There is a fire hydrant adjacent the rear entrance.

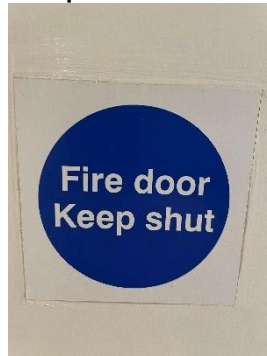
- 1) All fire doors display “Fire Door Keep Shut” where appropriate. Additional signage will be provided within the roof space.

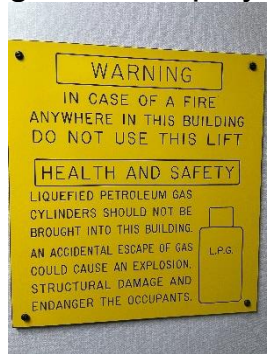
3) Yellow LPG warning signs are displayed within the lift cars.

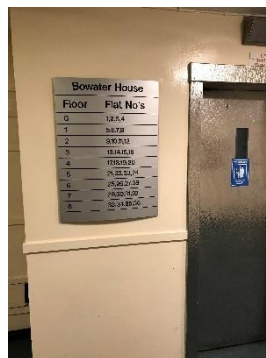
4) Signage depicting the floor location of each flat is fitted to the ground floor lobby wall.

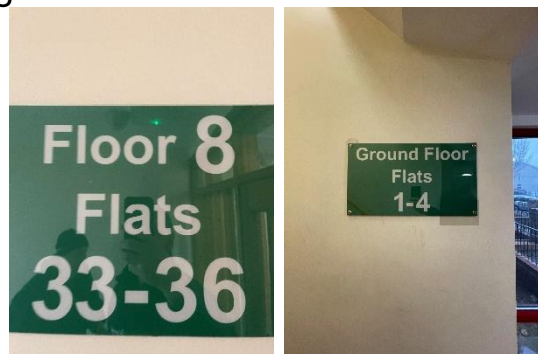
5) Photoluminescent wayfinding signage depicting floor level and flat numbers are fitted to the walls on all floors adjacent the lift car's and to the wall of each landing on the communal staircase. Signage that meets the requirement of ADB and Fire Safety (England) Regulations 2022.

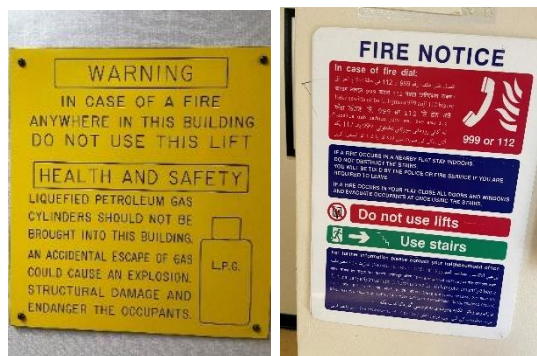
- 1) All Caretaking / Cleaning Employees have undertaken fire safety training. This includes use of bespoke 'Fire Safety in High / Low Rise Flatted Accommodation' Video.
- 2) All employees are encouraged to complete 'In the line of fire' training on an annual basis.
- 3) Caretaking Teams are not currently trained in the effective use of fire extinguishers. The only extinguisher is located within the lift motor room. Caretaking Teams are not expected to tackle fires in this area.
- 4) Staff undertaking fire risk assessments are qualified to Level 4 Diploma in Fire Risk Assessment.
- 5) Fire safety information has been provided as part of tenancy pack.
- 6) Building safety and evacuation notices are displayed in common areas and lift cars.

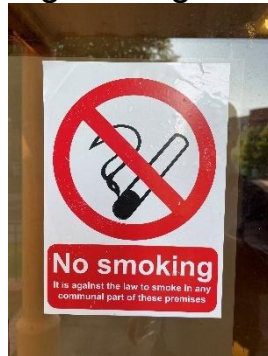
- 1) Smoking is prohibited within any communal parts of the building in line with Smoke Free England legislation.

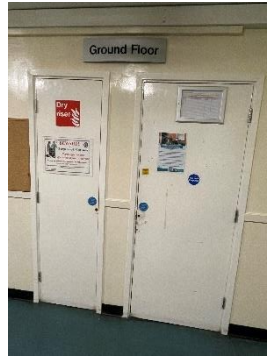
- 5) The electrical installation i.e. risers are contained within dedicated service cupboards that are secure and protected by means of a nominal FD30S door.

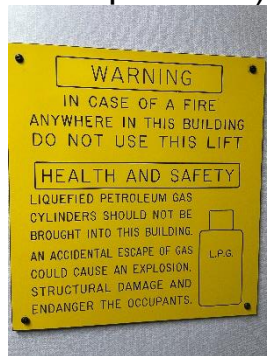
- 1) Residents instructed not to bring L.P.G cylinders into block.  
(Notice displayed in lifts see point 9-3)
