# Fire Risk Assessment

## Lissimore House

**Maria Street, West Bromwich,  
B70 6DR.**

**Date Completed: 01/12/2025**

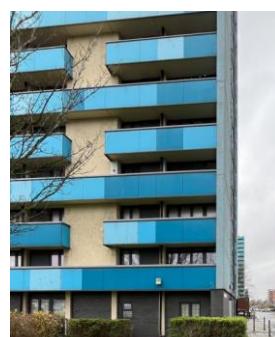
- 5) The bin store, located at the rear elevation of the block, is secured with a roller shutter door.
- 6) It was noted that some balconies had combustible materials in the form of hanging washing, this is deemed an acceptable risk due to the likelihood of a fire starting in this area being low combined with the temporary nature of the activity.
- 7) Fenestration consists of aluminium faced timber composite for resident's flat windows/balcony doors and communal windows.

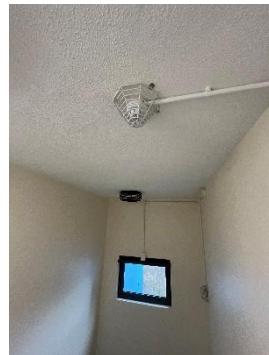
10) A ventilation grill was noted to the head of the staircase.

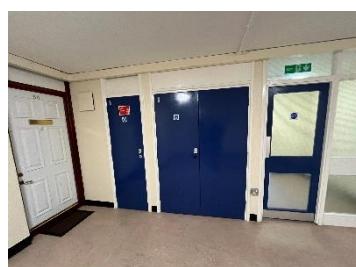
**17) A suspended ceiling tile was noted to be missing in the ground floor lift lobby. This tile is required to be replaced. Missing ceiling panels may slow down smoke getting to an AOV detector head. See action 7/17**

Question/ Ref No	Required Action	Supporting photograph	Priority	Timescale and Person Responsible	Date Completed
7/17	A suspended ceiling tile was noted to be missing in the ground floor lift lobby. This tile is required to be replaced.

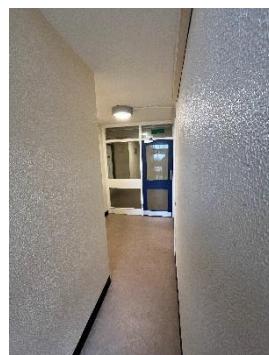
**19) Individual floor mats were noted outside some flats. Fire rating of the mats is unknown but deemed to be of low risk.**

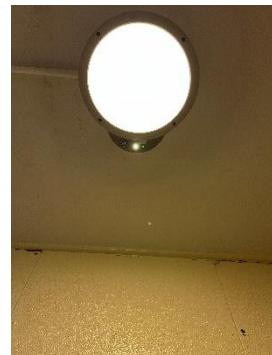
- 1) The premises has a sufficient emergency / escape lighting system in accordance with BS 5266 and has test points located within electrical cupboards.

- 2) The self-contained units are provided to the communal landings, stairs, and lift motor room.
- 3) All installed equipment is checked and tested monthly by Sandwell MBC in house electrical team or approved contractor, in accordance with current standards.

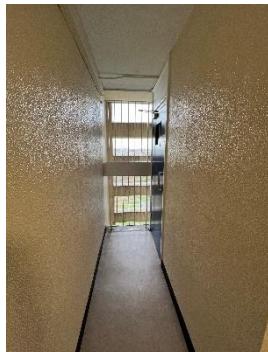
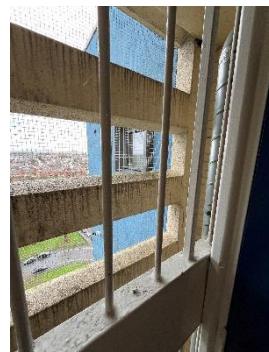
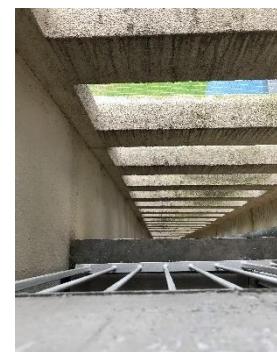
- 3) The design of the naturally ventilated shaft serving the single escape corridor presents a breach of compartmentation throughout the height of the building from the 1<sup>st</sup> floor upwards. The potential therefore does exist for smoke logging on all floors within an escape route. This situation is further affected by the proximity of flat windows to the ventilated shaft. Current measures are in place to help mitigate the risk such as the stay put policy, smoke detection within resident's flats to an LD2 standard, notional FD30s doors providing protection from the landing to the flat lobby and protected staircase. The external wall next to shaft has a fire classification of Euro class A2 (NON combustible can be used above 18m). Fire Safety Meetings have taken place to discuss said issue, resulting in the opinion of the Fire Safety manager and the Team Lead Building Safety stating the risk was low. It is the opinion of the fire risk assessor that to reduce the risk even further when future improvement works next take place, consideration should be given to improving fire stopping/ compartmentation at floor level and/or adopt the design currently present within Mountford House (use of fire rated door and frames separating the bin chute lobby and

landing/corridor area within the means of escape). See Observations.

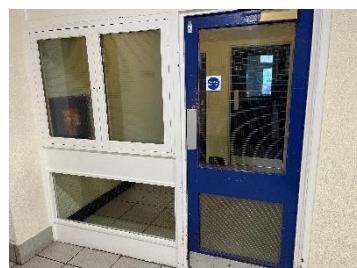
- 4) A variety of methods / materials have been used to achieve fire-stopping including Rockwool and intumescent pillows.
- 5) All communal doors are fitted with automatic closing devices that are checked on a regular basis by Caretaking Teams as part of their checks. Defective closing devices are replaced either by the Caretaking Team(s) or the in-house repairs team(s).

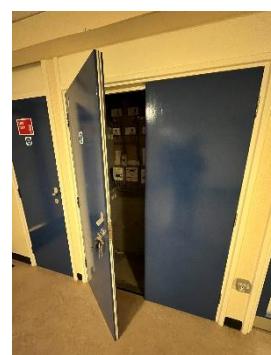
- 5) All service cupboards to communal landings have notional fire doors with a minimum of 30 minutes fire resistance, upgraded with smoke and intumescent seals and locked with suited mortice locks.

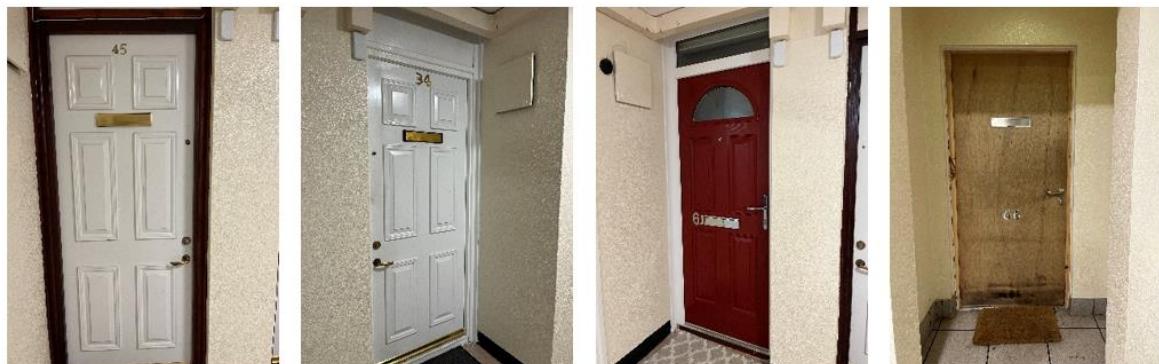
7) Individual flat doors are predominantly nominal FD30s fire door sets except for some nominal timber door sets.

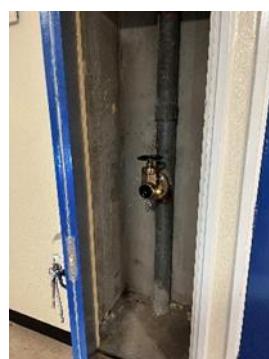
8) Dry riser outlets on lobbies are housed in secured service cupboards (suited 54 mortice lock) with 54mm nominal 60-minute fire doors with intumescent strips and cold smoke seals.

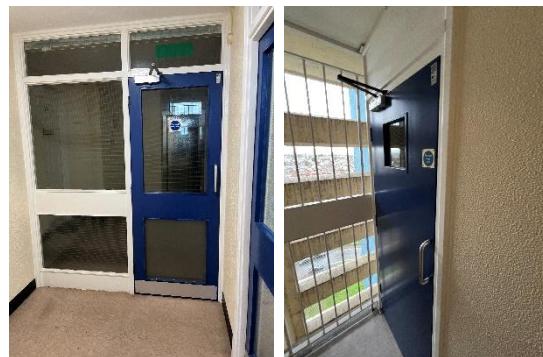
9) The communal landing, staircases & chute rooms are protected by notional self-closing 44mm 30-minute timber fire doors with vision panels & 25mm stops.

Some communal notional fire doors show signs of wear and tear due to age. Consideration should be given to upgrade these doors with certified FD30s door sets & combination frames as part of any future work programme.

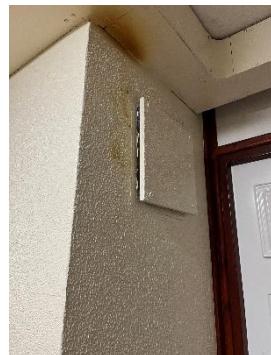
10) Access panels to service pipework are Supalux and bedded on intumescent mastic.

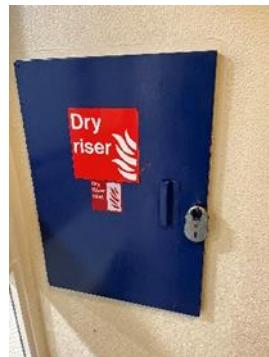
- 1) The dry riser inlet is located within the ground floor lift lobby, inside a cupboard secured with a fire service bridge door padlock.

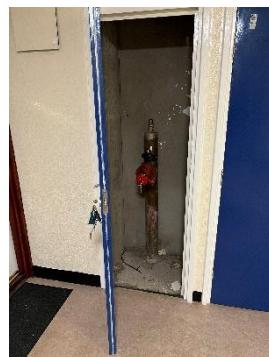
- 2) There is a dry riser outlet on each floor lift lobby, secured within a riser cupboard, the cupboards are locked with a suited 54 key.

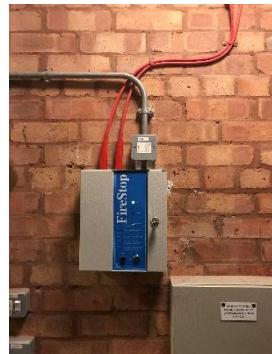
6) A sprinkler or deluge system is provided to the refuse chute bin store. An approved contractor maintains the system. The frequency for the maintenance checks is twice per year (April and October) of each calendar year.

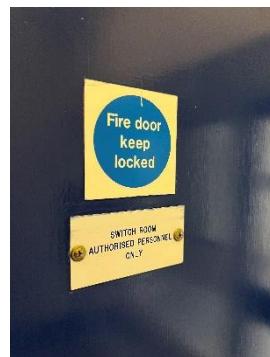
- 1) Fire doors display suitable signage where appropriate.

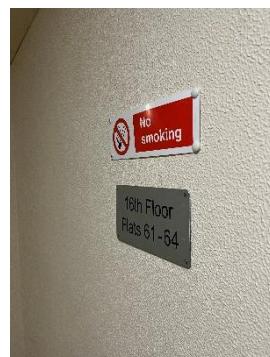
- 2) No smoking (Smoke Free England) signage is displayed throughout the premises.

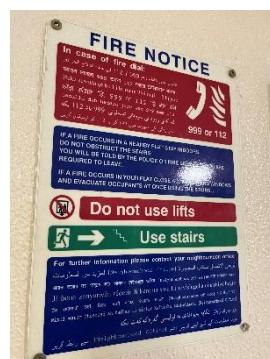
- 3) Fire Action Notices are displayed throughout the building.

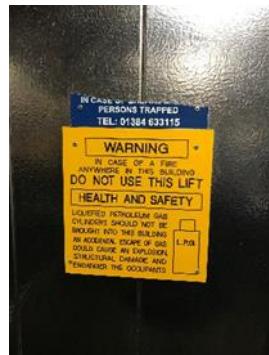
4) Yellow LPG warning signs are displayed within the lift cars.

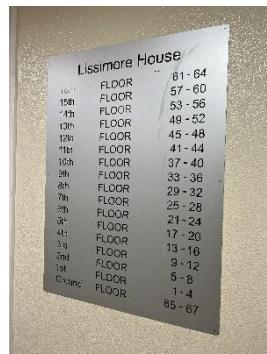
5) Signage to depicting the floor location of each flat is fitted to the ground floor lobby wall.

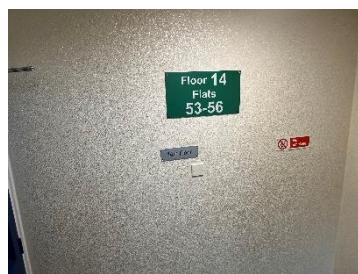
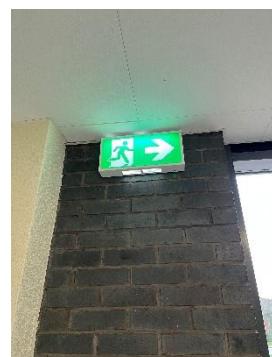
6) Photoluminescent wayfinding signage depicting floor level and flat numbers and directional fire escape signage has been installed. The signage meets the requirement the Fire Safety (England) Regulations 2022.

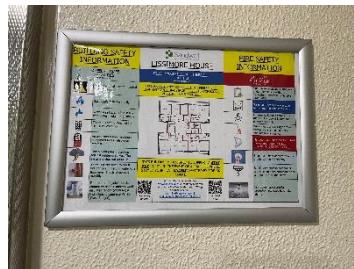
- 1) All Caretaking / Cleaning Employees have undertaken fire safety training. This includes use of bespoke 'Fire Safety in High / Low Rise Flatted Accommodation' Video.
- 2) All employees are encouraged to complete 'In the line of fire' training on an annual basis.
- 3) Caretaking Teams are not currently trained in the effective use of fire extinguishers. The only extinguishers are located within the lift motor room. Caretaking Teams are not expected to tackle fires in this area.
- 4) Building safety and evacuation notices are displayed in common areas and lift cars.

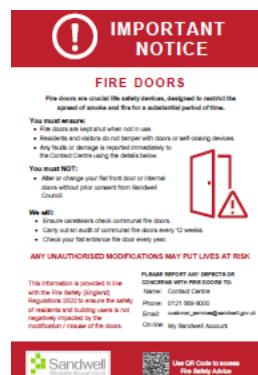
- 5) Staff undertaking fire risk assessments in high rise buildings are qualified to a Level 4 Diploma in Fire Risk Assessment.
- 6) Fire safety has been provided as part of tenancy pack. This includes information about Fire Doors.

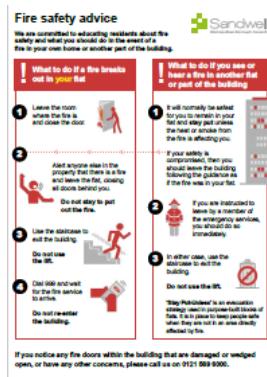
7) Information regarding the Stay Put unless fire evacuation strategy is provided to residents.

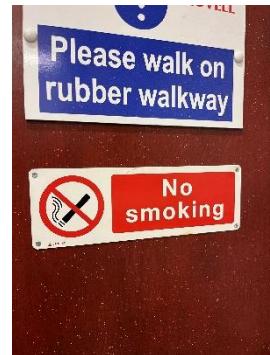
- 1) Smoking is prohibited within any communal parts of the building in line with Smoke Free England legislation.

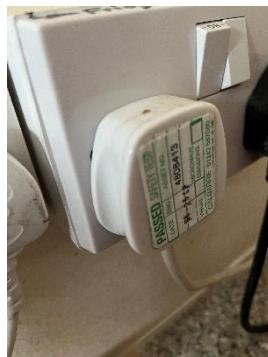
- 8) Electrical appliances within the kitchen/ welfare room have been subject to PAT testing and noted down as being in date 06/25.

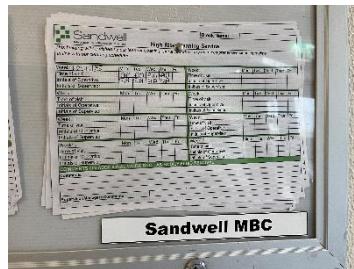
- 1) There is a regular Cleaning Service to the premises.

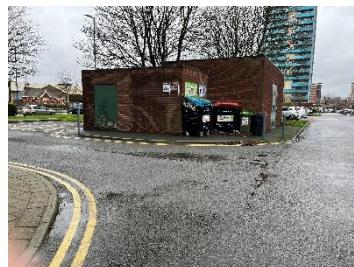
- 2) Refuse & recycling containers are emptied regularly. Refuse containers are in the bin store which is at the rear of the block. There is also a recycling project currently being undertaken at the block, recycling bins are stored at a suitable distance away from the block within the car park.

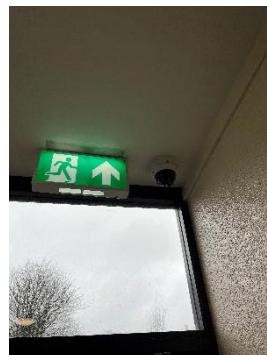
- 3) CCTV has been installed to the ground floor lobby, each entrance and around the building.
