# **Fire Risk Assessment**

## **Meadow Avenue (Beech).**

**Charlemont Farm, West Bromwich,  
B71 3EJ.**

**Date Completed: 03/02/2026**

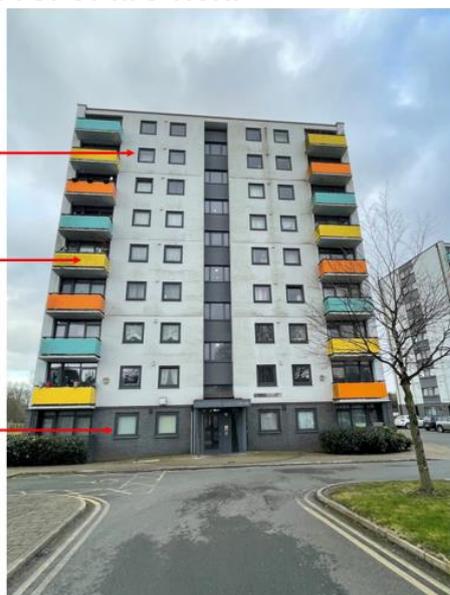
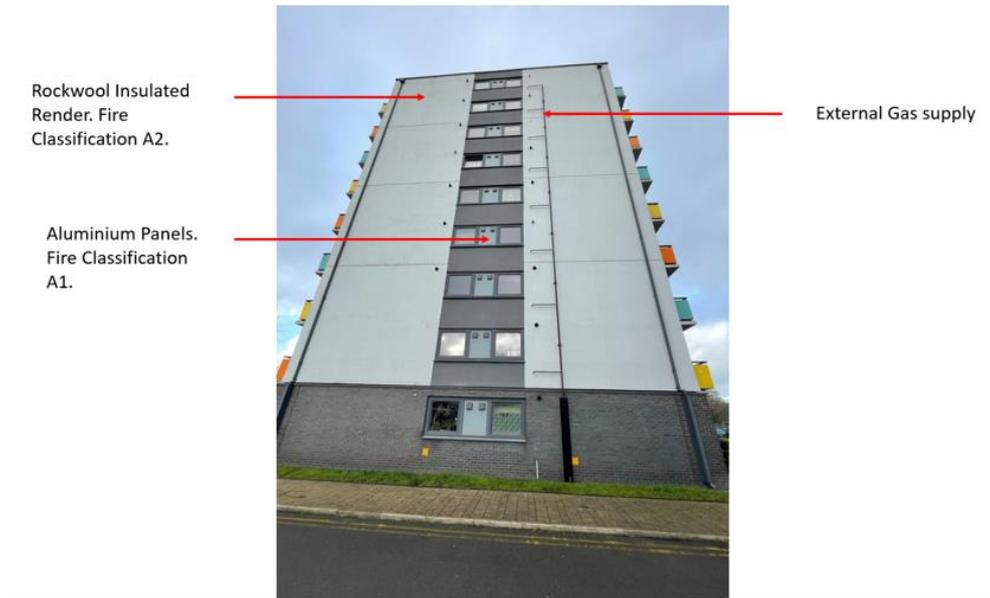
- 1) The external wall at Beech House has 3 separate areas of cladding. The external wall system was upgraded in 2017/18 and comprises of:
  - Brickwork from ground to 1ST floor. Fire classification A1.
  - At the time of the assessment repairs were ongoing to rectify damaged caused by a vehicle impact to the ground floor exterior wall.

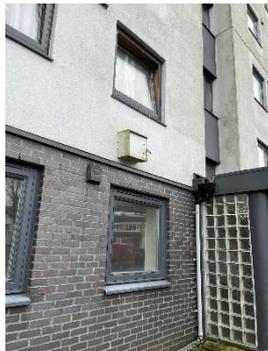
- Wetherby EW1 render system 1st to 8th floor. Fire classification A2

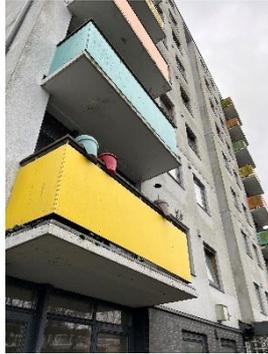
- Trespa HPL panels to balconies. Fire classification B-s1, d0.

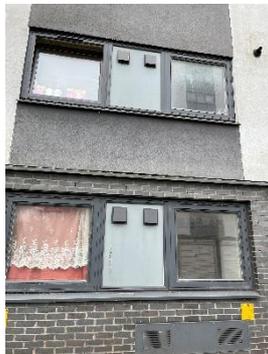
- Aluminium panels. Fire classification A1.

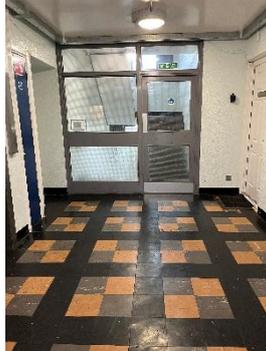
- 6) The communal landing / staircases are protected by use of notional FD30s fire doors with vision panels. These doors have been upgraded with a combined strip consisting of a cold smoke seal and intumescent strip.

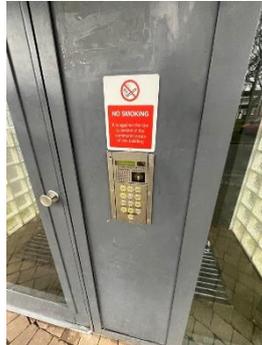
- 13) The final exit doors have door entry systems installed. These systems are designed to fail safe i.e. door unlocked in the event of a power failure. This prevents residents being locked in or out of the building.

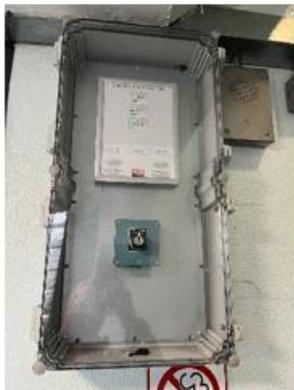
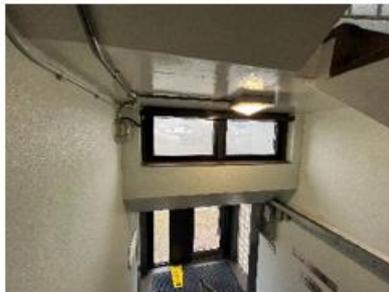
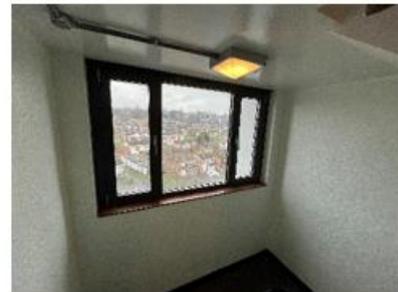
- 14) Automatic smoke ventilation is employed in the front protected staircase, on half landings on floors 1, 5 and 7. This is tested, inspected, and maintained by a competent procured contractor in accordance with BS7346. The frequency for the maintenance checks is twice per year. (April and October). The rear staircase has louvre ventilation on all floors. Windows can be opened with use of a key.

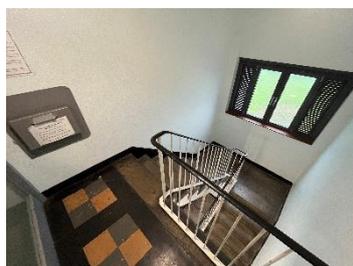
- 15) Refuse chute hoppers are available on each floor, within the rear stairwell. The chute system is connected to the bin store at the rear of the building.

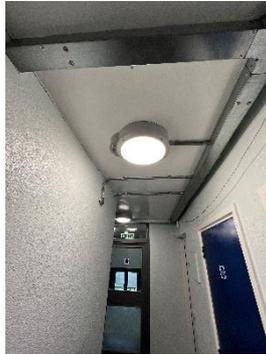
- 16) Emergency lighting is provided to communal lobbies and stairs. Checks are done monthly by Sandwell MBC in house electrical team or approved contractor.

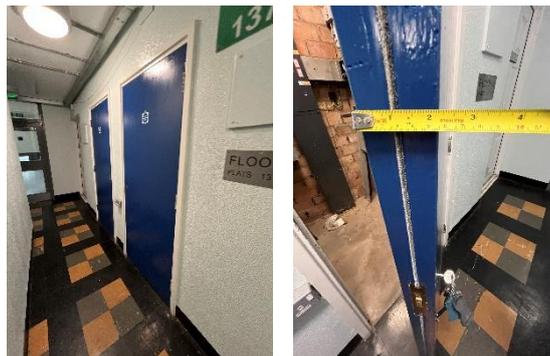
- 17) Residents' electrical meters are situated in the cupboards on all floors, protected with FD60s doors.

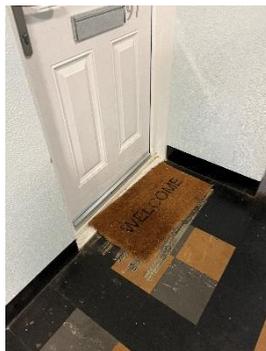
- 19) Individual floor mats were noted outside some flats. Fire rating of the mats is unknown but deemed to be of low risk.

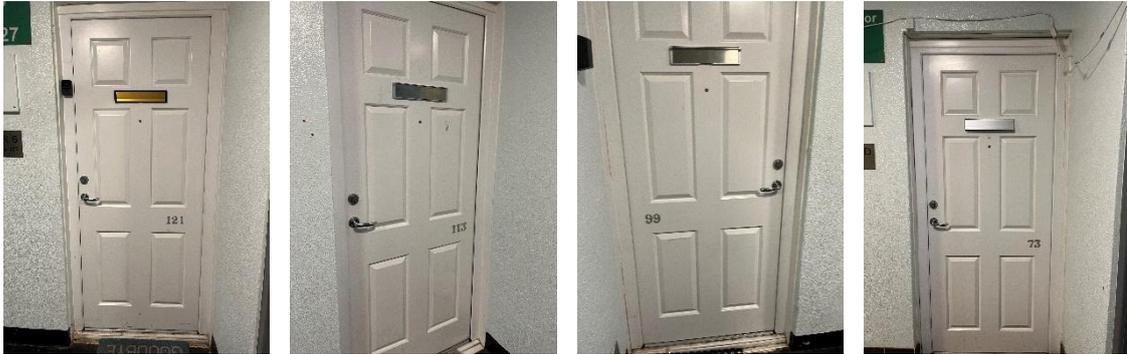
20) Individual flat entrance doors are FD30S rated Permadoor of composite construction.

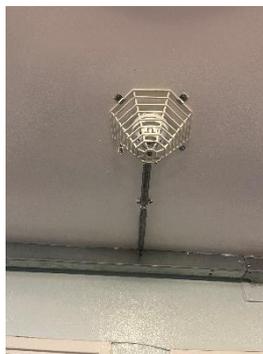
- 3) There is no effective means for detecting an outbreak of fire to the remaining communal areas. Automatic fire alarm systems are not usually required in the common areas of residential blocks as this can compromise the 'Stay Put' evacuation policy.
- 4) Smoke detectors linked to the automatic opening vent have been installed on stairwell and landing lobbies. The vents in the front stairwell will automatically open when smoke has been detected.

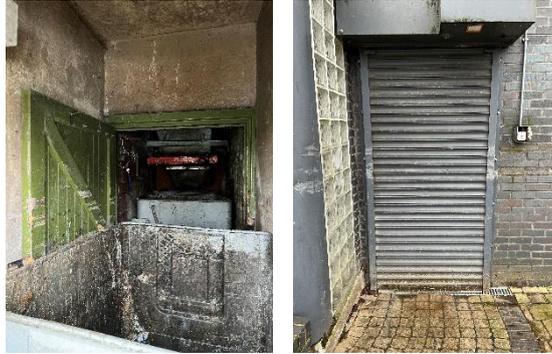
- 5) A deluge system is provided to the refuse chute bin store. Detectors for actuation are sited within the bin store. An approved contractor maintains the system. The frequency for the maintenance checks is twice per year (April and October).

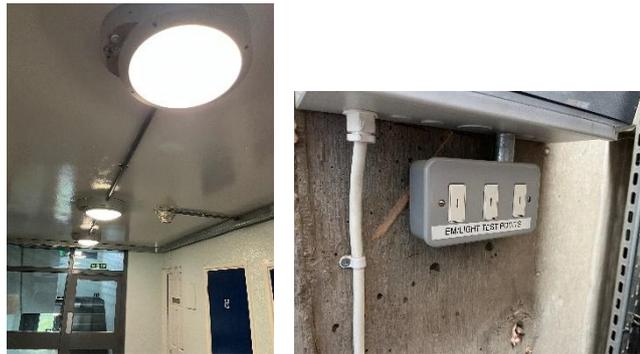
- 1) The premises has a sufficient emergency / escape lighting system in accordance with BS 5266 and has test points located within electrical cupboards. The self-contained units are provided to the communal landings, stairs and lift motor room.

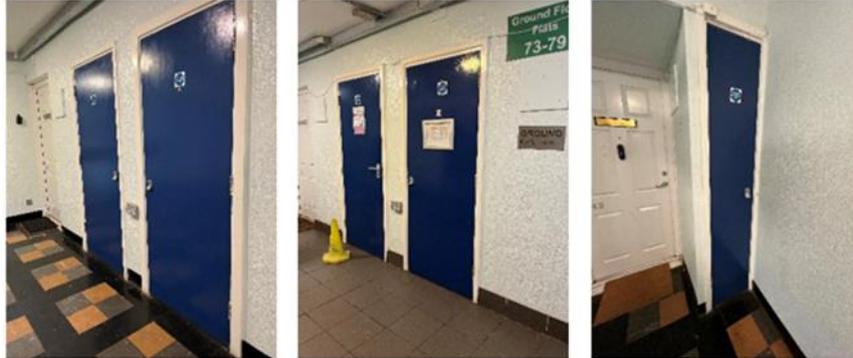
- 6) All floor service cupboards are notional, upgraded, FD30s or FD60s timber fire door sets. The keys are held centrally at SMBC Roway Lane, and within the firefighter's white box.

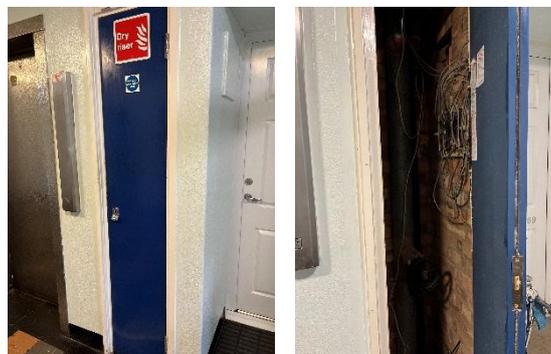
- 8) Dry riser cupboards on all floors are behind upgraded FD30s fire doors.

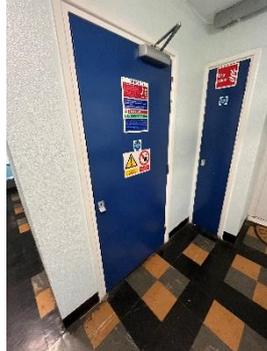
- 9) The lift motor room door is a notional FD60s timber fire door set. The keys are held centrally at SMBC Roway Lane, and within the firefighter's white box.

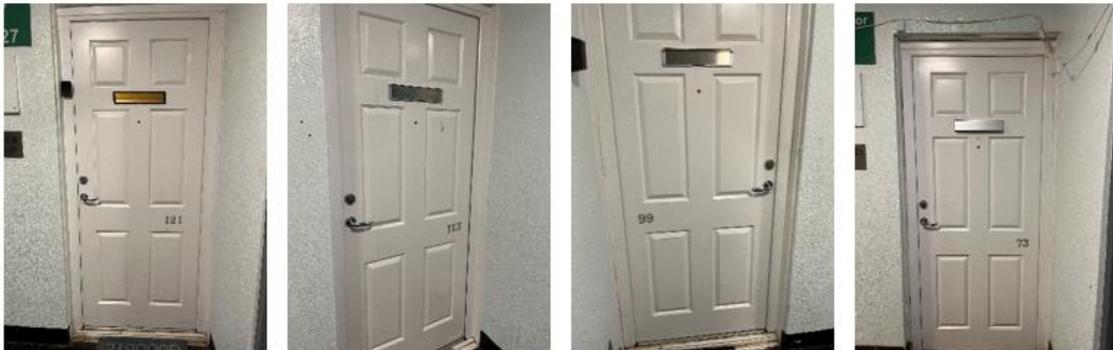
- 10) Individual flat entrance doors are FD30S rated Permadoor of composite construction.

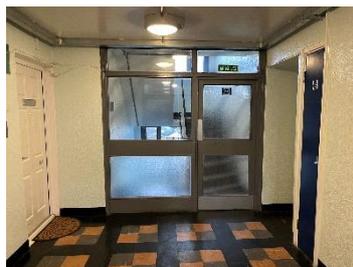
- 11) The communal staircase, lobbies and corridors are protected by use of notional FD30s self-closing timber fire doors with vision panels. The vision panels are georgian wired glass.

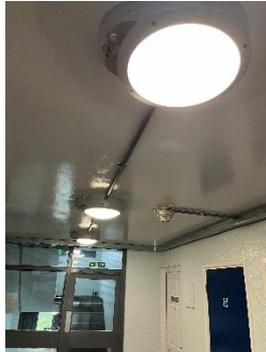
- 12) Cabling from service cupboards / risers to individual meter cupboards and AOV controls is housed in metal trunking.

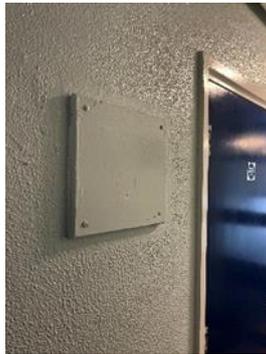
- 13) Access panels to stop taps are secured behind a panel cupped and screwed above the meter cupboards.

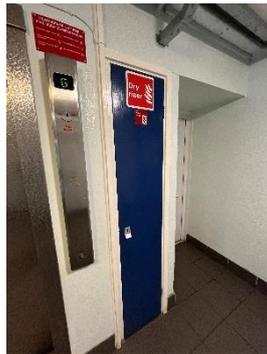
- 1) The dry riser inlet is internal, within a cupboard in the ground floor lift lobby. Secured with a type 54 suited mortice lock.

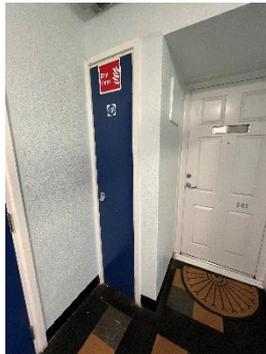
- 2) The dry riser outlets are located within cupboards on all floors, secured with a type 54 suited mortice lock. The dry risers are checked regularly as part of the caretakers' duties.

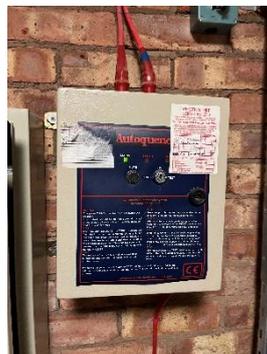
- 6) A deluge system is provided to the refuse chute bin store. The control unit is situated in the ground floor electrical cupboard. An approved contractor maintains the system. The frequency for the maintenance checks is twice a year (April and October).
