Fire Risk Assessment Greenford House

**Maria Street, West Bromwich,
B70 6DX**

Date Completed: 17/01/2024

Current Risk Rating = Tolerable

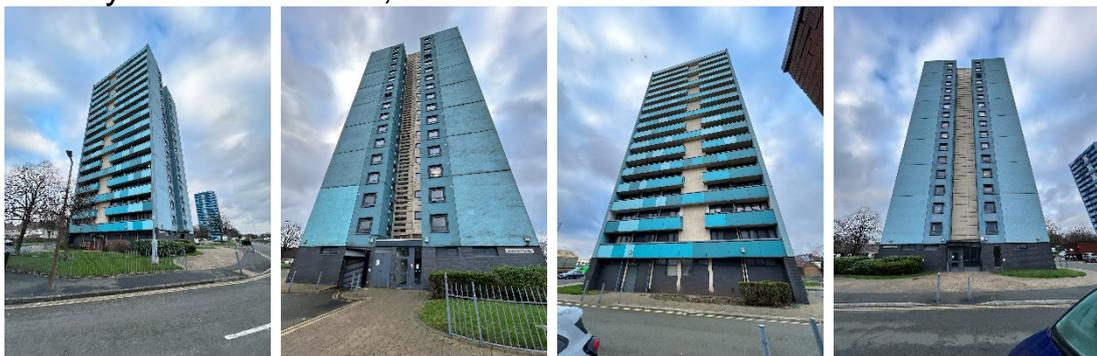
- 2) External facade is made up of four materials 1% brick, 53% render, 28% Glass, and 18% balcony cladding (high density laminate).

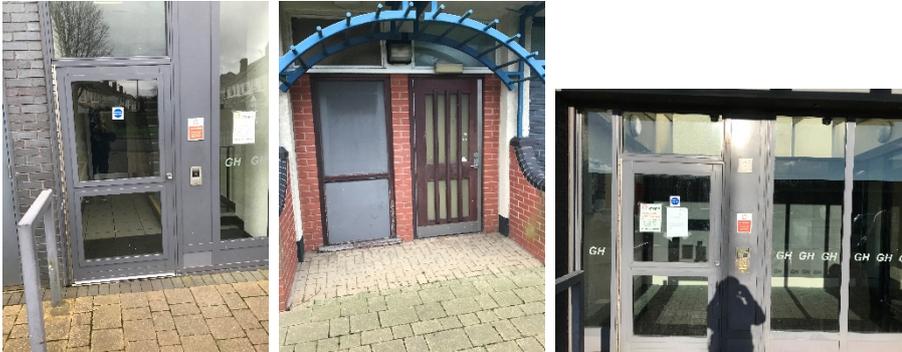
- 3) Front and rear entrance/exit is constructed of an aluminium door and frame with double glazing. Front entrance you pass through two sets of doors before entering the ground floor lobby area of the block. Additional side entrance is a timber door and frame.

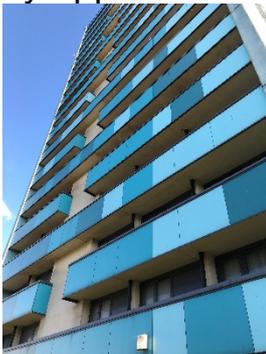
- 4) Residents have access to balconies, Trespa over cladding to a concrete panel between balconies with 100mm rockwool insulation by approved aluminium cladding.

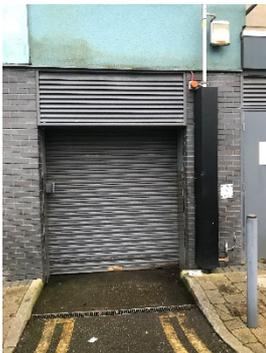
- 5) Bin store located at the rear elevation of the block; bin store is secured with a steel roller shutter door.

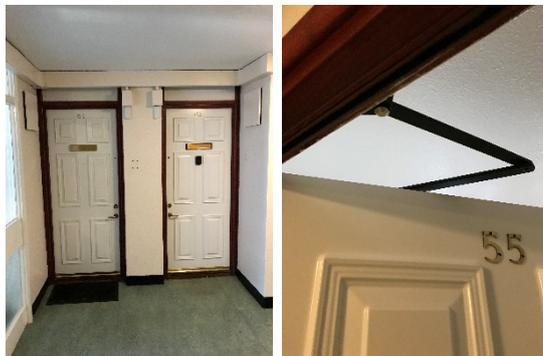
- 19) The building has sufficient passive controls that provide effective compartmentation in order to support a Stay Put-Unless Policy. Therefore, residents are advised to remain in their flat unless the fire directly affects them, or they are asked to leave by the emergency services.
- 20) Individual flat doors are predominantly nominal 44mm composite fire door sets with the exception of some nominal timber door sets with intumescent strips, cold smoke seals and self-closing devices FD30S.

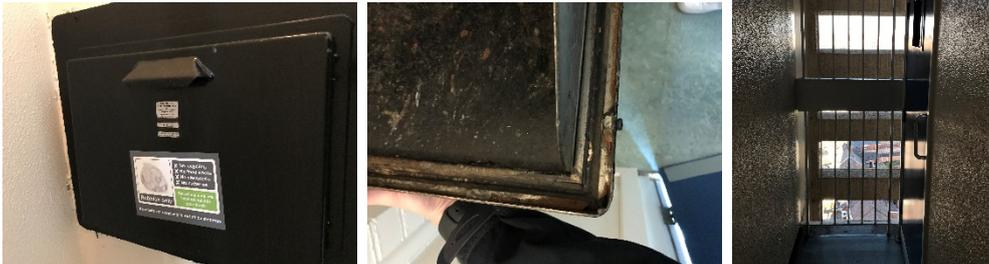
- 22) The refuse chute hoppers are fitted with intumescent strips and are secured behind nominal 44mm, 30-minute fire doors with combined intumescent strips & cold smoke seals along the means of escape.

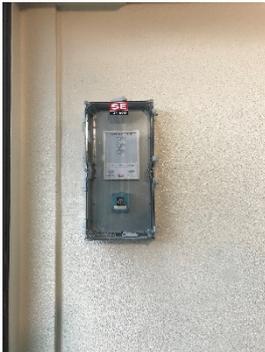
- 23) Smoke control systems located on the ground floor near the main entrance to the block.

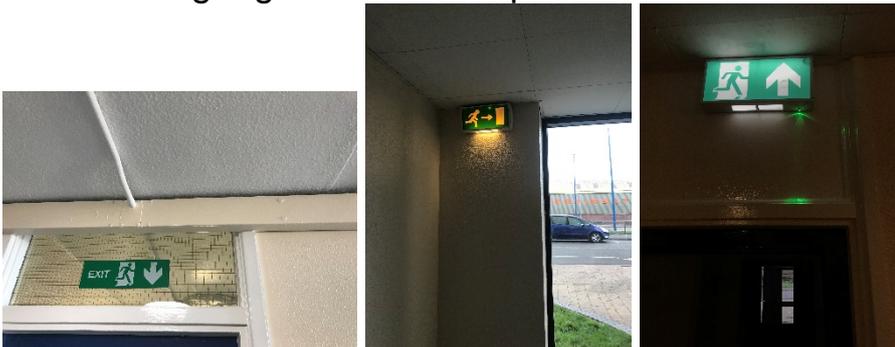
- 24) There is a plan in place for new wayfinding signange to be introduced on all floors within the block including lift lobby and the stair landing area.there is current signange in place dipicting floor location and flat numbers

- 25) Fire exit signange has been implimented on all floors of the block.

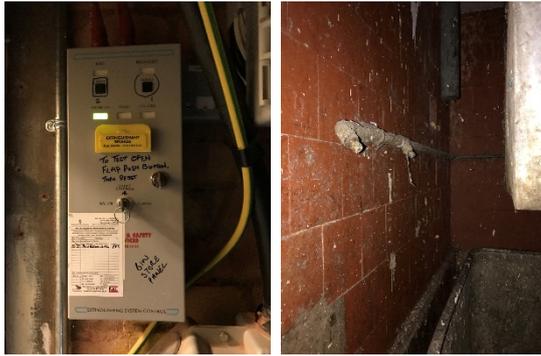
- 3) There is no effective means for detecting an outbreak of fire to communal areas. The reason for this are:
 - I. Such systems may get vandalised.
 - II. False alarms would occur.
 - III. A Stay Put - Unless policy is in place
 - 4) A sprinkler or deluge system is provided to the refuse chute bin store. An approved contractor maintains the system. The frequency for the maintenance checks are twice per year (April and October) of each calendar year. the control panel for the sprinkler deluge system is located within the electrical intake store next to the bin store at the rear of the block.
-

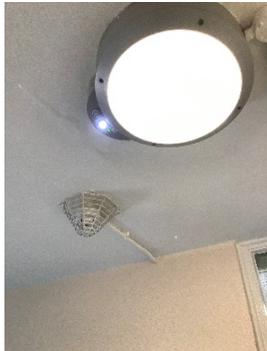
- 1) The premises have a sufficient emergency system in accordance with BS 5266 and has test points strategically located.
- 2) The self-contained units are provided to the communal landings, stairs and lift motor room.

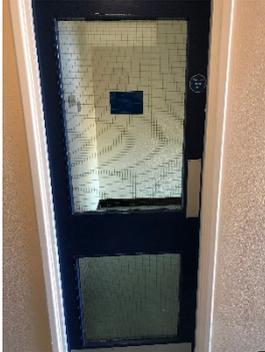
The communal landing, staircases & chute rooms are protected by use of notional self-closing 44mm 30-minute timber fire doors with vision panels & 25mm stops.

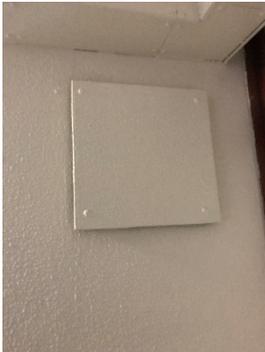
- 10) Access panels to stop taps are fixed to masonry and bedded on Intumescent material

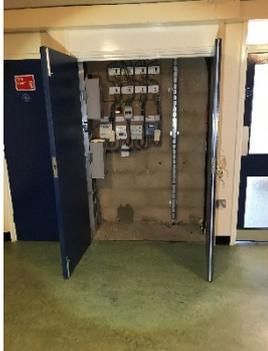
- 13) Cupboard doors within the communal areas such as residents meter cupboards/ electrical risers & Dry Riser cupboards are nominal 44mm composite fire door sets with intumescent strips, cold smoke seals.

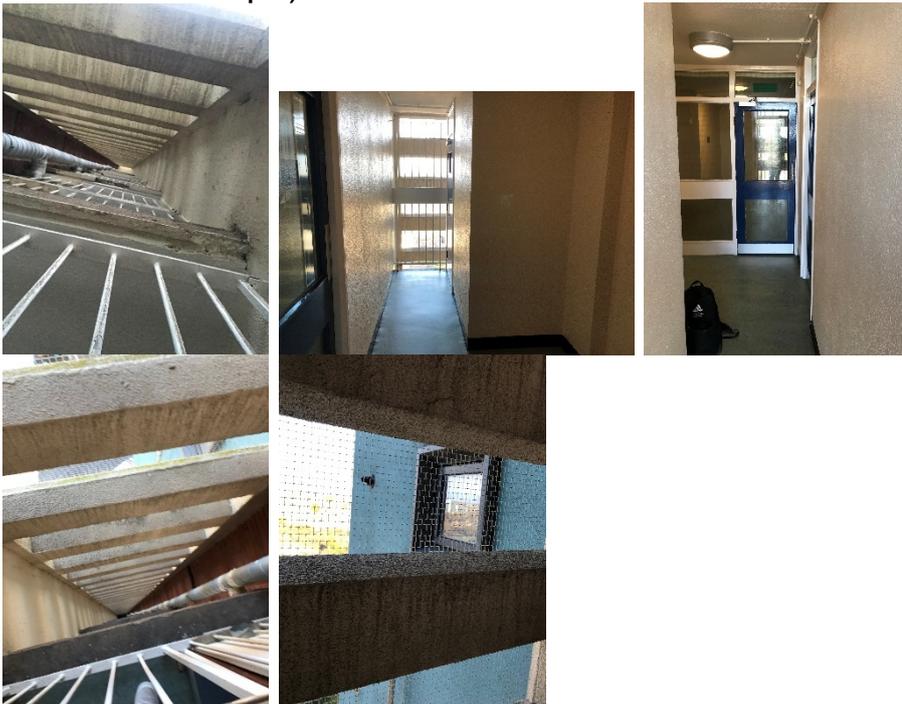
Noting that present day regulations would require ventilation to the corridor (ADB) which Lissimore has in the form of natural ventilation to all floors. Meetings have taken place to discuss said issue.

It is the opinion of the fire risk assessor that to reduce the risk even further when future improvement works next take place at the block consideration should be given to improving fire stopping/compartmentation at floor level and/or adopt the design currently present within Mountford House (use of fire rated door and frames separating the bin chute lobby and landing/corridor area within the means of escape).

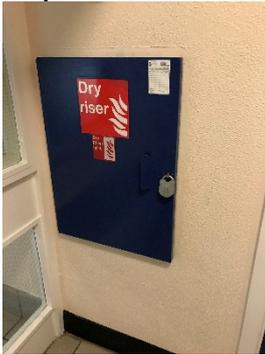
- 1) The dry riser inlet cupboard is located in the ground floor lift lobby and is appropriately signed. The riser is accessed behind a metal cupboard and secured via a padlock

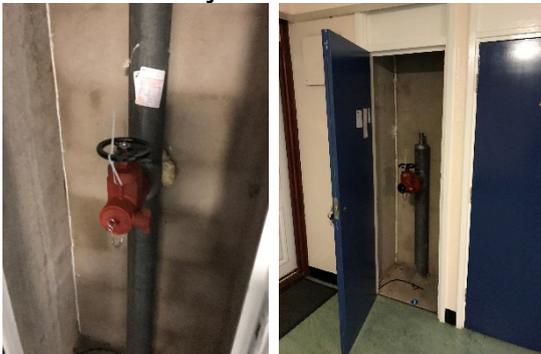
- 2) The riser outlets are available on each floor lobby (1st – 16^h) these are protected via nominal 44mm 30-minute fire doors secured by suited 54 key & mortice locks.

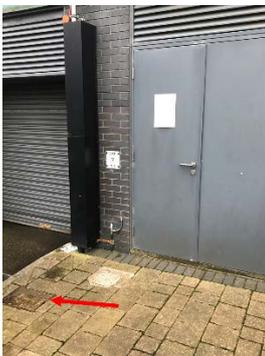
- 6) Fire hydrant can be located at the rear entrance/exit of the building 1m from the door near the bin store shutters.

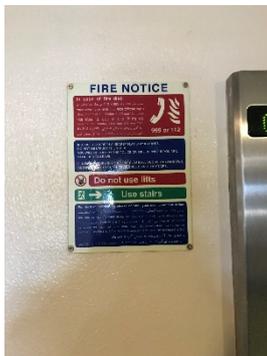
- 2) Fire Action Notices are displayed throughout the building.

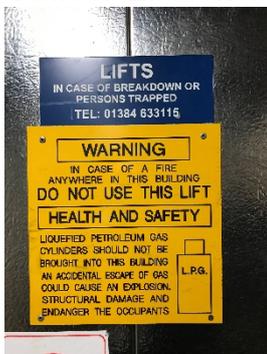
- 3) Yellow LPG warning signs are displayed within the lift cars.

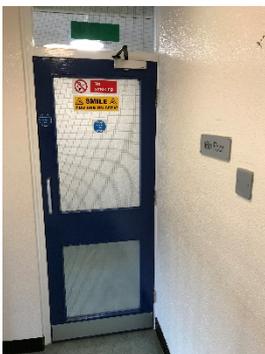
- 5) A plan to install new Wayfinding Signage to the block depicting floor level and flat numbers is to be fitted to the wall adjacent to lift and within the staircase. This will meet the requirements set out in the Fire Safety (England) Regulations 2022.
- 6) Currently there is signage on each floor of the block as well as on the wall of each floor from the staircase

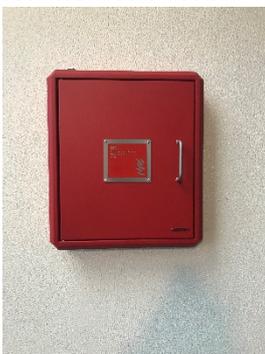
- 7) Premise information box is signed appropriately and located at the main entrance to the block.

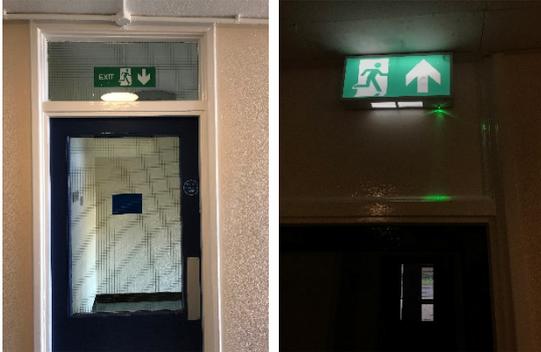
- 8) The fire escape routes have directional signage placed within the block, note the illuminated emergency escape light testing records are yet to be established and should be confirmed.

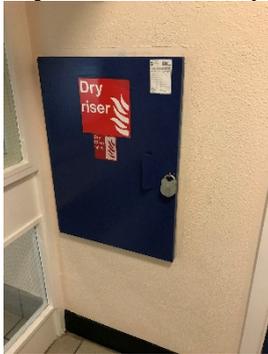
- 9) Dry risers are appropriately signed

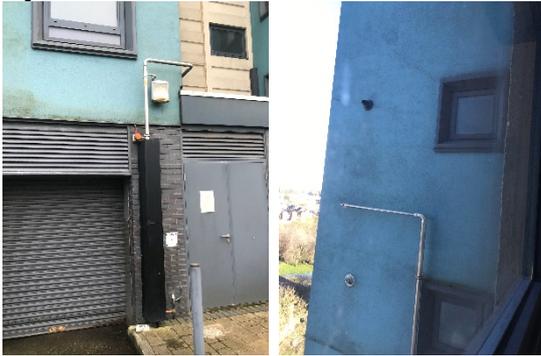
- 6) There is lightening protection installed to the block. Maintenance contracts are in place for lightning conductor testing in accordance with BS 6651.
- 7) Portable heaters are not allowed in any common parts of the premises.
- 8) Gas appliances and pipework (where installed) are subject to annual testing and certification. This cyclical contract is managed by the in-house Gas Team. **Gas is installed and is external**

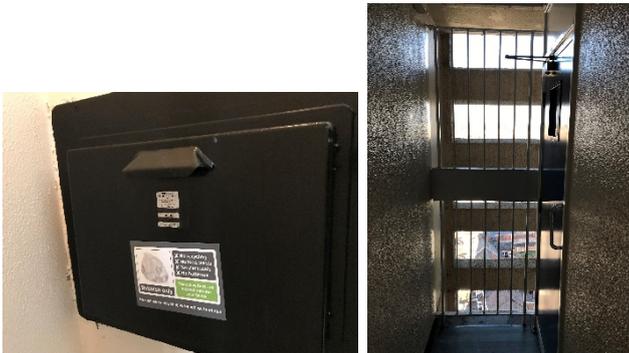
- 2) Refuse hoppers are accessed on each floor secured behind its own dedicated nominal 44mm 30-minute door with combined intumescent and cold smoke seals.

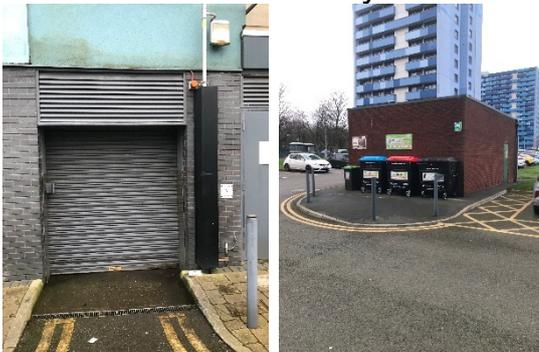
- 3) Refuse containers regularly emptied bin store located at the rear elevation of the block. There is also a recycling project currently being undertaken at the block, recycling bins are stored at a suitable distance away from the block within the car park.

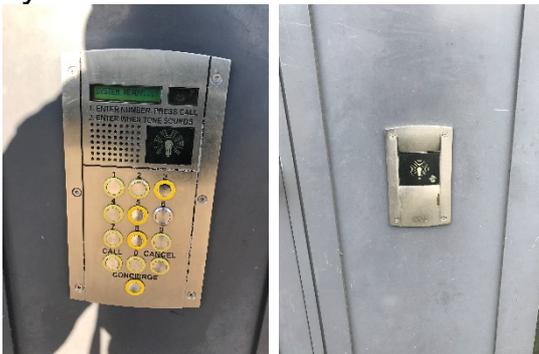
- 2) Restricted access to the premises by means of a door entry system.

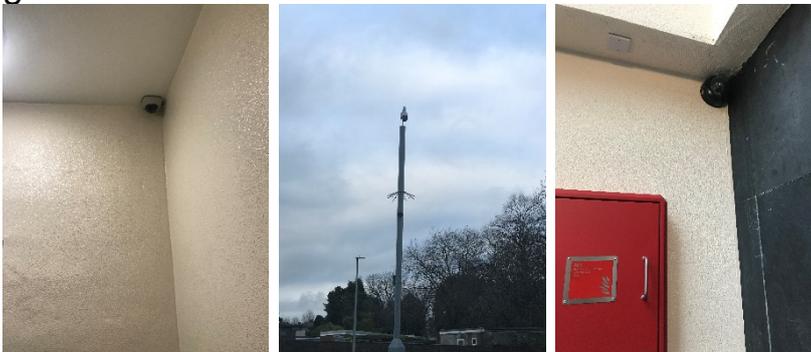
- 3) There is CCTV system in place that covers the external perimeter, ground & First floors and lift cars.

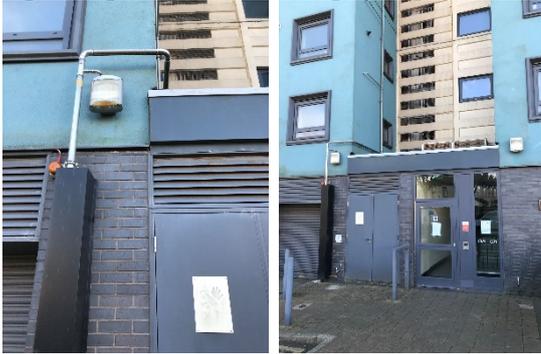
- 5) The perimeter of the premises is well illuminated with external lighting and street lighting.

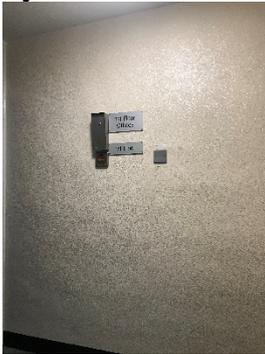
- 7) There is restricted access to the first floor via a fob and intercom system

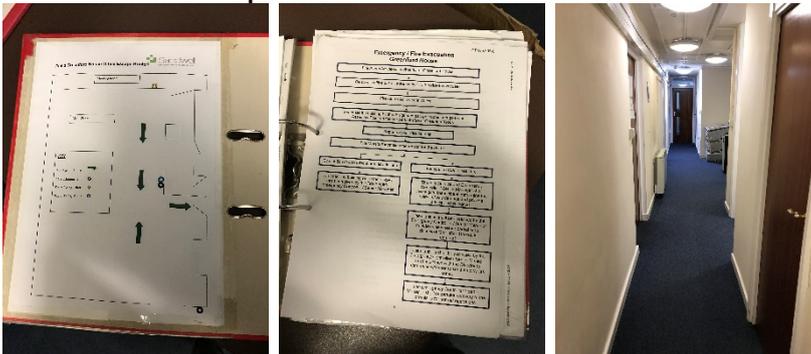
- 3) The means of escape remains clear and avoids obstruction there is a plan in place and displayed within the office areas showing the means of escape and what to do in the case of an emergency

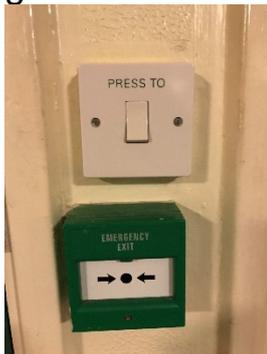
- 6) Travel distances to a point of relative safety/ ultimate safety within 18m
- 7) Noted entrance doors into the office spaces still contain notional FD30s doors with self-closing devices with internal doors also being notional FD30s doors providing good compartmentation throughout the offices paces including the internal additional staircase area.
- 8) Noted that the ground floor office space accessed from the timber staircase is mainly unused space that remains safe and secured with limited fire hazards
- 9) Kitchens are located the furthest point away from the exit doors (see plans)
- 10) Push to exit buttons allow safe easy exit from the office space into the protected staircase from the lobby area, thumb turns in place on ground floor doors leading to the ground floor lobby area.

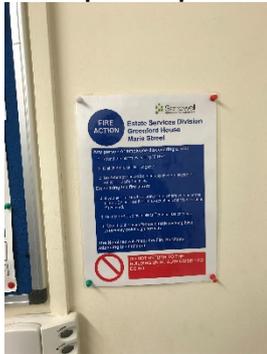
- 12) Fire action notices are strategic placed along the means of escape depicting what to do in the event of a fire

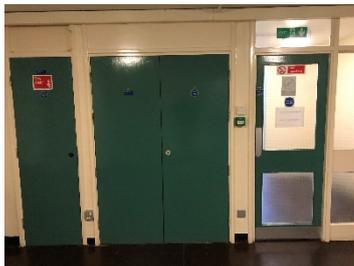
- 13) Emergency lighting is present throughout the means of escape
- 14) The office spaces maintain good compartmentation with the use of compartment walls and notional doors throughout the means of escape
- 15) A dry riser is present within the lobby entrance in the first floor office area.

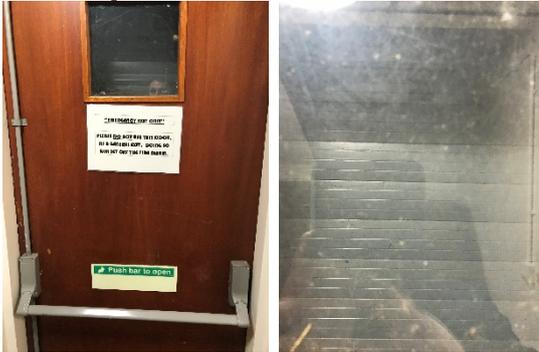
- 18) There is an emergency exit door that is not used for normal entrance/exit to the office spaces located at the bottom of the timber stair, this should remain up/ open during office opening hours and should be part of the office opening and close procedures

08/2	Replace missing smoke detection that has been removed from flat 32	N/A	P2	1-3 months Electrical	
20/18	This shutter should remain up during normal working hours and should be part of the open and close procedure for the offices

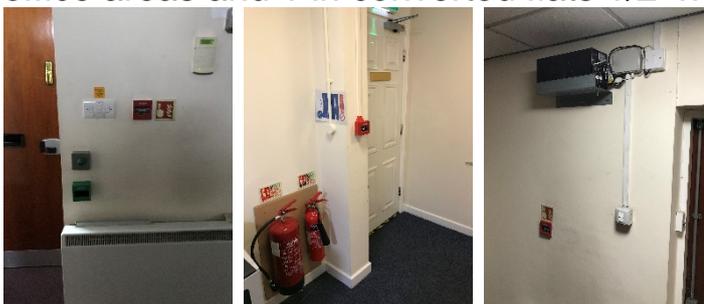
- 21) Early warning systems are limited to hard wire battery smoke alarms within the main office and manual call points in which are strategically placed along the means of escape
- 22) There are 3 break glass manual call points strategically located within the premises in accordance with the requirements of BS EN54-11. With two manual call points located in the downstairs office areas and 1 in converted flats 1/2 now meeting area

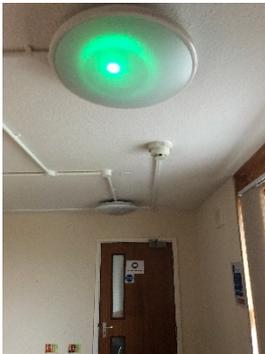
27) **It could not be determined whether the installed equipment is checked and tested, this is something that should be documented within the logbook**

P2	Bryan low	
20/23	Provide evidence of weekly fire alarm testing and document within the fire log book	N/A	P2	Bryan Low	
20/27	Provide evidence of the emergency lighting test and document within the logbook	N/A	P2	Bryan Low	
20/44	Fire marshals should be nominated and	N/A	P2	Bryan Low

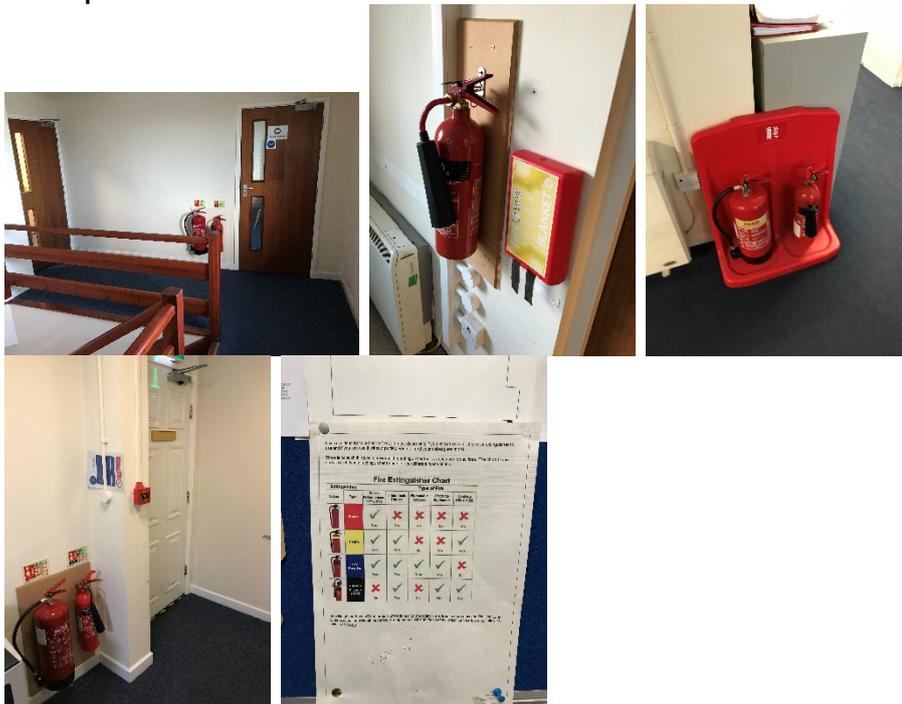
- 30) The office spaces contain adequate provisions for firefighting equipment.
- 31) Firefighting equipment is strategically located along means of escape routes including fire blankets within kitchens with extinguishers in the hallway, main office area, meeting room areas and ground floor office spaces . with guidance on fire extinguishers also provided.

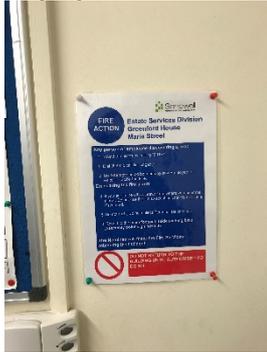
35) Fire action notices are displayed throughout the office spaces. It is not expected for employees who are not trained to use firefighting equipment.

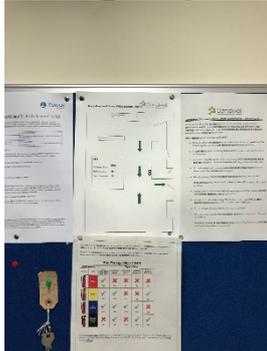
36) Signage detailing the escape route from offices placed strategically around the offices

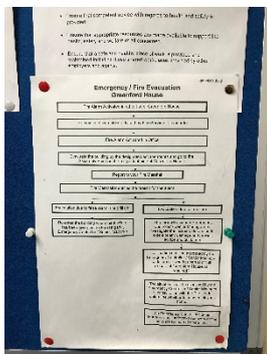
37) Emergency fire evacuation plans placed strategically around the offices

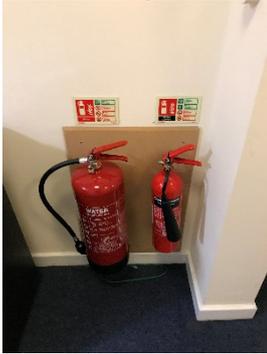
- 38) Appropriate signage has been installed for firefighting equipment's and call points

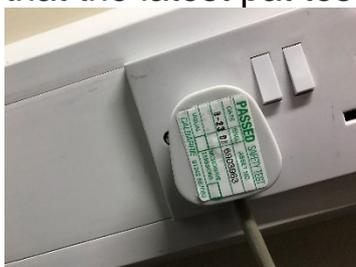
- 46) Smoking is prohibited within any communal parts of the building in line with Smoke Free England legislation.
- 47) Hot working is not normally carried out. If essential maintenance requires the use of hot work processes, then corporate policies and procedures are to be followed.
- 48) Portable electrical equipment used as part of the Caretaking / Cleaning regime is subject to annual PAT Testing. This information is held by the Estate Services Manager Bryan Low.
- 49) Portable electrical equipment that is used within the office should be tested in accordance with corporate procedures. It was noted that the latest pat testing was conducted August 2023

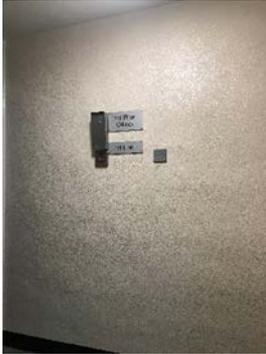
- 60) There is fob entry system that only employees that work within the office can use to access the space visitors must use an intercom and be approved access to enter

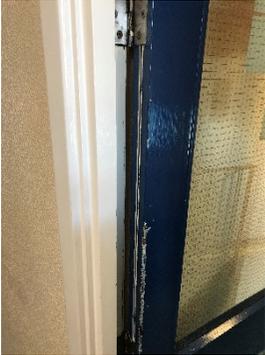
- 26) 16th floor Communal door coming from stair is missing cold smoke seal on hinge side of the door.

07/21	Flat 20 Install cold smoke seals to flat entrance door	N/A	P2	Fire Rapid Response 1-3 months	
07/26	16 th floor replace missing cold smoke seal on hinge side to door leading to the protected stair

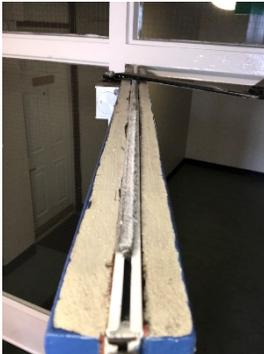
- 27) Communal door from the flat/lift lobby area into the chute landing area missing a small piece of cold smoke seal at the right hand side atop of the door on the 14th floor.

P2	Fire Rapid Response 1-3 months	
07/27	14 th floor replace missing piece of cold smoke seal to top right hand side of door entering into the lift lobby
