# **Fire Risk Assessment**

## **Meadow Avenue (Willow).**

**Charlemont Farm, West Bromwich,  
B71 3EN.**

**Date Completed: 09/02/2026**

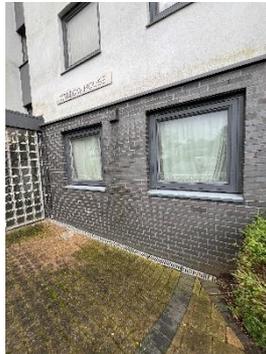
- 1) The external wall at Willow House has 3 separate areas of cladding. The external wall system was upgraded in 2009 and comprises of:
- Brickwork from ground to 1ST floor. Fire classification A1.

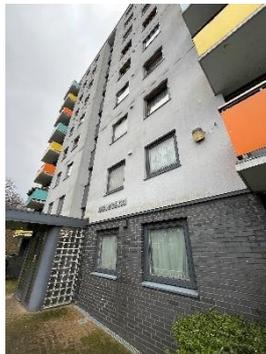
- Wetherby EW1 render system 1st to 8th floor. Fire classification A2

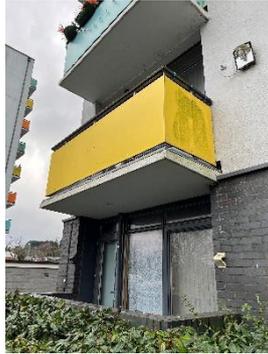
- Trespa HPL panels to balconies. Fire classification B-s1, d0.

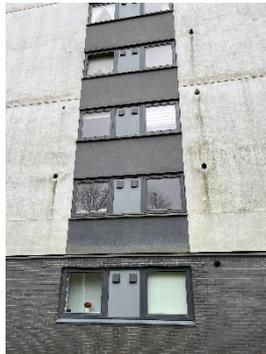
- Aluminium panels. Fire classification A1.

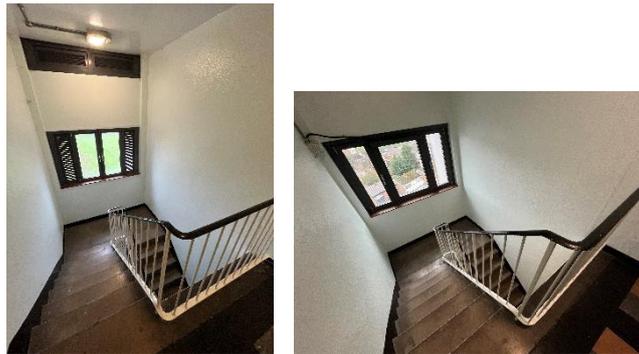
- 1) The building has two protected staircases that provide adequate means of escape. The staircase is 1030mm in width. The staircases are of concrete construction from the ground floor up to top floor.

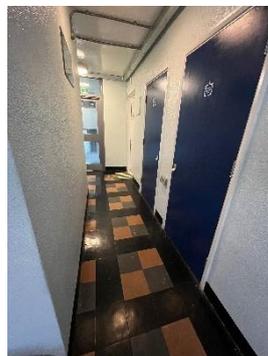
- 2) All corridors are of adequate width (at least 1070mm) and will be maintained clear to that width as a minimum.

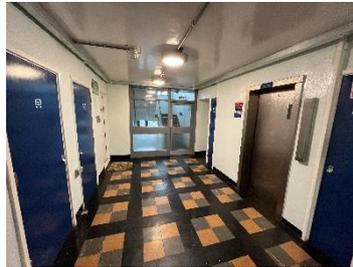
- 6) The communal landing / staircases are protected by use of notional FD30s fire doors with vision panels. These doors have been upgraded with a combined strip consisting of a cold smoke seal and intumescent strip.

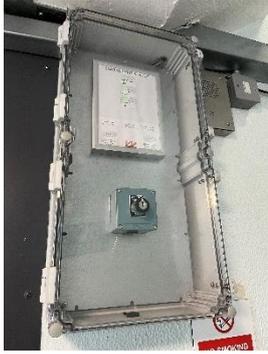
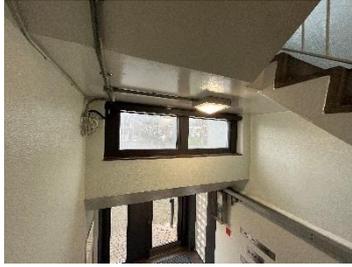
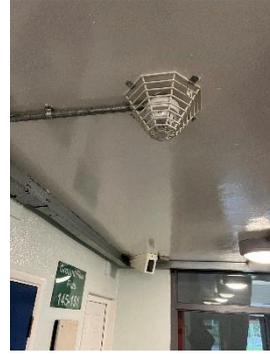
- 10) Automatic smoke ventilation is employed in the front protected staircase, on half landings on floors 1, 5 and 7. This is tested, inspected, and maintained by a competent procured contractor in accordance with BS7346. The frequency for the maintenance checks is twice per year. (April and October). The rear staircase has louvre ventilation on all floors. Windows can be opened with use of a key.
-

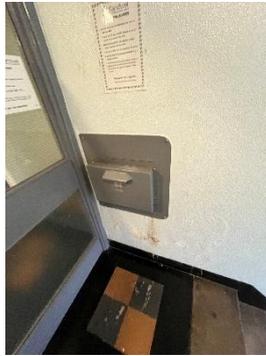
11) Refuse chute hoppers are available on each floor, within the rear stairwell. The chute system is connected to the bin store at the rear of the building.

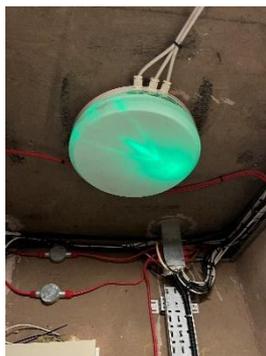
12) Emergency lighting is provided to communal lobbies and stairs. Checks are done monthly by Sandwell MBC in house electrical team or approved contractor.

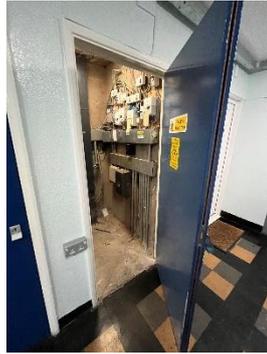
13) Residents' electrical meters are situated in the cupboards on all floors, protected with FD60s doors.

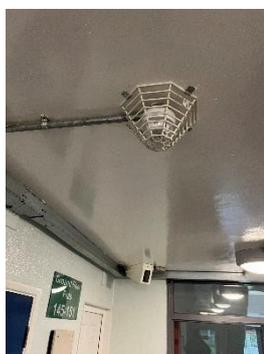
- 1) There is no effective means for detecting an outbreak of fire to the remaining communal areas. Automatic fire alarm systems are not usually required in the common areas of residential blocks as this can compromise the 'Stay Put' evacuation policy.
- 2) Smoke detectors linked to the automatic opening vent have been installed on stairwell and landing lobbies. The vents in the front stairwell will automatically open when smoke has been detected.

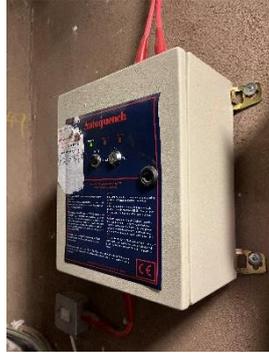
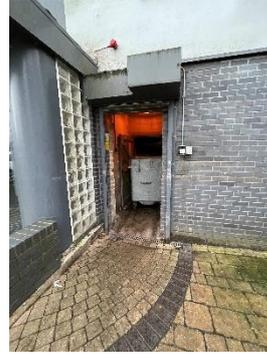
- 3) A deluge system is provided to the refuse chute bin store. Detectors for actuation are sited within the bin store and the control unit is sited in the ground floor electrical cupboard. An approved contractor maintains the system. The frequency for the maintenance checks is twice per year (April and October).

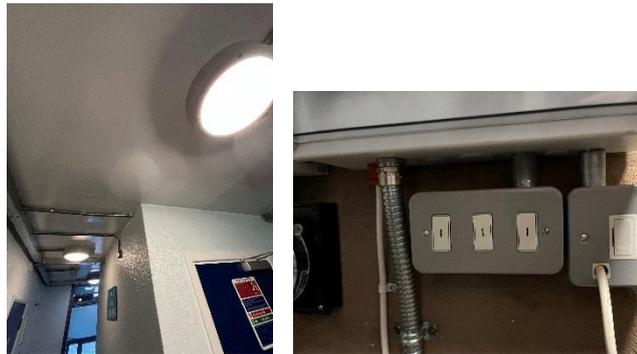
- 1) The premises has a sufficient emergency / escape lighting system in accordance with BS 5266 and has test points located within electrical cupboards. The self-contained units are provided to the communal landings, stairs and lift motor room.

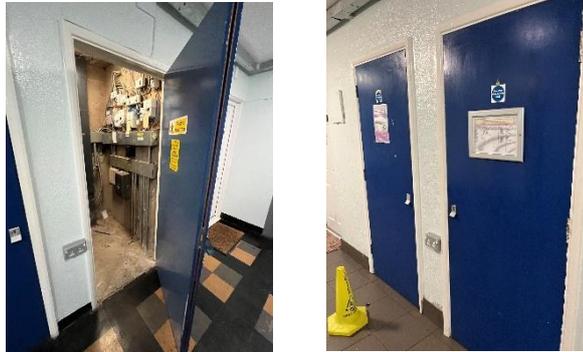
- 6) All floor service cupboards are notional, upgraded, FD30s or FD60s timber fire door sets. The keys are held centrally at SMBC Roway Lane, and within the firefighter's white box.

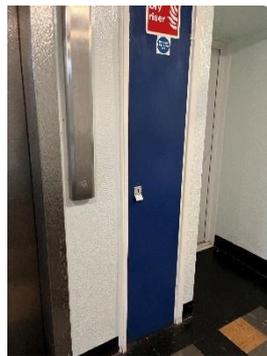
- 7) Dry riser cupboards on all floors are behind upgraded FD30s fire doors.

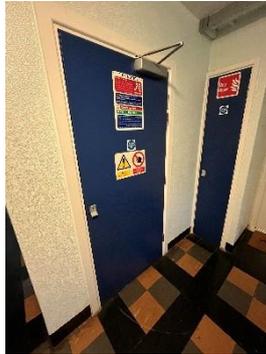
- 9) The lift motor room door is a notional FD60s timber fire door set. The keys are held centrally at SMBC Roway Lane, and within the firefighter's white box.

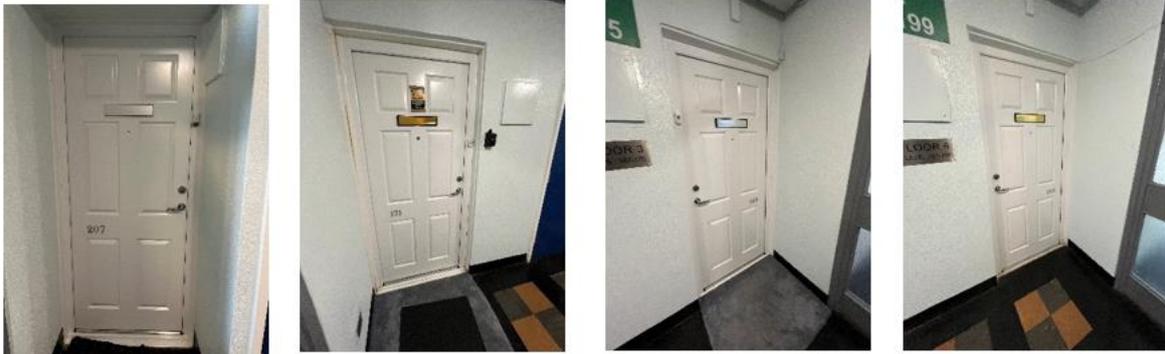
- 10) Individual flat entrance doors are FD30S rated Permadoor of composite construction.

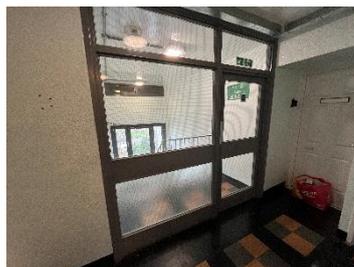
- 11) The communal staircase, lobbies and corridors are protected by use of notional FD30s self-closing timber fire doors with vision panels. The vision panels are Georgian wired glass.

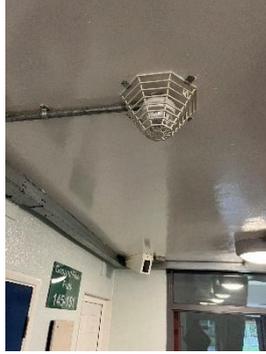
- 12) Cabling from service cupboards / risers to individual meter cupboards and AOV controls is housed in metal trunking.

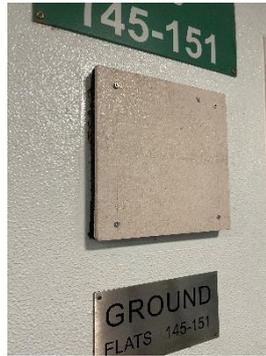
- 13) Access panels to stop taps are secured behind a panel cupped and screwed above the meter cupboards.

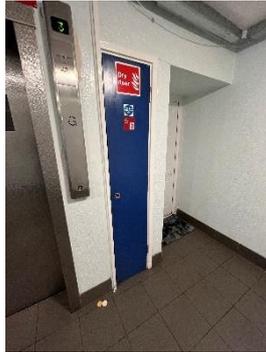
- 1) The dry riser inlet is internal, within a cupboard in the ground floor lift lobby. Secured with a type 54 suited mortice lock.

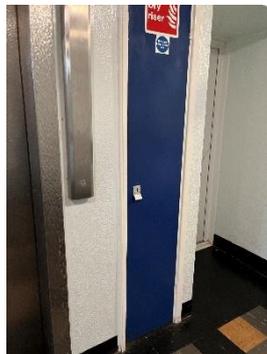
- 2) The dry riser outlets are located within cupboards on all floors, secured with a type 54 suited mortice lock. The dry risers are checked regularly as part of the caretakers' duties.

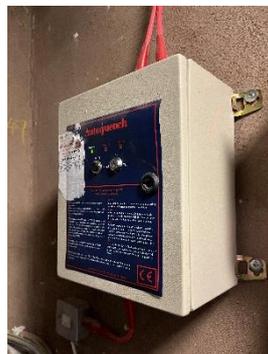
- 4) A deluge system is provided to the refuse chute bin store. The control unit is situated in the ground floor electrical cupboard. An approved contractor maintains the system. The frequency for the maintenance checks is twice a year (April and October).

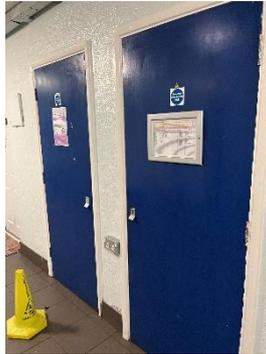
- 4) The electrical installation i.e. risers are contained within dedicated service cupboards that are secured with locked FD60s fire doors.

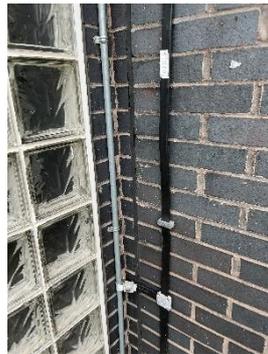
- 5) There is a lightning protection system installed to the building. Maintenance contracts are in place for lightning conductor testing in accordance with BS 6651.

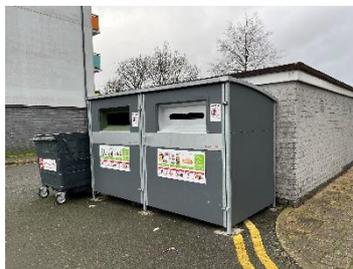
- 2) Refuse & recycling containers are emptied regularly. Refuse containers are in the bin store which is at the rear of the block. Recycling containers are kept away from the block.

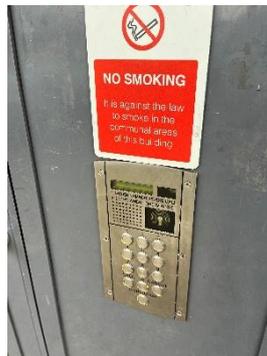
- 1) Regular checks are undertaken by Caretakers / Cleaning Team(s) 365 days per year which helps reduce the risk of arson.
- 2) Restricted access to the premises by means of a door entry system.
