# **Fire Risk Assessment**

## **Wimberger House 1-36**

**Hallam Street, West Bromwich,  
B71 4HA.**

**Date Completed: 02/03/2026**

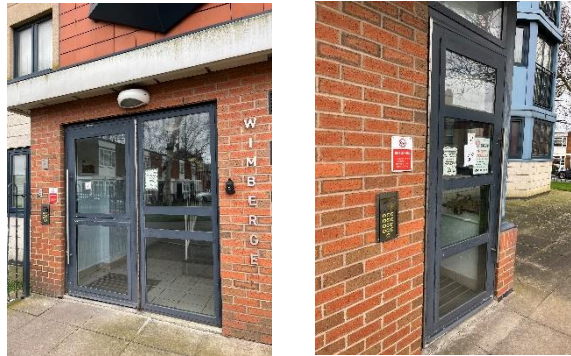
The block has a main entrance/exit to the front elevation, and a further entrance/exit located on the rear elevation. The main entrance to the front elevation has a door entry system with a fob reader installed. The entrance to the rear elevation is accessed by the installed fob reader. The front entrance only, has a firefighter override by use of a drop latch key.

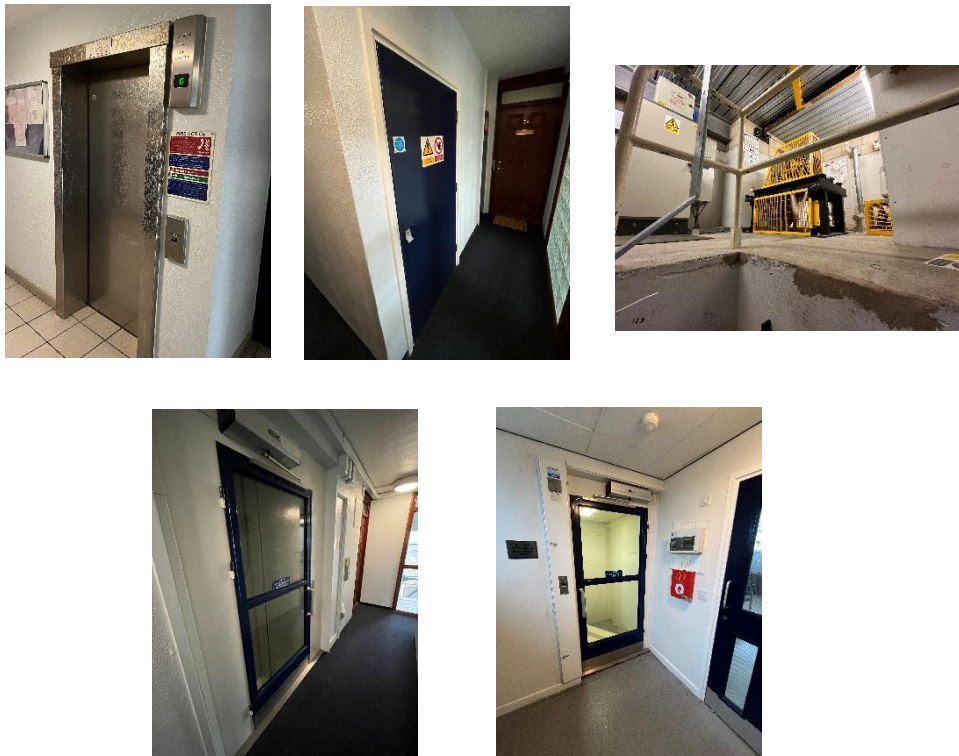
There is one main passenger lift car serving the block, going to the 7<sup>th</sup> floor, the lift motor room is located on the 8th floor. Access to lift motor room is via a 60-minute timber fire door. There is a platform lift for disabled access linking floors 7,8 and 9, this lift is currently out of service.

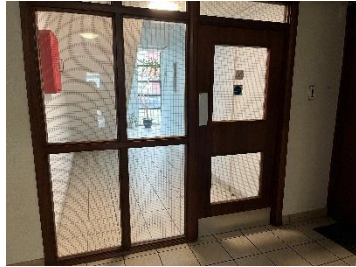
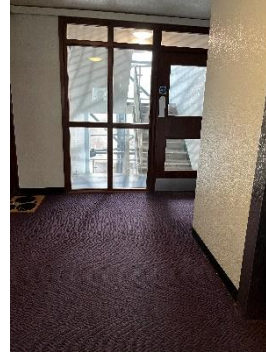
The lift lobbies, ground floor lobby and the two protected staircases are compartmented with nominal FD60s fire doors which separate the lobbies and flats from the staircases either side.

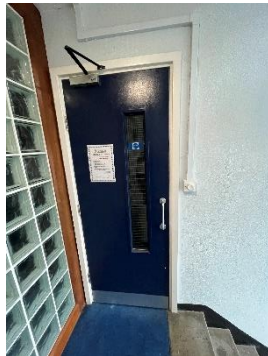
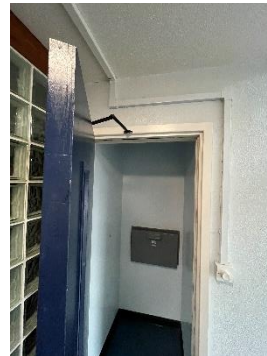
Refuse chute hoppers are available on floors ground to 8, within the front stairwell, behind FD60s doors. The chute system is connected to the bin store at the front of the building.

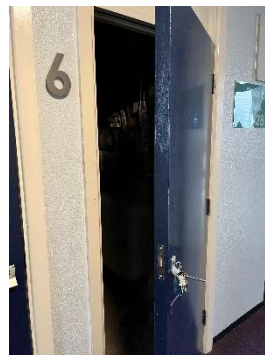
Riser cupboards on floors ground to 8 contain the flats electrical meters and communications equipment. These cupboards are protected by FD60s doors.

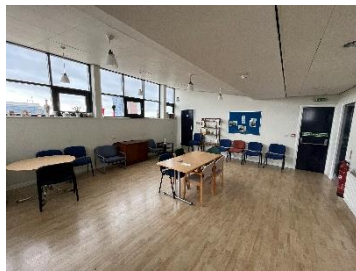
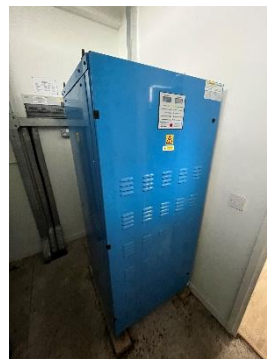
During the 2007 refurbishment a structure was added on to the original concrete flat roof. This structure is accessible by the blocks two staircases, which were extended up and through the original concrete roof, the front stair being of steel construction. Further access is available from a disabled access platform lift, from the 7<sup>th</sup> and 8<sup>th</sup> floors only. The structure houses a purpose built communal room with a kitchenette and a disabled access toilet. There is also a small plant room housing the blocks emergency lighting battery back-up unit. The structure sits below the pitched metal roof.

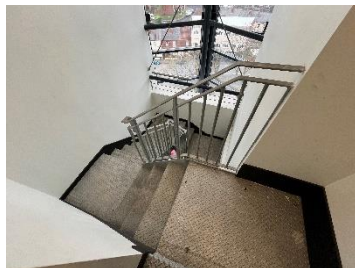
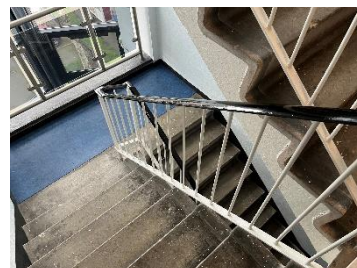
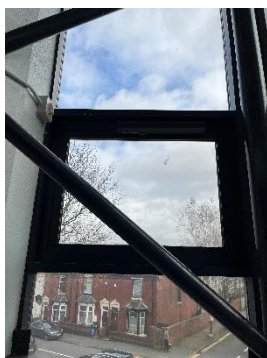
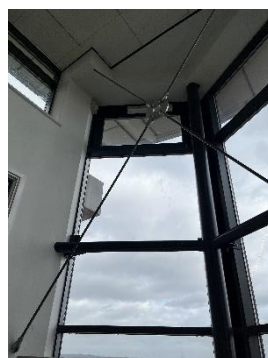
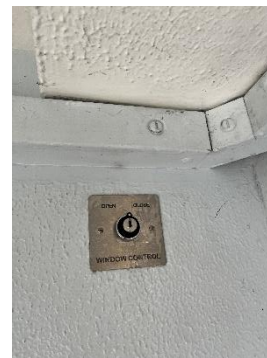
The block has two concrete (except the front stairwell joining the 8th floor with the top floor is of metal construction) protected staircases, front and rear. Automatic smoke vents (AOV) have been installed on the half landings of each floor and at the top of each protected stairwell. block has two concrete protected staircases, front and rear. The firefighter override switch is within the rear entrance lobby.

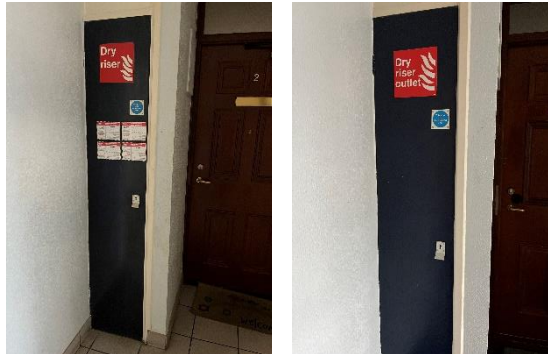
Dry riser outlets are in cupboards on all floors (except the top floor) within the flat lobbies. The dry riser inlet is located in a cupboard in the ground floor lift lobby.

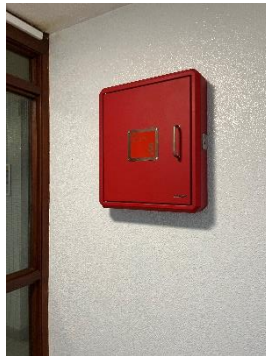
There is a secure information box (SIB) located in the ground floor front entrance lobby. It is a Gerda box that utilises a standard WMFS suited key. The SIB contains operational information for the responding fire service.

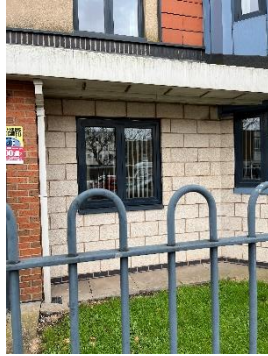
- Brickwork from ground to 1st floor. Fire classification A1.

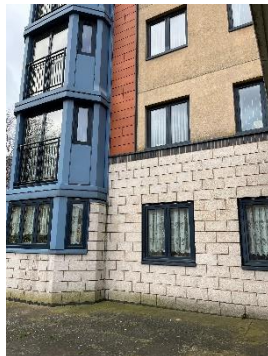
- Render system 1st to 8th floor. Fire classification A1.

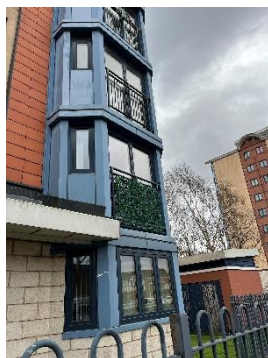
- Terracotta tiles. Fire classification A1.

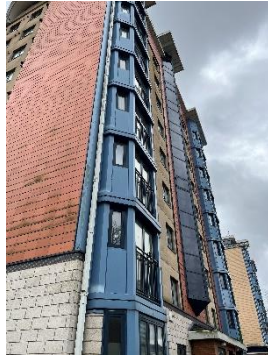
- Aluminium panels. Fire classification A2.

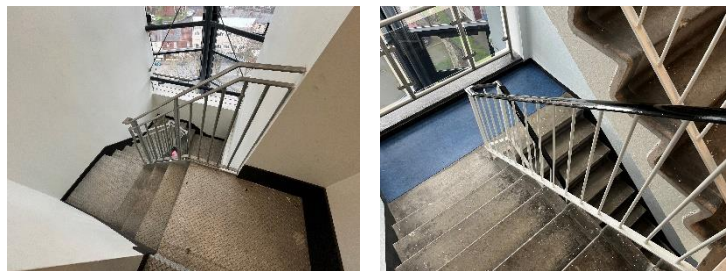
- 1) The building has two protected staircases that provide adequate means of escape. The staircases are 1030mm in width. The staircases are of concrete construction from the ground floor up to top floor at the rear and from the ground floor to the 8th floor at the front. The staircase from the 8<sup>th</sup> to the 9<sup>th</sup> at the front is of steel construction.

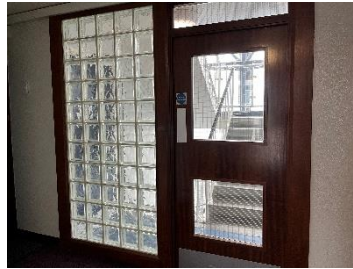
- 6) The communal landing / staircases are protected by use of nominal FD60s fire doors with vision panels.

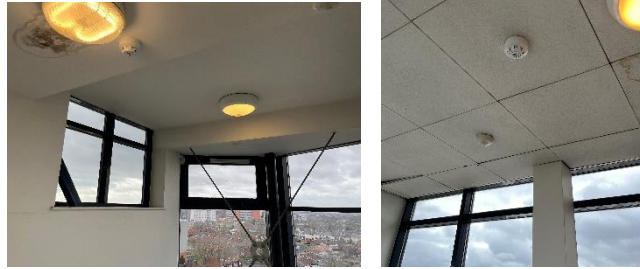
- 10) Automatic smoke vents (AOV) have been installed on the half landings of each floor and at the top of each protected stairwell. The firefighter override switch is within the rear entrance lobby. This is tested, inspected, and maintained by a competent procured contractor in accordance with BS7346. The frequency for the maintenance checks is twice per year. (April and October).
-

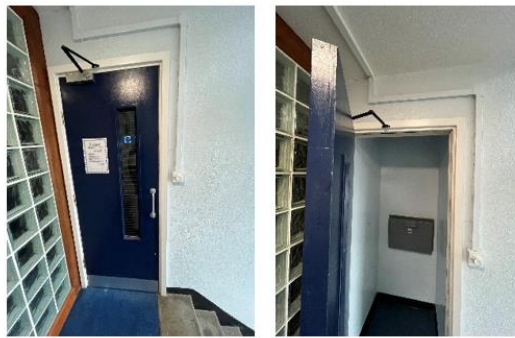
- 11) Refuse chute hoppers are available on each floor, protected by FD60s doors. The chute system is connected to the bin store at the rear of the building.

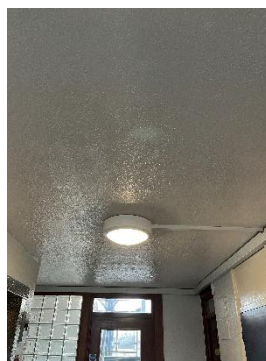
- 12) Emergency lighting is provided to communal lobbies and stairs. Checks are done monthly by Sandwell MBC in house electrical team or approved contractor.

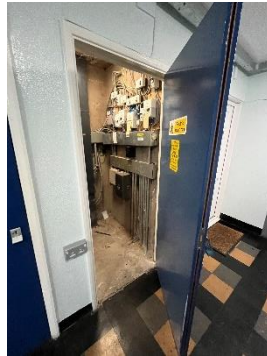
- 13) Residents' electrical meters are situated in the cupboards on all floors, protected with FD60s doors.

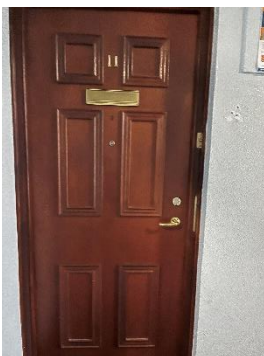
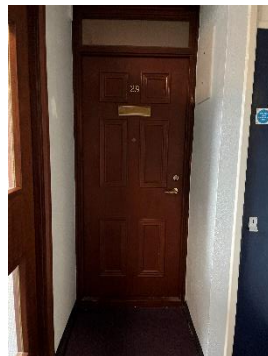
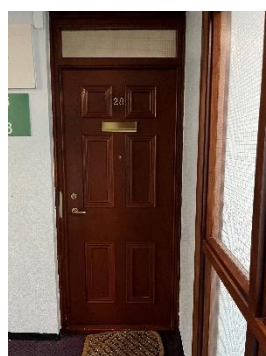
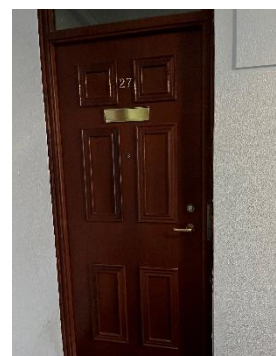
- 16) Individual flat entrance doors are predominately nominal FD30S rated timber fire doors.

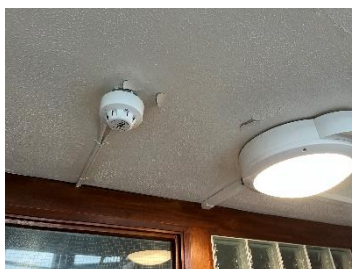
- 3) There is no means for detecting an outbreak of fire to the remaining communal areas. Automatic fire alarm systems are not usually required in the common areas of residential blocks as this can compromise the 'Stay Put' evacuation policy.
- 4) Smoke detectors linked to the automatic opening vents have been installed on stairwell and landing lobbies. The vents in the stairwells will automatically open when smoke has been detected.

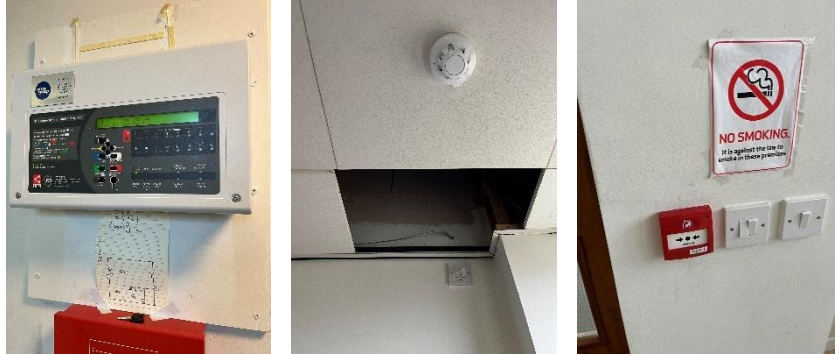
- 5) The communal room on the top floor has an automatic fire alarm system that appears to conform to BS5839. There are detector heads, manual call points and a fire alarm control panel within the communal room. There is also a repeater panel for this system in the front ground floor entrance foyer.

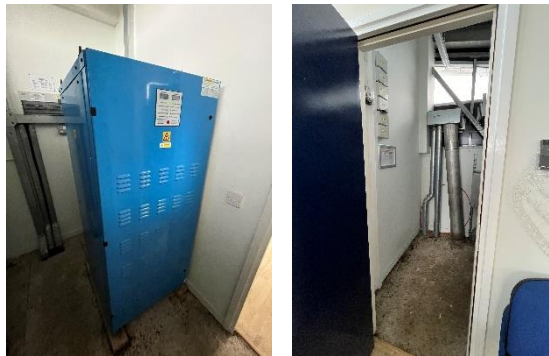
- 1) The premises has a sufficient emergency / escape lighting system in accordance with BS 5266. The emergency lighting is a central battery system. The central battery is situated in the cupboard in the communal room.

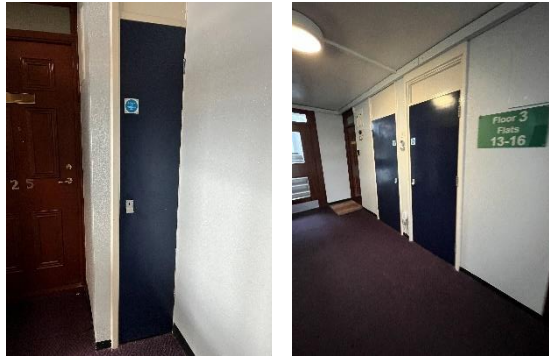
- 6) All floor service cupboards are nominal FD30s or FD60s timber fire door sets. The keys are held centrally at SMBC Roway Lane, and within the firefighter's white box.

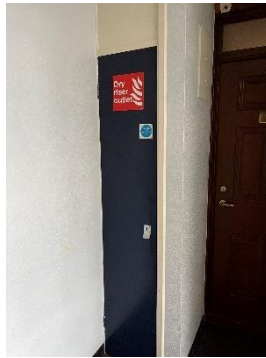
- 7) Dry riser cupboards on all floors are behind upgraded FD30s fire doors.

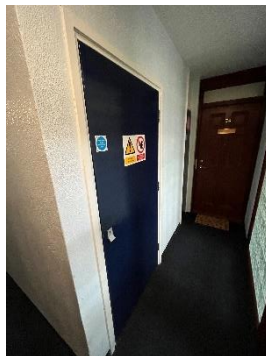
- 8) The lift motor room door is a nominal FD60s timber fire door set. The keys are held centrally at SMBC Roway Lane, and within the firefighter's white box.

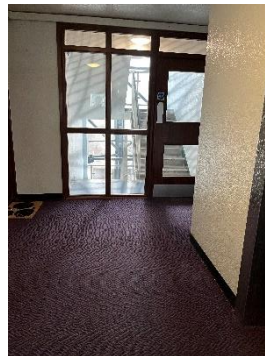
- 10) The communal staircase, lobbies and corridors are protected by use of nominal FD60s self-closing timber fire doors with vision panels. The vision panels are Georgian wired glass.

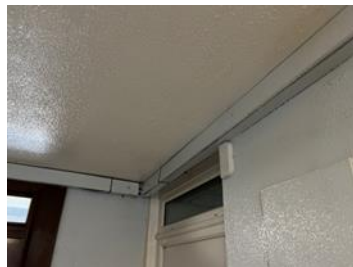
- 11) Cabling from service cupboards / risers to individual meter cupboards and AOV controls is housed in metal trunking.

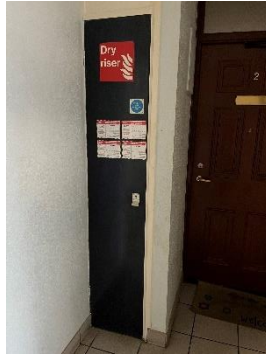
- 1) The dry riser inlet is internal, within a cupboard in the ground floor lift lobby. Secured with a type 54 suited mortice lock.

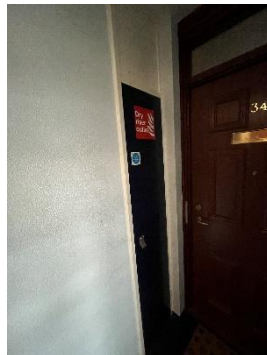
- 2) The dry riser outlets are located within cupboards on floors 1 to 8, secured with a type 54 suited mortice lock. The dry risers are checked regularly as part of the caretakers' duties.

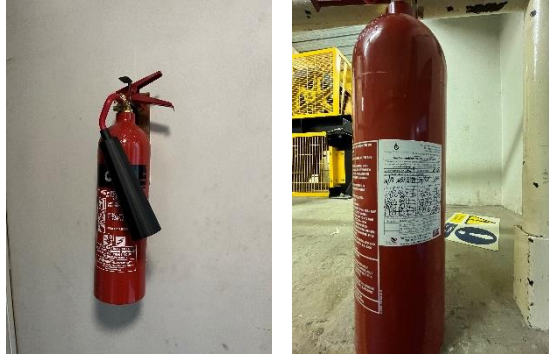
- 4) A portable fire CO2 fire extinguisher is provided in the lift motor room. A contract is in place for maintenance of the extinguisher. The frequency for the maintenance checks is once (October) each calendar year. There is no extinguisher information sign. A CO2 extinguisher information sign is required to be fitted. See action 11/4.

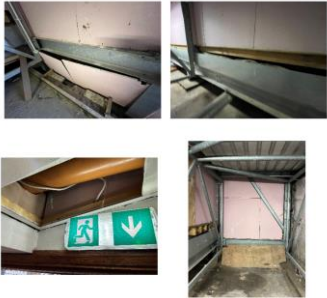
- 15) **Compartmentation above and around the communal room and on the outer side of both protected stairwells on the top floor is unsatisfactory and requires major rectification. It is recommended that the compartmentation above and around the communal room and on the outer side of both protected stairwells on the top floor and the disabled lift shaft receives major rectification by a suitably trained person. See action 10/15.**

<p>P2</p>	<p>Repairs 1 – 3 months.</p>	
<p>10/15</p>	<p>It is recommended that the compartmentation above and around the communal room and on the outer side of both protected stairwells on the top floor and the disabled lift shaft receives major rectification by a suitably trained person.</p>

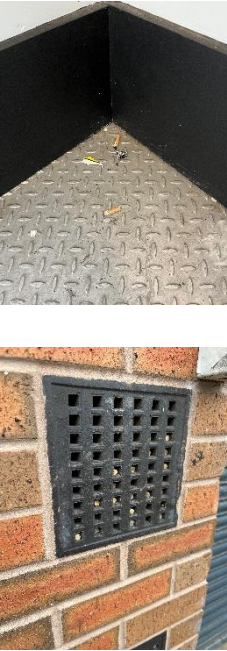
- 2) Evidence of smoking in the common areas was noted.
  - a) In the front stairwell towards the top floor and the rear stairwell on window ledges. The Housing Officer should communicate to residents regarding smoking in the block and the cleaning team should remove the cigarette butts. See action 14/2a.
  - b) Discarded cigarette butts can be seen in the airbricks near the bin store roller shutter. The housing officer should communicate to residents regarding smoking in the block and the cleaning team should remove the cigarette butts. The airbricks are required to be sealed to prevent discarded cigarettes entering the bin room. See action 14/2b.

<p>P2</p>	<p>Asset Management 1 – 3 months.</p>	
<p>14/2a</p>	<p>Evidence of smoking in the common areas was seen in the front stairwell towards the top floor and the rear stairwell on window ledges. Also discarded cigarette butts can be seen in the airbricks near the bin store roller shutter. The housing officer should communicate to residents regarding smoking in the block and the cleaning team should remove the cigarette butts.</p>
