Fire Risk Assessment

Brookview

Stanhope Road,
Smethwick, B67 6HG

Date Completed: 08/09/2025

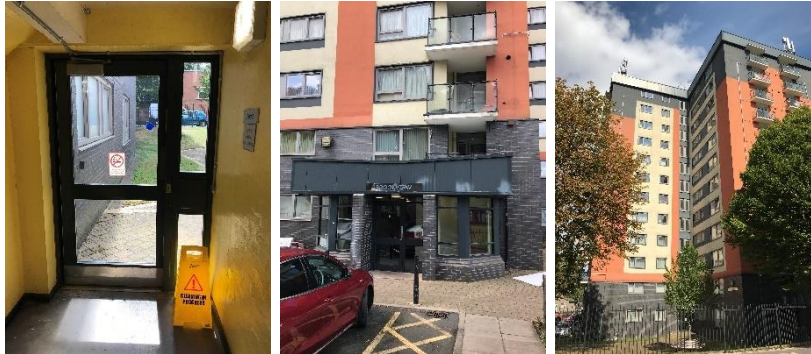
The block has a main entrance/exit to the front elevation and a further entrance/exit located on the rear elevation. Main entrance leads to an ultimate place of safety whereas the additional exit leads to a gated area. This gated area has the ability to be locked however was not locked on the day of the risk assessment.

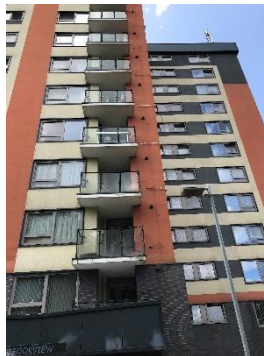
- 4) Each flat within the block has access to an individual balcony. These are cantilevered concrete with a steel and glass balustrade. Residents had stored items on balconies.

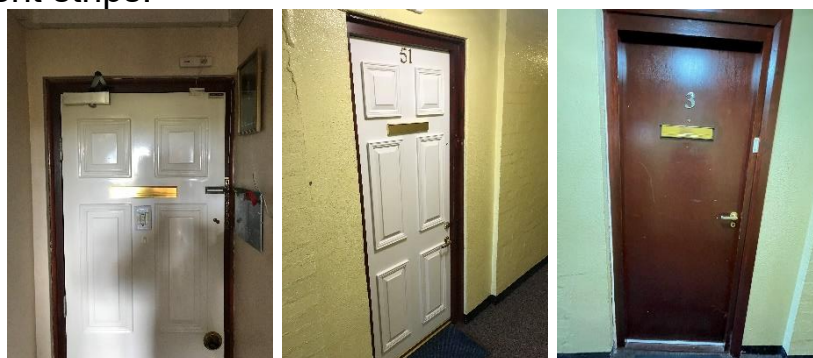
- 1) Individual flat doors are predominantly nominal self-closing 30-minute composite fire door sets with intumescent strips, cold smoke seals. Doors are predominantly manufactured by Permadoor or Nationwide. Flat 3 is a self-closing 44mm nominal 30-minute timber door with intumescent strips.

Upgrade flat 3 entrance door to certified FD30s rated composite door set as part of door replacement programme.

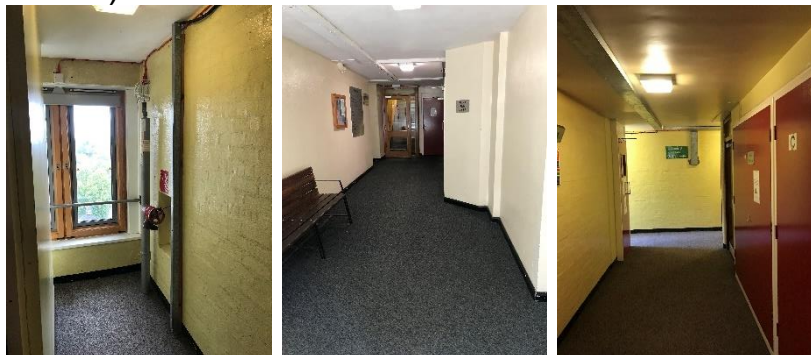
- 3) All corridors are of adequate width (at least 1050mm) and will be maintained clear to that width as a minimum. Dead end scenarios are present within the corridor along the means of escape however travel distances from the furthest flat entrances door to relative place of safety (staircase) are within 7.5m and therefore sufficient.

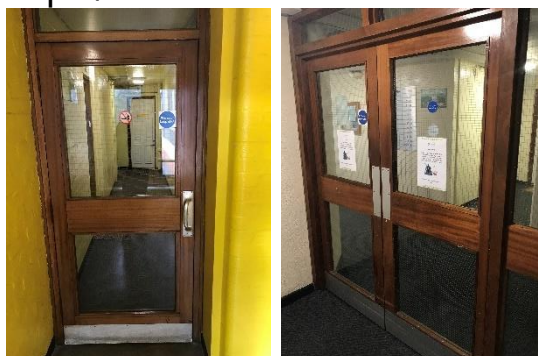
- 4) The communal landing / staircases are protected by use of self-closing 44mm notional timber 30-minute fire doors with vision panels & intumescent strips / cold smoke seals.

Some communal stairway doors show signs of wear and tear due to age. Consideration should be given to upgrade all doors with certified FD30s door sets as part of future programmed works.

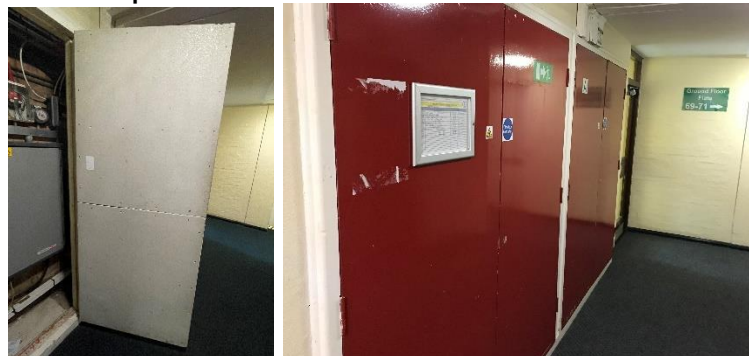
- 10) Service cupboards are 44mm notional fire doors with intumescent strips and cold smoke seals, secured with type 138 suited mortice locks to allow residents access to their electricity meters. The service cupboard to the ground floor is 54mm and lined with Superlux fire resistant board. The service cupboard to floor E is also lined with Superlux. Evidence of fire stopping taking place within service cupboards.

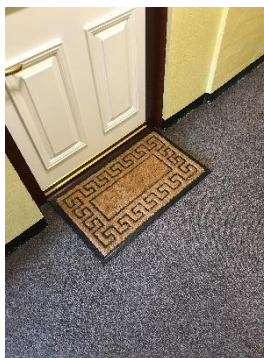
- 12)** Communal areas should be kept free of flammable items. The communal areas are checked on a regular basis by Caretaking / Cleaning teams 365 days per year and all items of rubbish are immediately removed. There is also an out of hour's service that allows combustible items of furniture / rubbish to be removed. This was found satisfactory with no items stored within communal areas.
- 13)** The surface coatings to the communal areas are a minimum of Class B-s3,d2 rated.
- 14)** Individual floor mats were noted outside some flats. Fire rating of the mats is unknown but deemed to be a trivial risk.

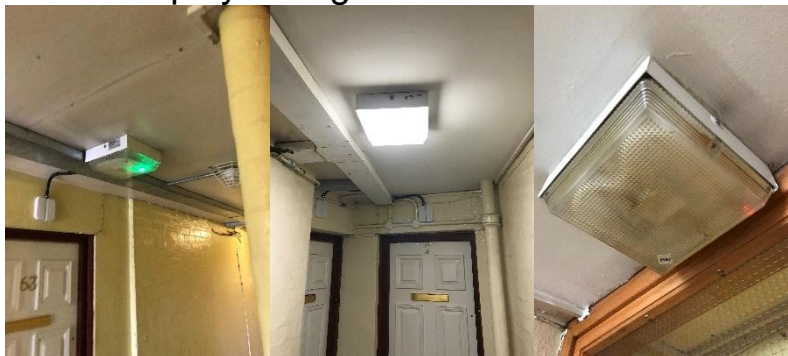
(Ground Floor)

- 1) The premises has a sufficient emergency / escape lighting system in accordance with BS 5266 and has test points strategically located. Some units displayed a red-light electrical confirmed older units will display red light.

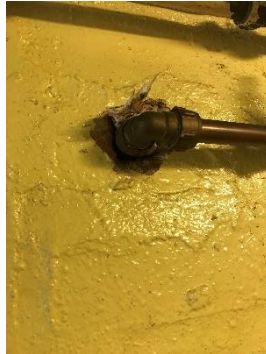
- 14) 10th floor outside flat 62 gaps / breaches where stop taps enter the wall, enhance fire stopping.**

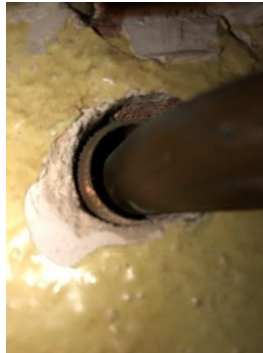
- 22) 4th floor, enhanced fire stopping required around copper pipe outside flat 21.**

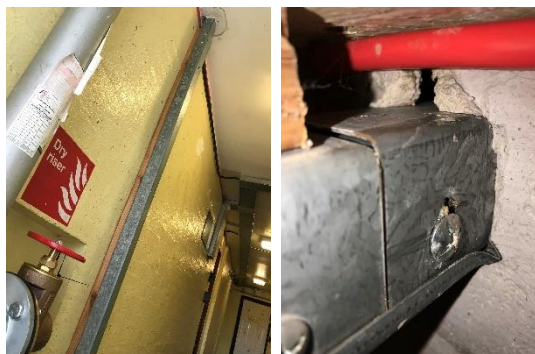
- 23) 4th floor Enhanced fire stopping required where metal trunking reaches floor above.**

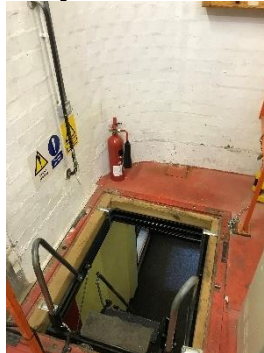
- 6) Portable fire extinguisher (CO2) is provided to the lift motor room. Maintenance contracts in place for maintenance of the extinguisher. The frequency for the maintenance checks is once (October) of each calendar year. The previous risk assessment identified that this should be repositioned so that it is easily accessible away from the roof space access hatch and fixed to a bracket. No access was granted during the time of the fire risk assessment however confirmation of works being completed has been recorded on in house systems.

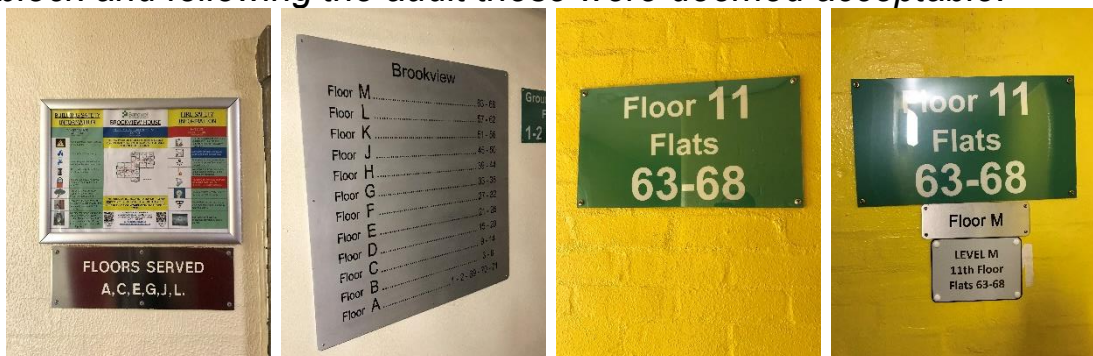
- 8) Photoluminescent wayfinding signage depicting floor level and flat numbers are fitted to the walls on all floors and to the wall of each landing on the communal staircase. Signage that meets the requirement of ADB and Fire Safety (England) Regulations 2022. the wayfinding signage is inconsistent with the elevator call buttons, smoke control vent panel, and the main sign in the main entrance lobby, which uses letters rather than numbers. this could cause confusion. Signs should read the same to keep consistency throughout the block. *This was raised on the previous FRA and is yet to be amended. Fire services are aware of the designs in the block and following the audit these were deemed acceptable.*

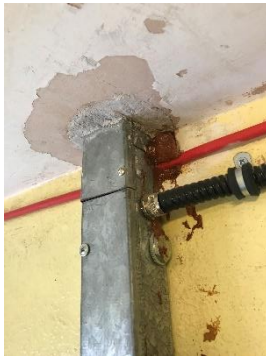
- 15) 10th floor insufficient fire stopping methods used where metal trunking reaches floor above, remove foam and enhance fire stopping.**

P2	1-3 Months Fire Rapid Response	
10/15	10 th floor, remove foam and enhance fire stopping where metal trunking meets floor above (near dry riser)

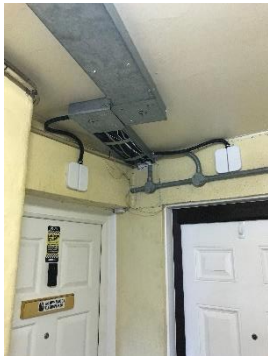
- 21) 6th floor metal tray missing panel outside flat 38.**

P2	1-3 Months Fire Rapid Response	
10/21	6 th floor outside flat 38, replace missing panel from metal tray.
