# Fire Risk Assessment

## Lawrence Court

**Aldridge Road  
Smethwick,  
B68 OHB**

**Date Completed: 11/04/25**

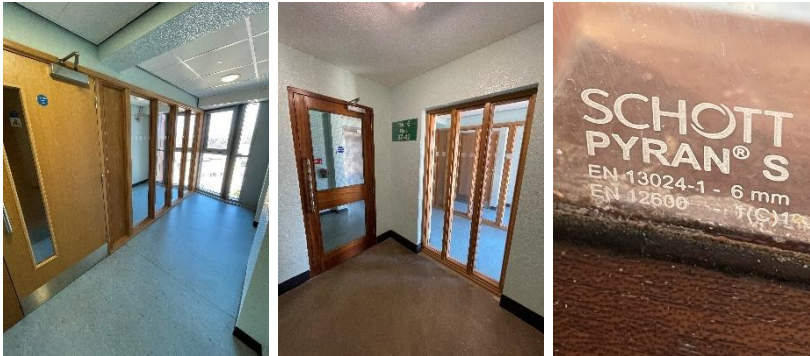
- 6) Glazed partition walls / screens to lobbies and stairwell are glazed with fire resistant glazing etched with Schott Pyran S 6mm to EN13054-1 & EN12600.

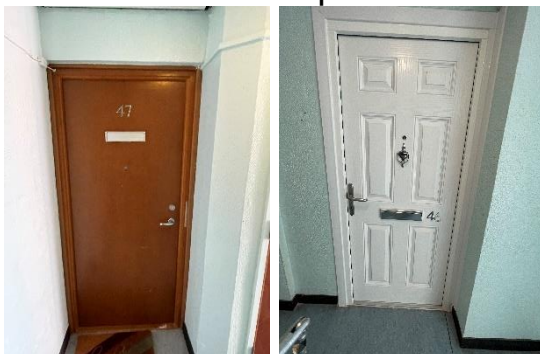
17) Individual flat doors are nominal FD30s rated timber fire doors sets predominantly manufactured by Russell Doors. Flat 46 has a nominal FD30 composite door set.

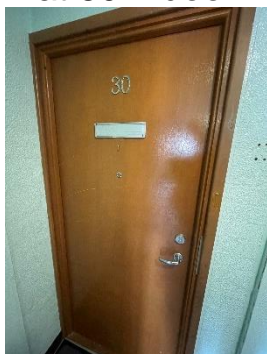
- D. Flat 30 – door was correct.**

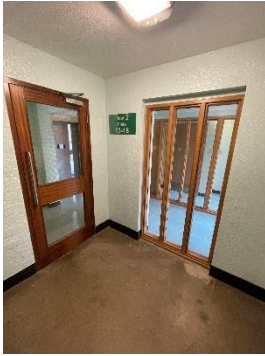
- 13) There are glazed partition walls / screens in hardwood frames to lift lobbies and stairwell landings. These are etched with Schott Pyran S 6mm EN13054-1 & EN12600 1C1. At the time of the FRA sufficient information was not available to determine precise classification with regards to integrity and thermal insulation. However, with automatic opening vents throughout these areas of the building, the management processes & procedures that SMBC have in place, the level of risk is acceptable. In addition, a retrospective fire strategy has been commissioned which will be completed by Firntec Building Compliance.

*Image taken from stairwell landing.*

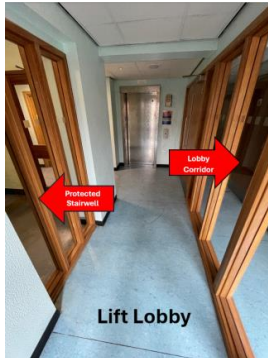
*Image taken from lift lobby.*

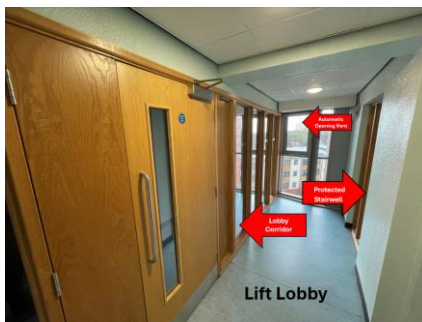
*Image taken from lift lobby.*

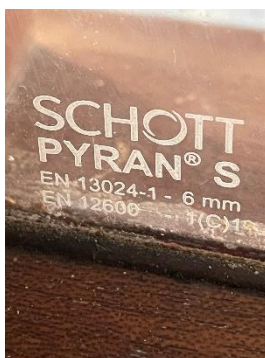
*Etching to all glazed partitions / screening.*

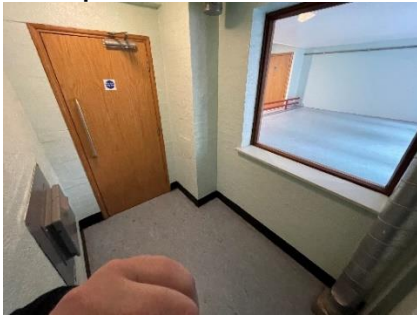
- 17) At 1<sup>st</sup> floor level only, there is a glazed section within the chute room partition wall / lobby corridor wall. The glazing is etched with Schott Pyran S 6mm EN13054-1 & EN12600 1C1. At the time of the FRA sufficient information was not available to determine precise classification with regards to integrity and thermal insulation. However, with a fire suppression system to the bin store intumescent seals to the hopper and, the management processes & procedures that SMBC have in place, the level of risk is acceptable. In addition, a retrospective fire strategy has been commissioned which will be completed by Firntec Building

The responsible person may wish to consider replacing the glazing in the glazed partition walls / screens that are in hardwood frames to the 1<sup>st</sup> floor chute room, lift lobbies and stairwell landings with a product that's precise fire classification including thermal insulation can be evidenced in line with the principles of the golden thread. Although these are etched with Schott Pyran S 6mm EN13054-1 & EN12600 1C1 the precise classification with regards to integrity and thermal insulation where not known during the assessment.

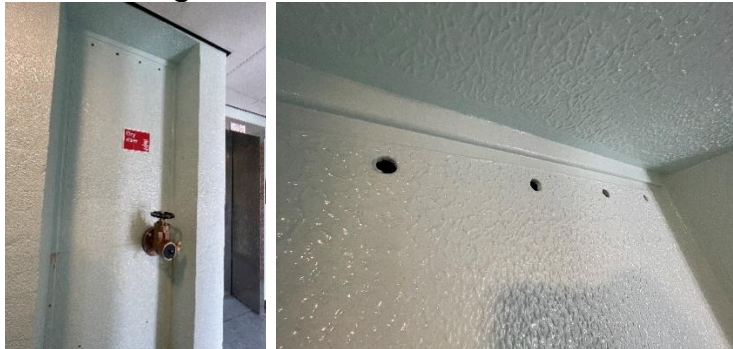
- 20) Access panels to stop taps are fixed to studwork and masonry in corridors on all floors.
- 21) There are ventilation holes in access panels housing the dry rising main on each floor above ground. It cannot be determined if compartmentation was adequate behind the panels where the rising main penetrates the floor slabs without destructive sampling. The Fire Safety, Facilities & Premise manager T. Thompson confirmed that all dry riser penetrations in the shaft were fire stopped in approximately 2017/18. The small ventilation holes in
-

each panel are to prevent condensation when the rising main has been charged.

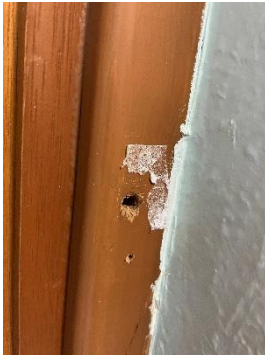
Question/ Ref No	Required Action	Supporting photograph	Priority	Timescale and Person Responsible	Date Completed
7/18b	Flat 32 – fill holes in entrance door frame where doorbell has been removed using intumescent wood filler.

P2	Within 1-3 months Fire Rapid Response

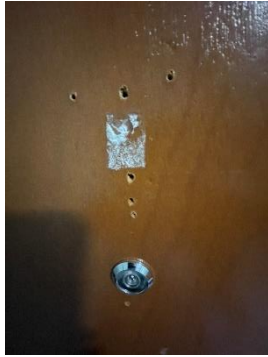
- C. Flat 33, access not gained however several small holes noted around door viewer to be filled with intumescent wood filler. Holes are not fully through door leaf.**

7/18c	Flat 33 - fill holes in entrance door around door viewer using intumescent wood filler..
