Fire Risk Assessment

Oak Court

**Acacia Avenue, Yew Tree Estate,
WS5 4HB**

Date Completed: 10/03/2026

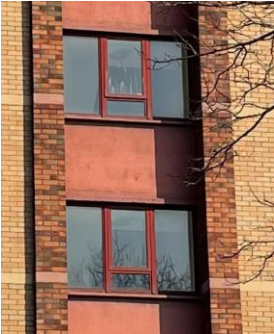
- 7) **Wicker screening has been installed to the balcony of flat 47. Timber screening has the potential to support the external spread of flame. This is a leaseholder property.**

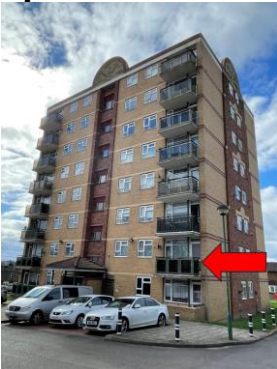
- 8) **Decorative trellis has been installed to the balcony of flat 69. Decorative trellis has the potential to support the external spread of flame.**

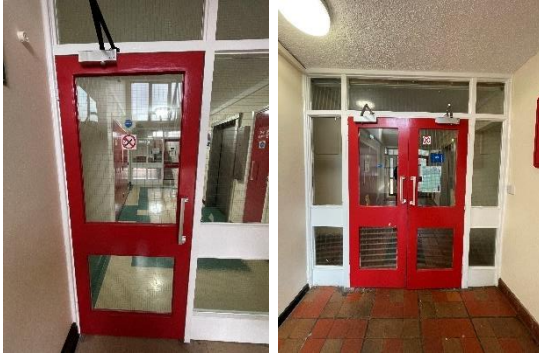
- 3) All corridors are of adequate width (at least 1050mm) and will be maintained clear to that width as a minimum.
- 4) There are no single travel condition corridors.
- 5) The means of escape are protected to prevent the spread of fire and smoke by means of notional fire doors.
- 6) The communal landing / staircases are protected by use of self-closing 44mm notional 30-minute timber fire doors with vision panels. All doors have been upgraded with intumescent strips / cold smoke seals.

As an interim measure, an action has been created for the Fire Rapid Response Team to improve the function of each communal landing door by, where necessary, re lipping, re aligning, removing old bat wings and oversized strips. Replace with new combined strips, new hinges, self-closers and address any defect beading if required.

P2	Within 1-3 Months Fire Rapid Response	
10/7	Improve the function of each communal landing door by, where necessary, re lipping, re aligning, removing old bat wings and oversized strips. Replace with new combined strips, new hinges, self-closers and address any defect beading if required.

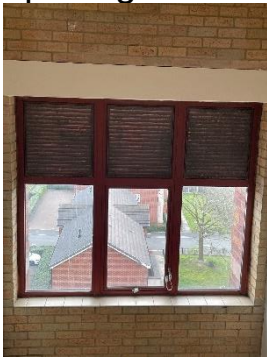
- 12) There are natural louvre vents/screens to the rear staircase and openable windows to the front staircase in addition to the automatic opening vent at the top of the front staircase.

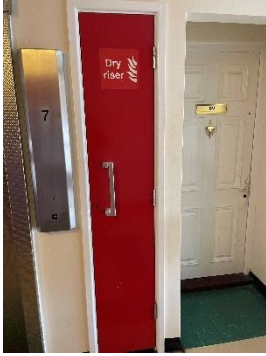
- 14) Communal areas should be kept free of flammable items. The communal areas are checked on a regular basis by Caretaking / Cleaning teams 365 days per year, all items of rubbish are immediately removed.
- 15) There is also an out of hour's service that allows combustible items of furniture / rubbish to be removed
- 16) Emergency lighting is provided to communal landings and stairs. Checks are done on a monthly basis by Sandwell MBC in house electrical team or approved contractor.
- 17) Dry riser cupboards are notional 44mm, 30-minute fire doors with combined intumescent strips & cold smoke seals through the block.
-

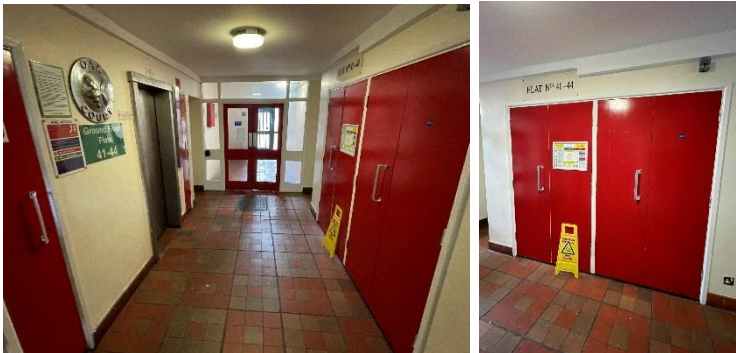
- 18) Service/electrical cupboards with lobby areas are notional 44mm 30-minute fire doors, secured with budget locks through the majority of the block.

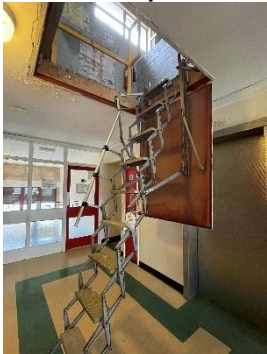
- 19) Lift motor room is located on the 7th floor of the block and is accessed via a drop-down hatch and zip ladder within the lift lobby.

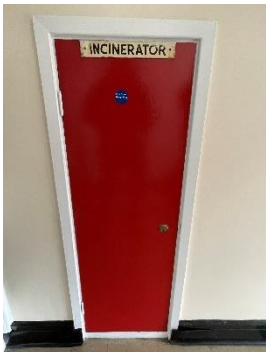
- 20) It was noted there is a redundant incinerator cupboard within the communal stairwell. (Access not gained)

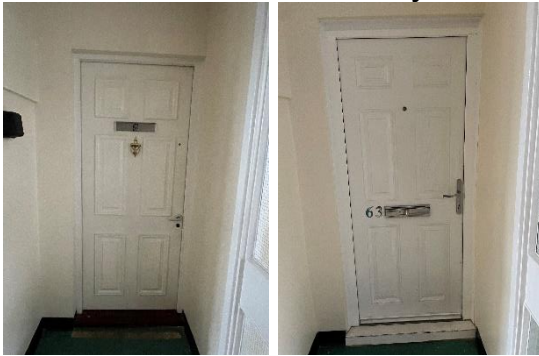
- 21) The surface coatings to the communal areas are Class 0 rated.
- 22) It was noted that there are service cupboards housing stop taps for individual flats protected behind are notional 44mm 30-minute fire doors, secured with Budget locks.
- 23) The building has sufficient passive controls that provide effective compartmentation in order to support a Stay Put-Unless Policy. Therefore, residents are advised to remain in their flat unless the fire directly affects them, or they are asked to leave by the emergency services.
- 24) Individual flat doors are predominantly nominal 44mm composite fire door sets with intumescent strips, cold smoke seals and self-closing devices. Manufactured by Permadoor.

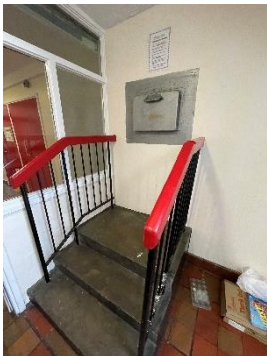
- 25) The refuse chute hoppers are located within the rear protected stairwell.

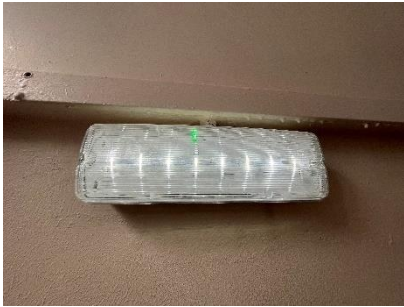
- 1) The premises have a sufficient emergency system in accordance with BS 5266 and has test points strategically located.
- 2) The self-contained units are provided to the communal landings, stairs and lift motor room.

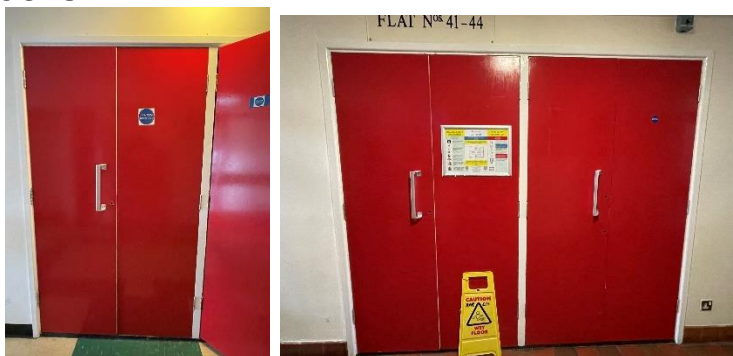
- 4) All communal fire doors are subject to a 12-week check by the Fire Safety Rapid Response Team.
- 5) All service cupboards to communal landings are notional fire doors with a minimum of 30 minutes fire resistance, partially secured with budget locks. **Because the budget locks are not securing the doors correctly they should be replaced with suited 138 mortice locks.**

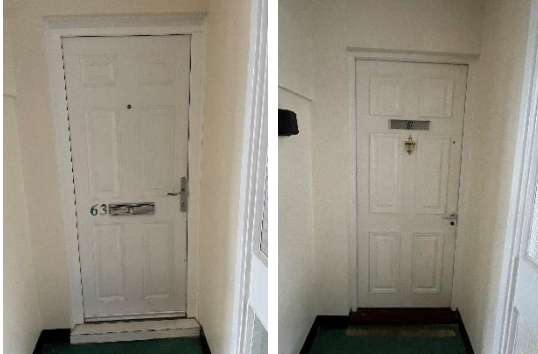
- 8) Dry riser and telecom service cupboards to communal landings have notional fire doors with a minimum of 30 minutes fire resistance, partially secured with budget locks. **Because the budget locks are not securing the doors correctly they should be replaced with suited 54 key mortice locks.**
- 9) Individual flat entrance doors are predominantly nominal 44mm timber/composite fire door sets with intumescent strips, cold smoke seals and self-closing devices of a Permadoor construction.

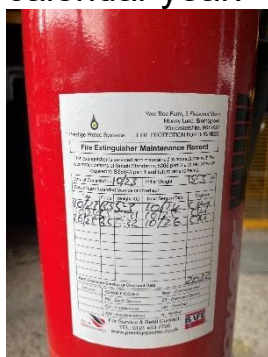
- 1) There is a dry riser that serves the building. The dry riser inlet is located within the ground floor dry riser cupboard.
- 2) The dry riser is checked regularly as part of the Caretakers duties.
- 3) The riser outlets are available on each floor lobby (1st – 7th) secured within cupboards by Budget Locks.
- 4) Maintenance contracts in place to service the valves twice per year (April and October) with a hydraulic test undertaken annually (October) to comply with the requirements of BS9990.
- 5) Portable fire extinguisher (CO2) is provided to the lift motor room. Maintenance contracts in place for maintenance of the extinguisher. The frequency for the maintenance checks is once (October) of each calendar year.

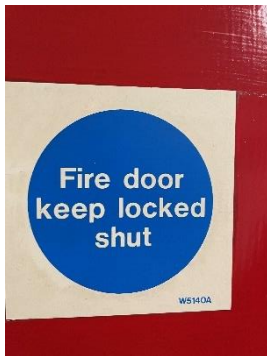
- 1) All fire doors display “Fire Door Keep Shut” & “Fire Door Keep Locked” where appropriate, communal cupboard doors display fire door keep shut signs rather than fire door keep locked signage however this is considered a trivia risk.

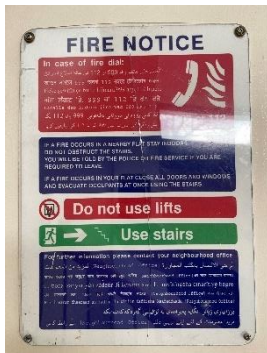
- 2) Fire Action Notices are displayed throughout the building.

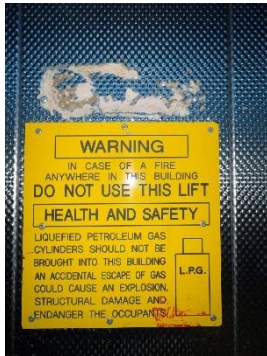
- 4) Yellow LPG warning signs are displayed within the lift cars.

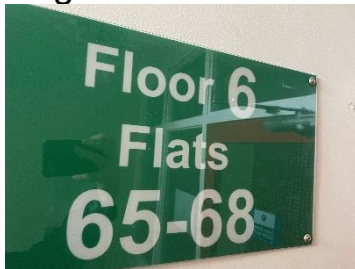
- 5) Photoluminescent wayfinding signage depicting floor level and flat numbers are fitted to the walls on all floors adjacent the lift car's and to the wall of each landing on the communal staircase. Signage that meets the requirement of ADB and Fire Safety (England) Regulations 2022.

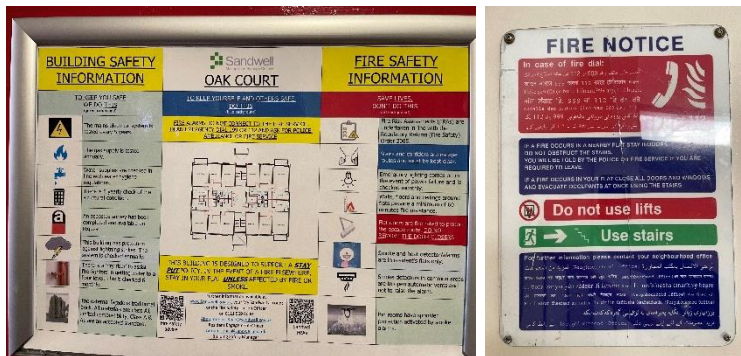
- 1) All Caretaking / Cleaning Employees have undertaken fire safety training. This includes use of bespoke 'Fire Safety in High / Low Rise Flatted Accommodation' Video.
- 2) All employees are encouraged to complete 'In the line of fire' training on an annual basis.
- 3) Caretaking Teams are not currently trained in the effective use of fire extinguishers. The only extinguishers located within the lift motor room. Caretaking Teams are not expected to tackle fires in this area.
- 4) Staff undertaking fire risk assessments are qualified to Level 4 Diploma in Fire Risk Assessment.
- 5) Fire safety information has been provided as part of tenancy pack.
- 6) Building safety and evacuation notices are displayed in common areas and lift cars.

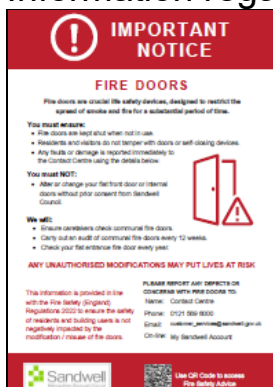
- 7) Information regarding use of fire doors is provided to residents.

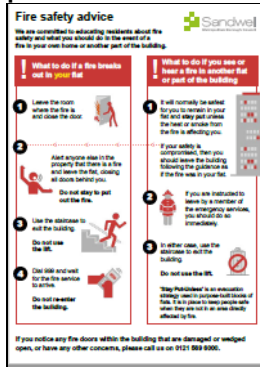
- 8) Information regarding the Stay Put unless fire evacuation strategy is provided to residents.

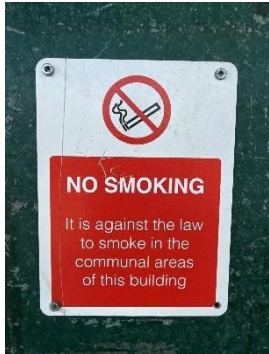
- 1) Smoking is prohibited within any communal parts of the building in line with Smoke Free England legislation and signage is present.

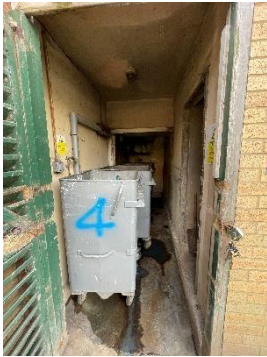
- 1) There is a regular Cleaning Service to the premises.
- 2) Refuse hoppers are accessed on each floor within the rear stairwell.
- 3) Refuse containers regularly emptied bin store located at the rear elevation of the block.

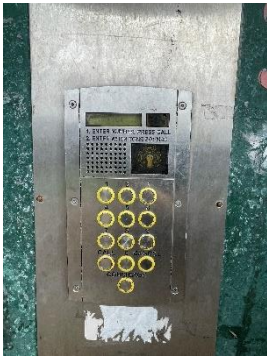
- 1) Regular checks are undertaken by Caretakers / Cleaning Team(s) 365 days per year which helps reduce the risk of arson.
- 2) Restricted access to the premises by means of a door entry system.

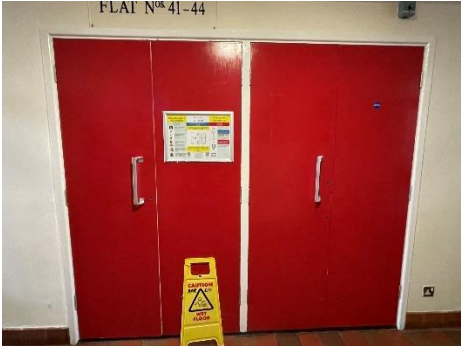
Also, all service cupboards in lift lobbies are secured with budget style locks which are failing to secure the fire doors correctly therefore these locks should be replaced with suited mortice locks.

P3	Within 3-6 Months Housing Manager	
10/5	Replace budget locks to all lift lobby electrical service cupboards with suited 138. All flats to be provided with a key for access to meters.

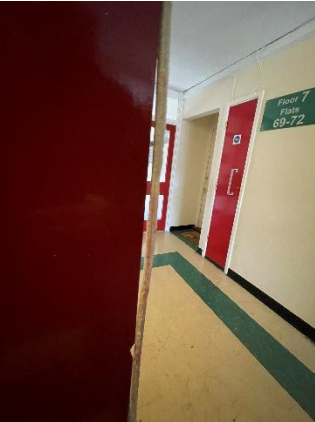
- 6) The right hand door to the left side service cupboard on the 7th floor has a defective cold smoke seal, replacement required.

10/6	7 th floor left hand service cupboard, replace defective cold smoke seal.

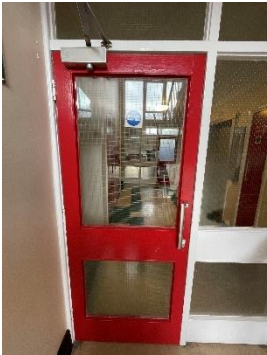
Whilst taking into account the standards at the time of construction, there are a number of 30 minute notional communal fire doors with gap sizes that are deemed excessive, worn bat wing type cold smoke seals and hinges. Although it has been noted that all of the notional doors have been upgraded with intumescent strips and cold smoke seals which does improve the original design it has been agreed that the Fire Rapid Response Team will review each door and where necessary, re- lip, re-align, remove old bat wings and oversized strips. Replace with new combined strips, new hinges, self-closers and address any defective beading if required.
