# Fire Risk Assessment Broadmede House

## 1-32, Pavillion Avenue, Smethwick, B67 6LB

Date Completed: 04/04/2025. Review Period: 12 months. Officer: A. Jones Building Safety Manager Checked By: C. Hill Building Safety Manager

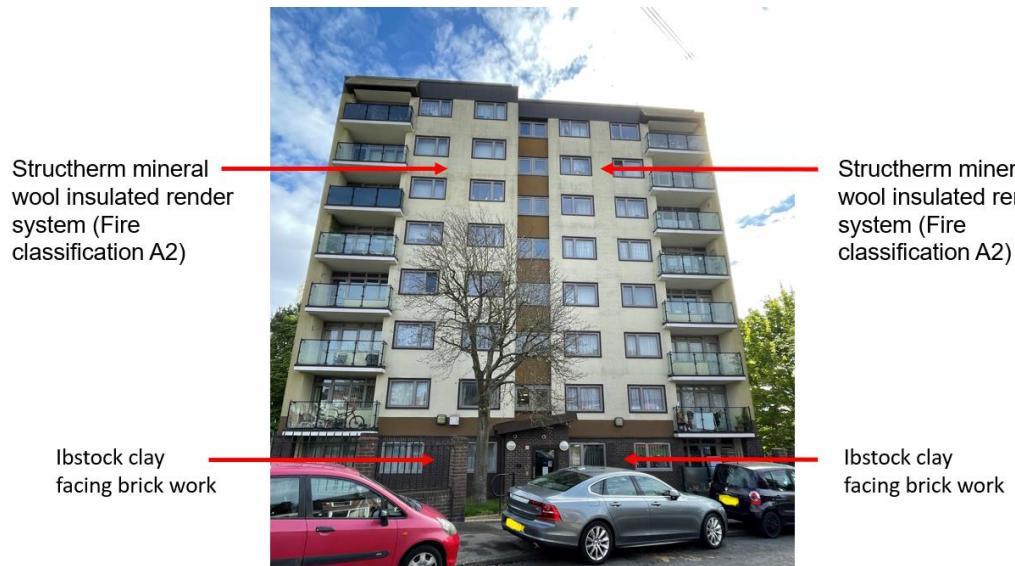
Structherm mineral wool insulated render

facing brick work

- 1) Broadmede House has two separate areas of cladding consisting of: -
  - Ibstock clay facing masonry.
  - Structherm mineral wool
- 2) The flat roof consists of single ply membrane on PUR/PIR board which was laid over the original roof construction.
- 3) All windows, including communal windows are constructed from wood with coated aluminium external clip on edging products.

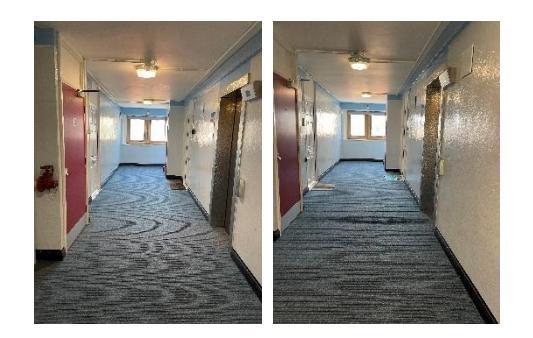
- 2) All corridors are of adequate width (at least 1050mm) and will be maintained clear to that width as a minimum.
- 3) Each lift lobby on all floors above ground forms a dead-end corridor situation that exceeds 7.5 metres (10.7m) the distance from the furthest flat entrance door to the protected staircase is 7.6m.

However, considering the 1965 construction date of the building which proceeded the first national building regulations introduced in February 1966, each flat has been installed with a nominal FD30s fire door set, service cupboards, storage cupboards and chute rooms also have 30 minute fire doors (notional), the communal areas are regularly inspected and remain sterile and automatic opening vents have been installed to each corridor, it is deemed that the risk has been sufficiently mitigated.

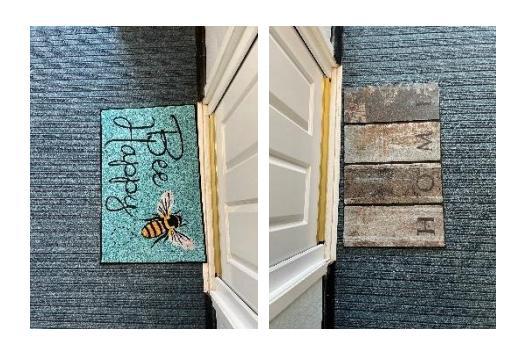
13) Communal areas are kept free of flammable items. The communal areas are checked on a regular basis by Caretaking / Cleaning teams 365 days per year and all items of rubbish are immediately removed. There is also an out of hour's service that allows combustible items of furniture / rubbish to be removed. 14) Individual floor mats were noted outside some flats. The fire rating of these mats is unknown but deemed to be of low risk.

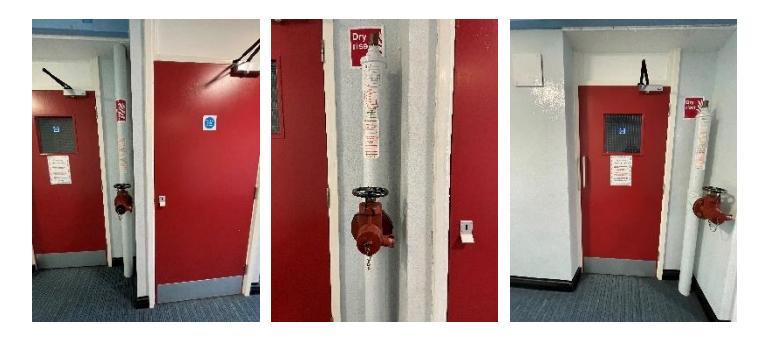
- 15) Emergency lighting is provided to communal landings and stairs. Maintenance & other servicing checks are completed at frequent intervals in accordance with BS5266.
- 16) Dry riser outlets on lobbies are not housed in service cupboards but deliveries are secured by cable tie.

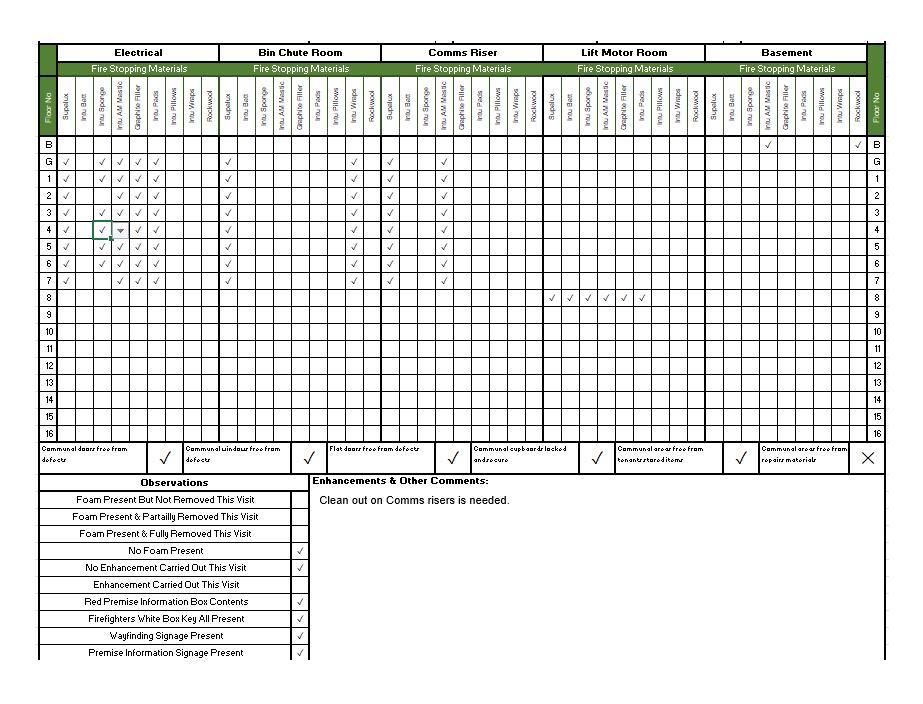
8) A variety of methods / materials have been used to achieve firestopping including Rockwool, fire rated sponge and Supalux boards.

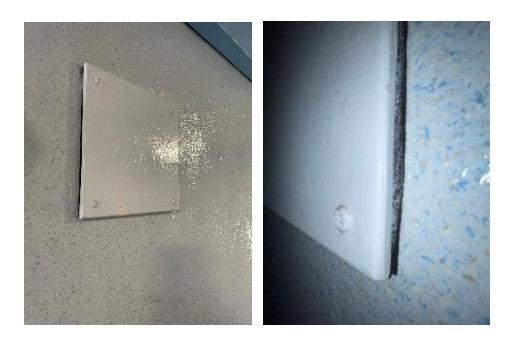
11) Access panels to individual stop taps are fixed to masonry and bedded on Intumescent material.

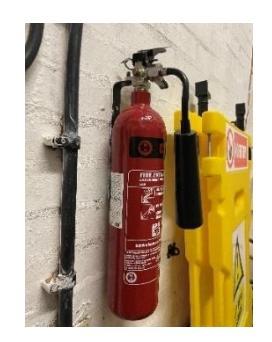
5) Portable fire extinguisher (CO2) is provided to the lift motor room. Maintenance contracts in place for maintenance of the extinguisher. The frequency for the maintenance checks are once (October) of each calendar year.

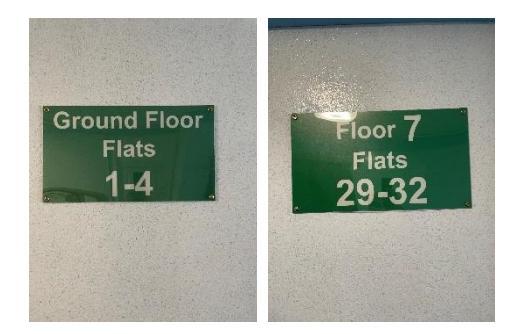
5) Photoluminescent wayfinding signage depicting floor levels and flat numbers are fitted to the walls on all floors and to the wall of each landing on the communal staircase. Signage that meets the requirement of ADB and Fire Safety (England) Regulations 2022.

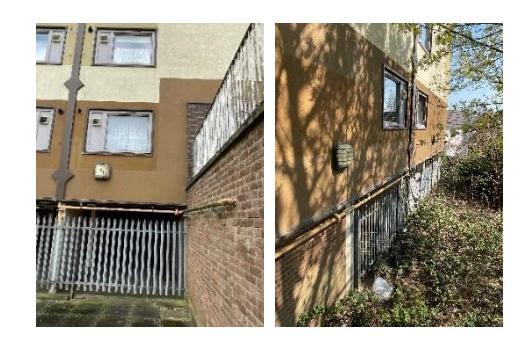
8) Gas appliances and pipework (where installed) are subject to annual testing and certification. This cyclical contract is managed by the inhouse Gas Team. Gas supply pipework is external to the building.

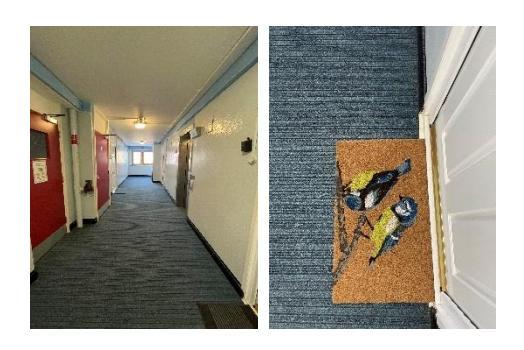
9) At the time of the assessment, it was noted that landing floors were fitted with carpet. It is understood that carpets have been procured in accordance with BS 5287: 1988 specification for assessment and labelling of textile floor coverings and & BS 4790 Fire Test to Textile Floor Coverings.

Due to these carpets being fitted by SMBC, its assumed that it meets the necessary standard set out above. See section 7/24 for further information. N.B, this has been recorded in the observations section.

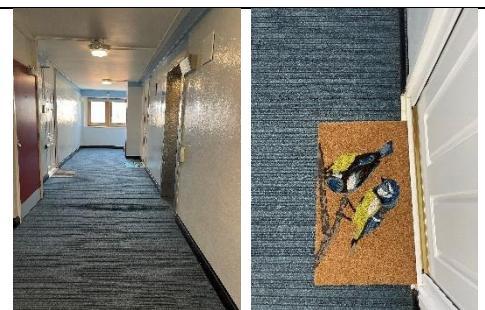
At the time of the assessment, it was noted that landing floors were fitted with carpet. It is understood that carpets have been procured in accordance with BS 5287: 1988 specification for assessment and labelling of textile floor coverings and & BS 4790 Fire Test to Textile Floor Coverings.

When any refurbishment of the building takes place consideration should be given to replace existing flooring for an approved floor covering that has appropriate fire resistance.

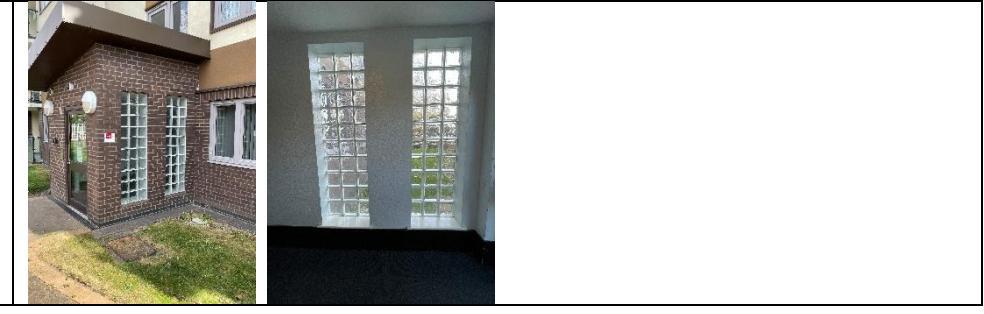
Following the refurbishment in 2008 glass blocks located on the front elevation are within 1.8 meters of residential window frames. It could not be confirmed that this type of glazing provides adequate protection as set out in ADB.
