# Fire Risk Assessment

## Scott House

**Langdale Road  
Great Barr, B43 5RD**

**Date Completed: 07/11/2025**

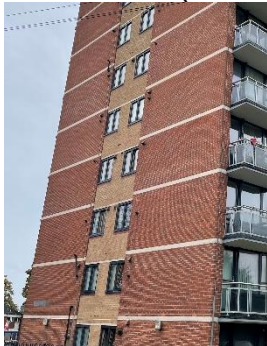
- Brickwork (Non-combustible) to both side elevations.

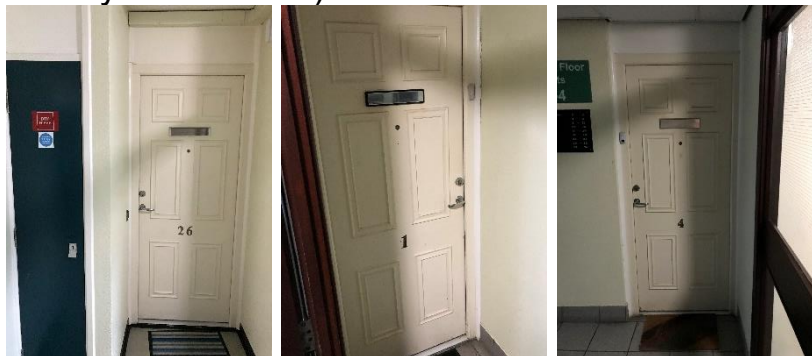
- 1) Individual flat doors are predominantly nominal self-closing 30-minute composite fire door sets with intumescent strips, cold smoke seals. majority being manufactured by Manse Masterdoor (Flat 27 manufactured by Permadoor).

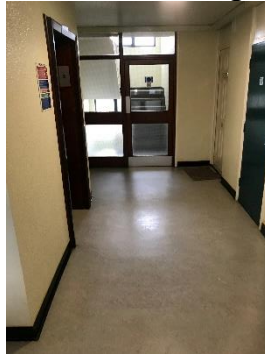
- 3) All corridors and communal landing areas are of adequate width and will be maintained clear. There are no dead-end scenarios within communal areas due to the block benefiting from 2 staircase.

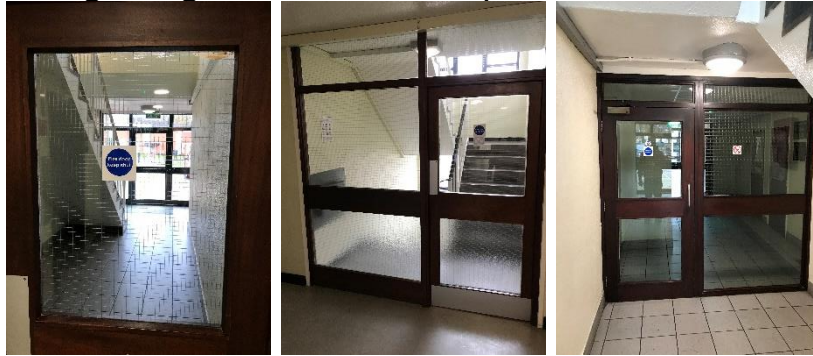
- 4) The communal landing / staircases are protected by use of self-closing 44mm notional timber 30-minute fire doors with vision panels with Georgian wired glazing, intumescent strips / cold smoke seals.

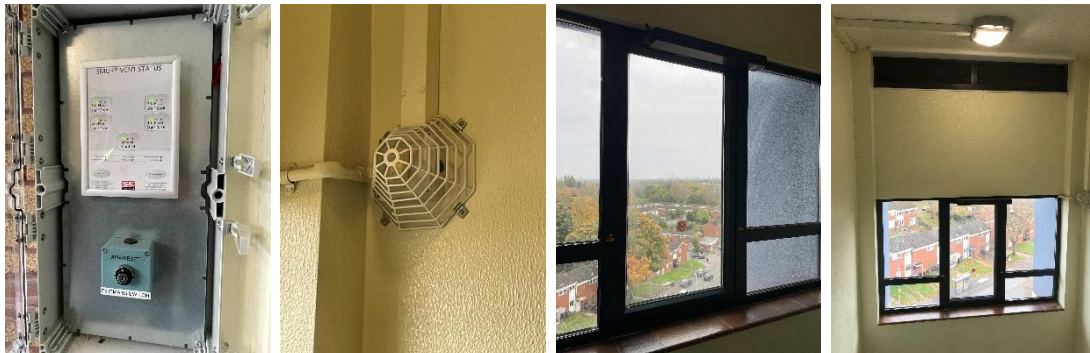
- 5) The means of escape are ventilated by the way of manual opening windows and Automatic smoke ventilation. The AOV system is tested, inspected, and maintained by a competent procured contractor in accordance with BS7346. The frequency for the maintenance checks is twice per year (April and October) of each calendar year. Automatic opening vents have been installed to the stairwell on floors. The block also has manual ventilation via vouvre vents at the head of the stairwell.

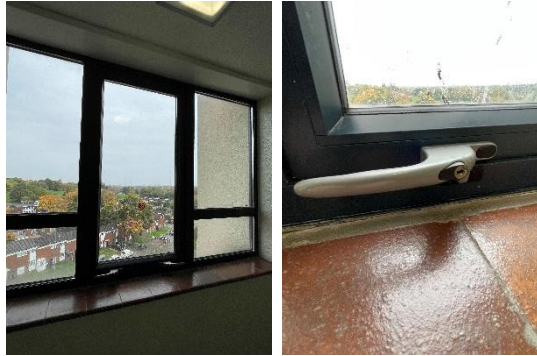
- 6) Communal windows can be opened without the need for a key and have restrictor devices fitted.

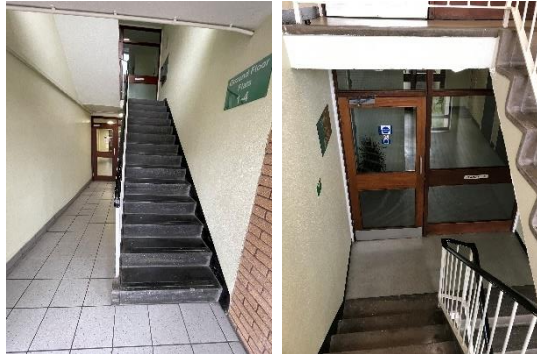
- 7) The premise has two staircases (approximately 1100mm in width from the rail to the wall) that provides a means of escape. All flats are within approximately 2 metres of a staircase.

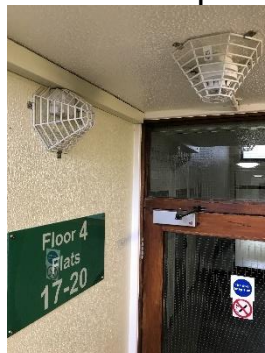
- 8) All communal doors are fitted with automatic closing devices that are checked on a regular basis by Caretaking Teams as part of their checks. Defective closing devices are replaced either by the Caretaking Team(s) or the in-house repairs team(s).

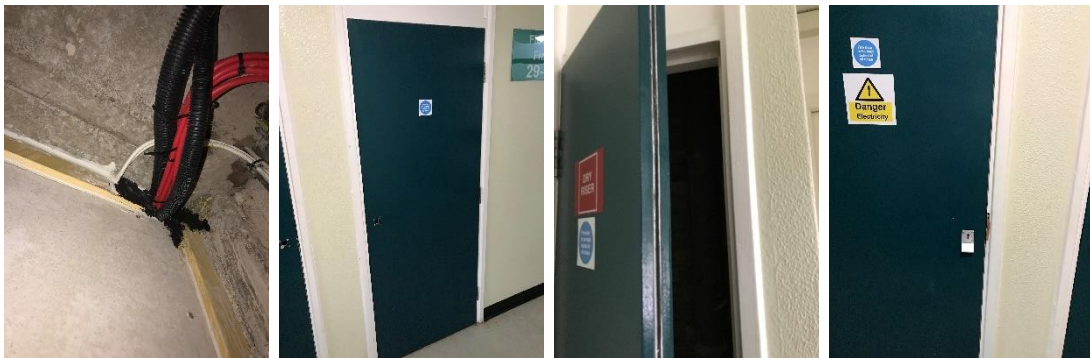
- 10) Service cupboards including those housing electricity meters are 44mm nominal fire doors with intumescent strips and cold smoke seals, secured with type 054 suited mortice locks to cupboards not accessed by residents and type 138 suited mortice locks to cupboards residents have access for the electricity meters. Fire stopping within service cupboards is evident.

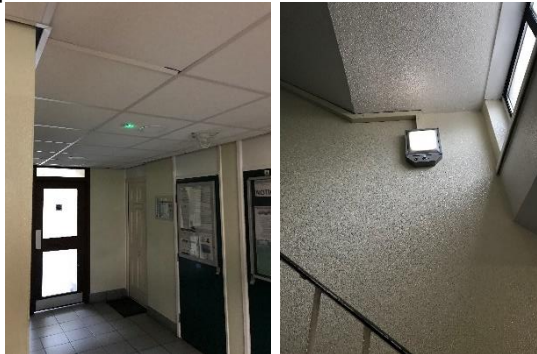
- 11) Emergency lighting is provided to communal landings and stairs. Checks are done on a monthly basis by Sandwell MBC in house electrical team or procured contractor.

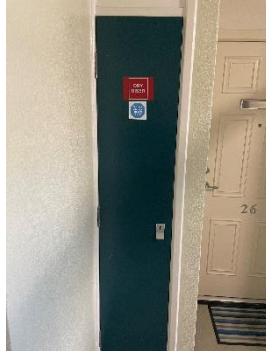
- 13) The surface coatings to the communal areas are a minimum of Class B-s3,d2 rated.
- 14) Individual floor mats were noted outside some flats. Fire rating of the mats is unknown but deemed to be a trivial risk.
- 15) Doors to dry riser cupboards are nominal FD30s, kept locked / secured with type 54 suited mortice lock(s).

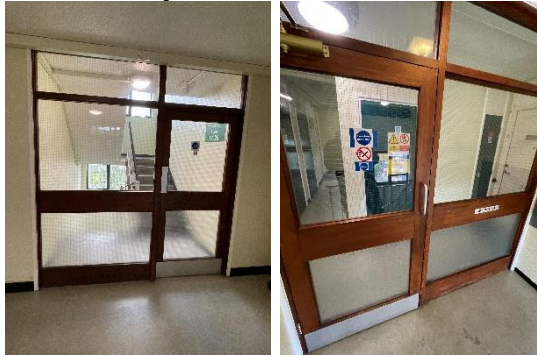
- 4) All communal fire doors are subject to a 12-week check by the Fire Safety Rapid Response Team.
  - 5) The communal landing & staircases are protected by use of notional self-closing 44mm 30-minute timber fire doors with vision panels, 25mm stops & screens. It is recognised that these doors do not meet today's benchmark of a certified FD30s fire door install however, because they were installed at the time of the building's construction and to the standard of that time they are deemed as acceptable so long as the doors are free of damage and function as they were intended to do so. It has been recognised that all of the landing / staircase notional doors in this block have been upgraded with combined intumescent strips & cold smoke seals to enhance their original design and minimise departures from today's standards (upgraded notional fire door). Were minor shortcomings have been
-

identified via the fire door inspections actions remediation works will be completed to address any issues.

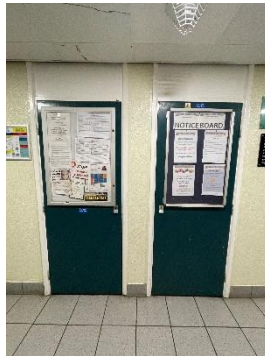
- 6) Ground floor service cupboards containing resident's electricity meters are nominal 54mm timber fire doors with combined intumescent strip / cold smoke seals.

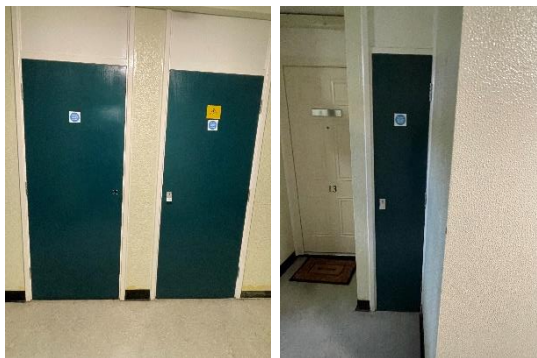
- 7) Other service cupboards, dry riser cupboards and cleaner's cupboard doors are nominal 44mm timber fire doors combined intumescent strip / cold smoke seals.

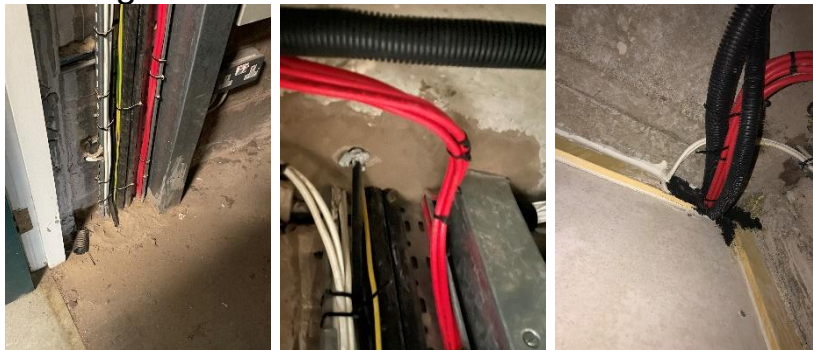
- 10) A variety of methods / materials have been used to achieve fire-stopping including fire mortar and intumescent mastic.

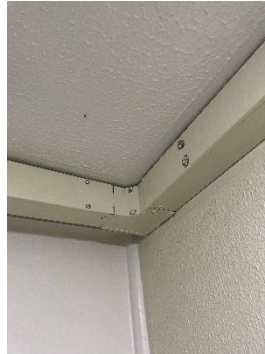
11) Cabling from service cupboards is contained in metal trunking.

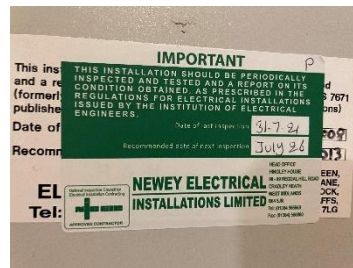
- 1) Smoking is prohibited within any communal parts of the building in line with Smoke Free England legislation.
- 2) Hot working is not normally carried out. If essential maintenance requires the use of hot work processes, then corporate policies and procedures are to be followed.
- 3) Portable electrical equipment used as part of the Caretaking / Cleaning regime is subject to annual PAT Testing. This information is held by the Estate Services Manager Bryan Low.
- 4) The fixed electrical installation shall be tested every 5 years. It was noted that the last inspection was 31/07/2021.

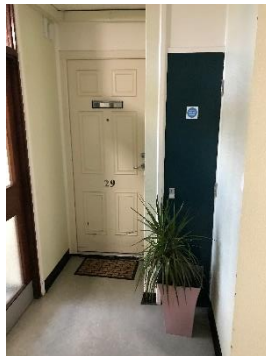
Question/ Ref No	Required Action	Supporting photograph	Priority	Timescale and Person Responsible	Date Completed
07/18	Outside flat 29 - Remove Plant obstructing service cupboard

P3	3-6 months Housing Management

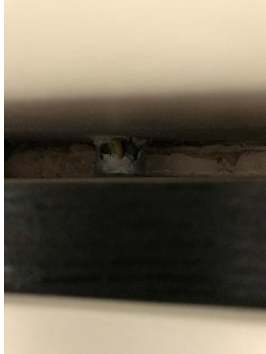
10/16	Further checks required above the false ceiling on the ground floor, fire stop if required.

P2	1-3 Months Fire Rapid Response	
-------	---	--	----	--------------------------------------	--

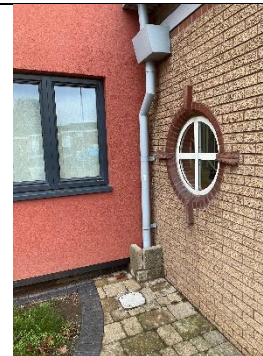
There's a small round window to each side of the front and rear entrances / protected stairwells all within 1.8 metres of ground floor accommodation (bedroom) window, it is assumed that the glazing is not fire resistant. Taking into consideration the Stay Put – Unless strategy and the two protected stairwells with AOV's installed the risk is deemed low. However, compensatory measures should be considered as part of a future works programme such as installing 60 minute fire resistant glazing, bricking up the window, or installing sprinkler system to the flats.
