# Fire Risk Assessment

## Lancaster House

**1-120, Oldbury Rd,  
Rowley Regis, B65 0QF**

**Date Completed: 02/04/2025**

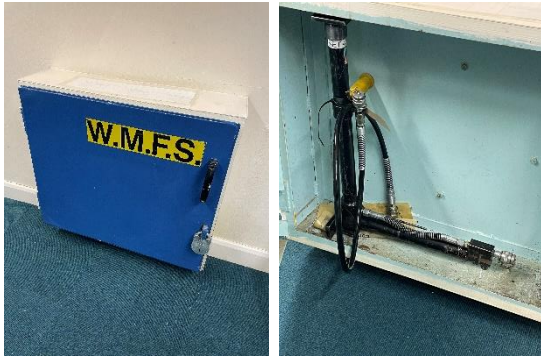
There is a WMFS Hydraulic Door Opener stored in a secured cupboard within the ground floor meeting room which is adjacent the Premise Information Box. The cupboard is secured with a Bridge Door padlock. The door opener is a shorter version than the ones carried on WMFS fire appliances and is specifically designed for the narrower front entrance doors at Lancaster House.

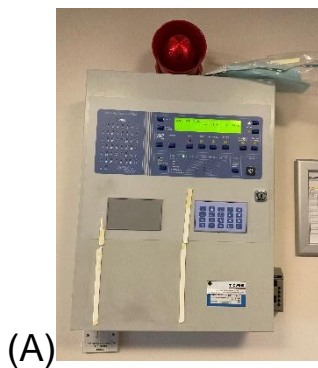
There is a fire alarm panel and detection system within the 1<sup>st</sup> floor community room (Image A). The system provides detection to the community room only.

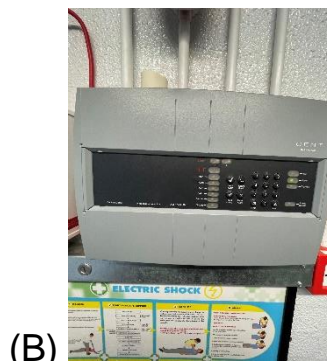
There is a fire alarm panel and detection system to the lower ground floor server room (Image B). The system provides detection to the server room only.

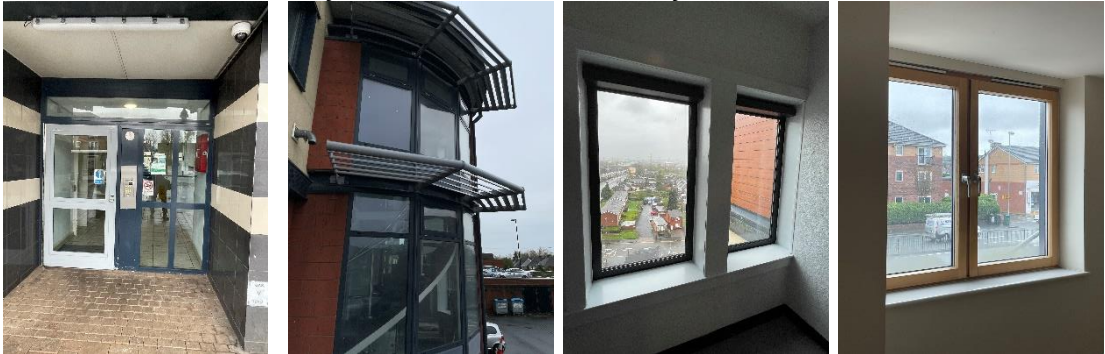
- 3) Entrance doors and communal windows are powder coated aluminium units. Windows to individual flats are powder coated aluminium externally and timber internally.

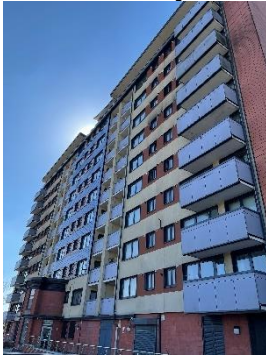
- 4) Each flat within the block has access to an individual balcony. The balconies are constructed utilising cantilevered concrete and are clad with Marley Eternit Board.

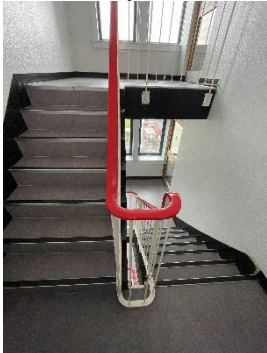
- 1) The site has 2 protected staircases that provide a sufficient means of escape. Each staircase in width is 960mm from handrail to wall.

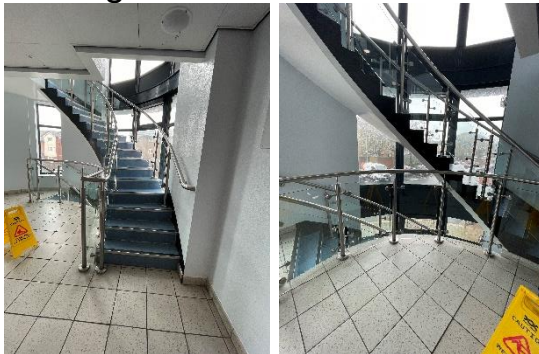
- 2) Additionally, there is a third staircase (open plan) that serves from lower ground rear entrance atrium to the 1<sup>st</sup> floor.

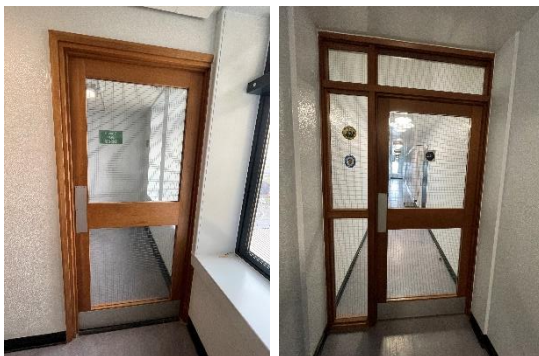
- 5) The means of escape are protected to prevent the spread of fire and smoke.
- 6) The communal landing / staircases are protected by use of nominal FD30S timber doors with vision panels and combination frames. All doors were installed during the 2009/10 refurbishment works.

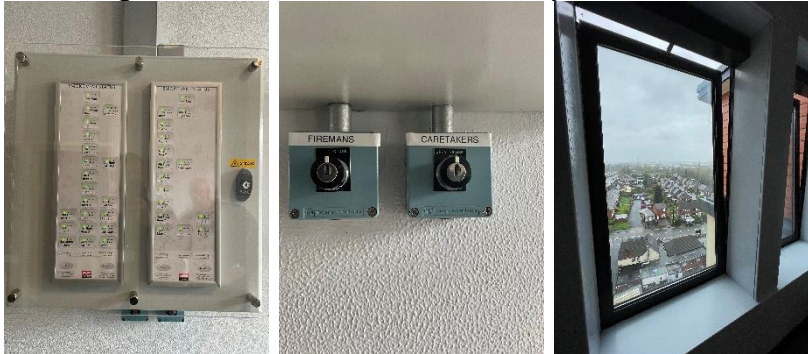
- 11) Automatic opening vents have been installed to both stairwells and corridors including the dead-end corridors in the two wings. The information panel and firefighter override switch are located in the ground floor entrance lobby.

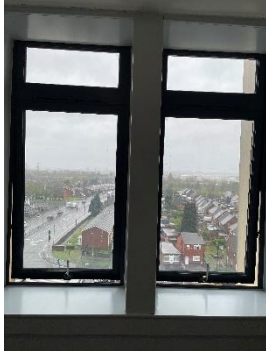
- 12) Communal windows to each stairwell are openable.

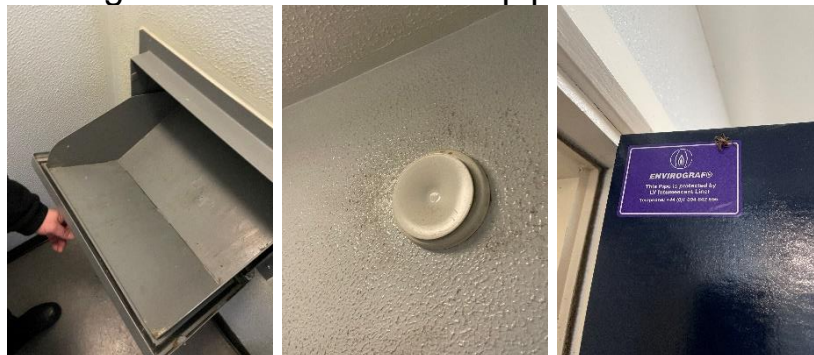
- 13) The refuse chute hoppers are fitted with seals. There are two hoppers per floor from the first floor upwards. All hoppers are located in cupboards installed with a nominal timber FD30s self-closing door and a ventilation pipe with intumescent liner.

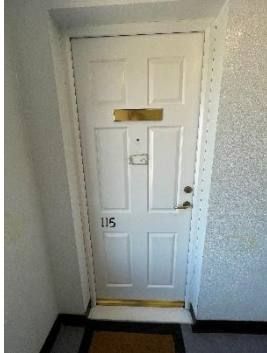
- b) Flat 115 – Door was correct.

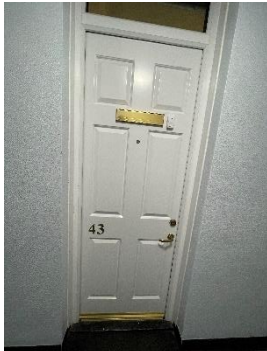
- d) Flat 43 – Door was correct.

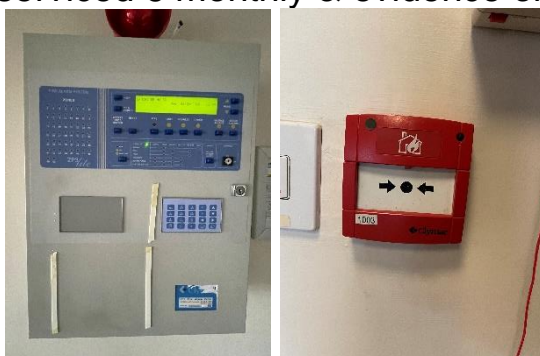
- 3) There is no effective means for detecting an outbreak of fire to communal corridors, lobbies, landings and stairs. The reason for this are:
  - I. Such systems may get vandalised.
  - II. False alarms would occur.
  - III. A Stay Put - Unless policy is in place
- 4) There is a fire alarm system to the 1<sup>st</sup> floor community room. The system provides detection & alarm to this room only. The alarm panel is located just inside the entrance door. The system is serviced 6 monthly & evidence of weekly testing was displayed.

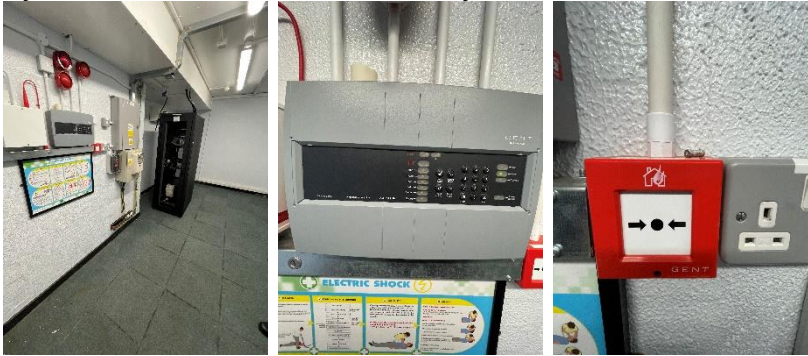
- 5) There is a fire alarm system to the lower ground floor server room. The system provides detection, monitoring & alarm to this room only. The alarm panel is located just inside the entrance door. The system is serviced 6 monthly.

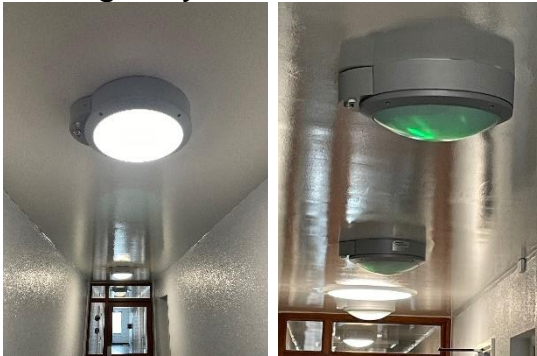
- 1) The premises have a sufficient emergency / escape lighting system in accordance with BS 5266 and has test points strategically located.

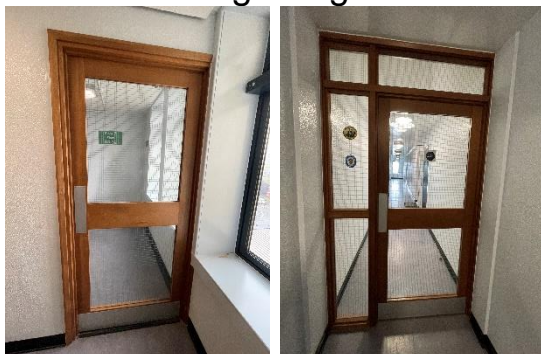
- 4) All communal fire doors are subject to a 12-week check by the Fire Safety Rapid Response Team.
- 5) All communal landing, corridors & staircases are protected by use of FD30S timber doors with vision panels and combination frames. Fire resistant glazing has been installed to all vision panels.

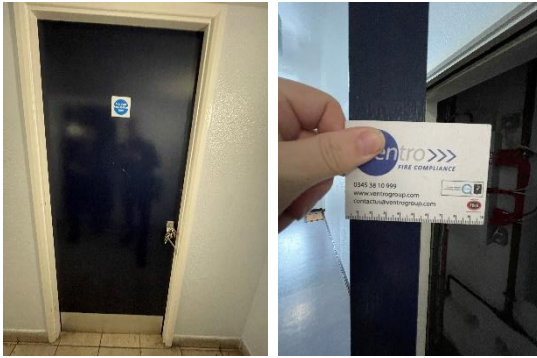
- 6) All service cupboards doors and doors to staff and communal rooms are either 44mm FD30s or 54mm FD60s nominal fire doors and are locked with all keys available in the firefighter's white box.
-

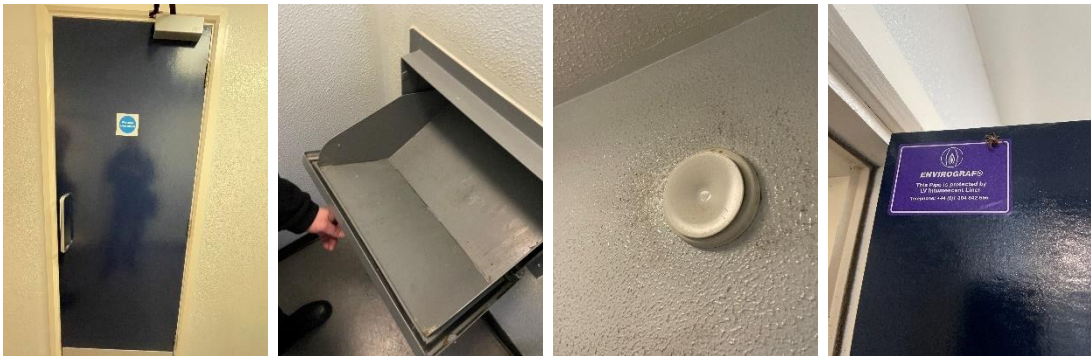
- 7) There are two hoppers per floor from the first floor upwards. All hoppers are located in cupboards installed with a nominal timber FD30s self-closing door and a ventilation pipe with intumescent liner.

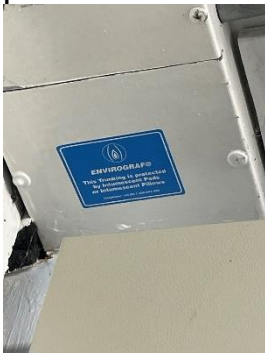
- 8) Cabling is run through metal trunking with intumescent pads or pillows.

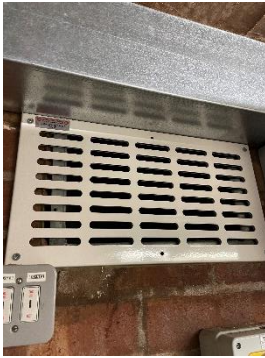
- 9) An intumescent ventilation grill was noted in the lower ground floor switch cupboard.

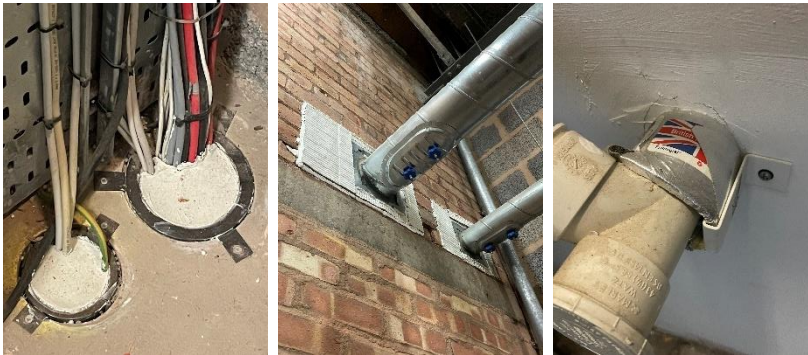
- 10) A variety of methods / materials have been used to achieve fire-stopping including intumescent coated slabs, fire mortar and intumescent pillows.

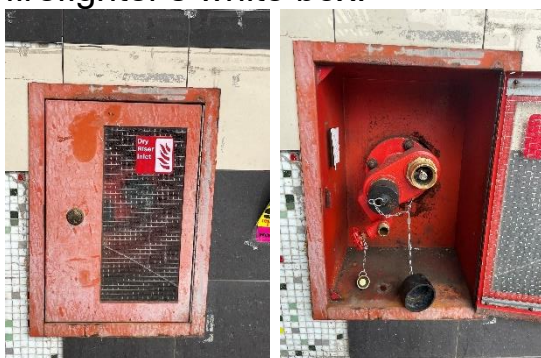
- 1) There are two dry riser systems at Lancaster House. The inlet cupboards are both to the front of the building adjacent the protected stairwell exits. The key for the inlets is within the firefighter's white box.

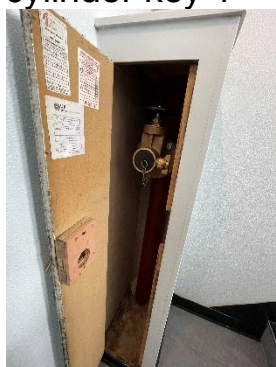
- 2) The riser outlets are available on each half landing in each protected stairwell (1<sup>st</sup> – 10<sup>th</sup>) within cupboards secured by suited cylinder key 1<sup>st</sup> – 9<sup>th</sup> floors & 54 key mortice locks on the 10<sup>th</sup>.

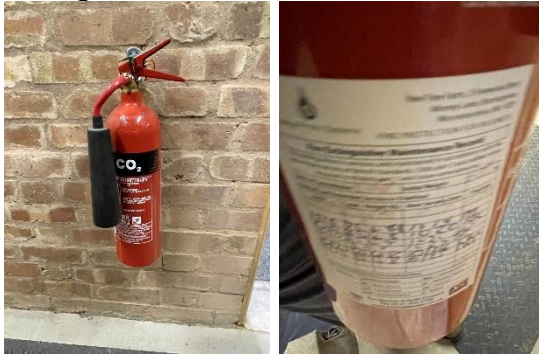
- 3) The dry riser is checked regularly as part of the Caretakers duties.
- 4) Maintenance contracts in place to service the valves twice per year (April and October) with a hydraulic test undertaken annually (October) to comply with the requirements of BS9990.
- 5) Portable fire extinguishers are provided to the lift motor room, tank room, basement, laundry rooms , community and meeting rooms. Fire blankets are fitted in the kitchens of both the community and meeting rooms. Maintenance contracts in place for maintenance of the extinguisher. The frequency for the maintenance checks are

once (October) of each calendar year. The last service date on extinguishers was noted as October 2024.

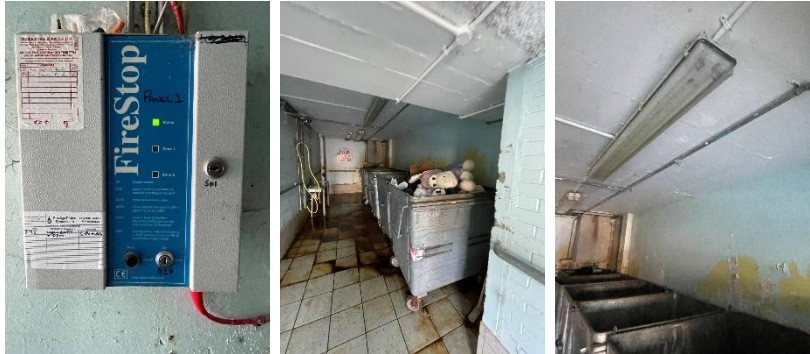
- 6) The bin stores are protected by a fire suppression system and serviced 6-monthly. The control panels are located on the wall within each bin store.

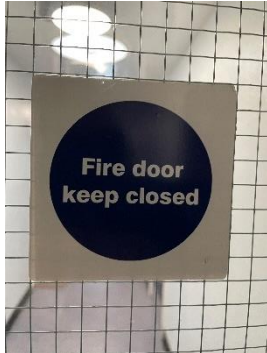
- 1) All fire doors display appropriate signage.

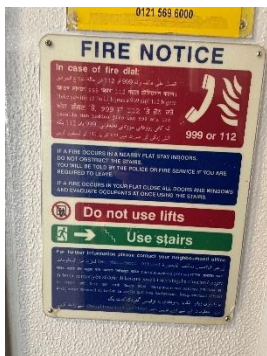
- 2) Fire Action Notices are displayed throughout the building.

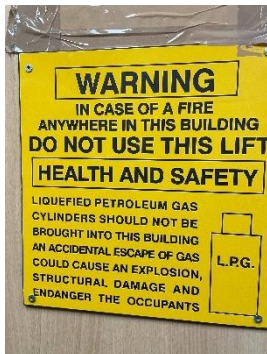
- 3) Yellow LPG warning signs are displayed within the lift cars.

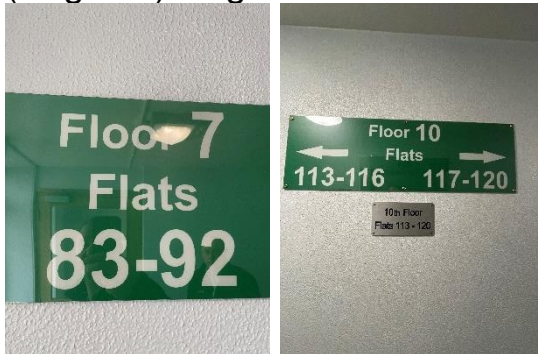
- 5) Photoluminescent wayfinding signage depicting floor level and flat numbers are fitted to the walls on all floors adjacent the lift car's and to the wall of each landing on the communal staircase's. Signage that meets the requirement of ADB and Fire Safety (England) Regulations 2022

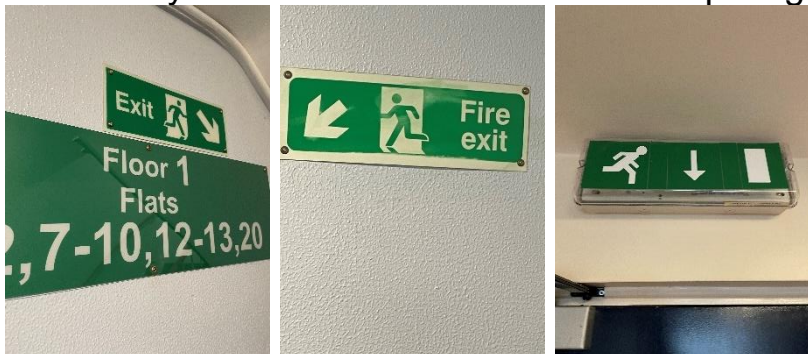
- 6) Fire escape routes on the 1<sup>st</sup> and 2<sup>nd</sup> floor wing staircases and community room have directional fire escape signage displayed.

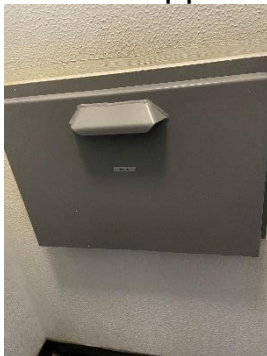
- 1) There is a regular Cleaning Service to the premises.
- 2) Refuse hoppers are accessed on each floor from 1<sup>st</sup> to 10<sup>th</sup> floor.

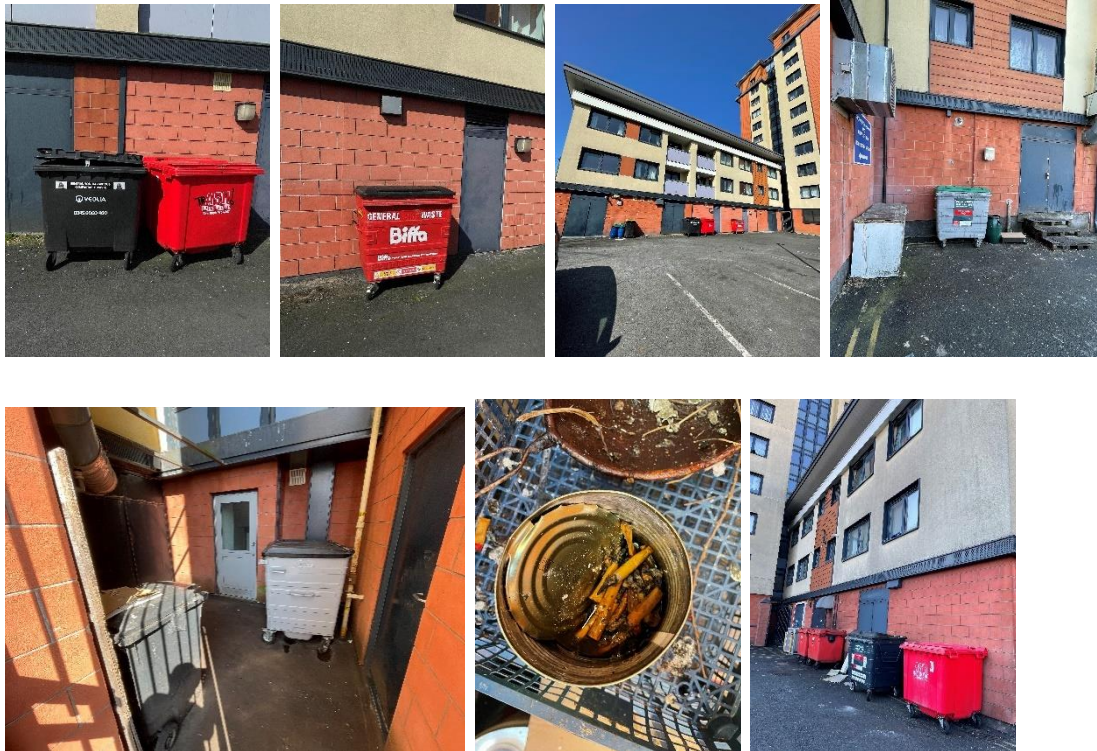
- 4) Regular checks by Caretakers minimise risk of waste accumulation.
- 5) 'Out of Hours' service in place to remove bulk items.
- 6) **There is a build-up of waste products at the rear of Hans Cantonese Take-Away. Plastic crates & drum, cooking oil drums, cardboard boxes and MDF sheets have been discarded against the wall of the building. It was also noted that cigarettes are discarded in a tin can amongst the waste. The premise also stores a waste bin here which is covered in the next point.**

**This is an ongoing issue which was recorded in the previous FRA April 2024. An SMBC commercial property officer has been liaising with the commercial retail tenants to discuss the concerns.**

**A suitable area should be identified where all waste containers can be stored safely at a horizontal distance of 6 metres from the building as per the recommended guidance of the Confederation of Fire Protection Associations Europe (CFPA-E).**

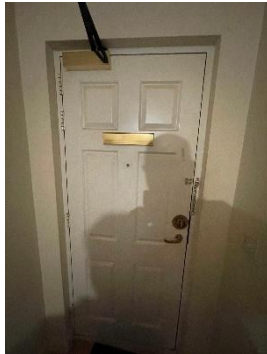
Question/ Ref No	Required Action	Supporting photograph	Priority	Timescale and Person Responsible	Date Completed
7/19a	Flat 114 – Adjust self-closer to speed up entrance door

P2	Within 1-3 months Fire Rapid Team

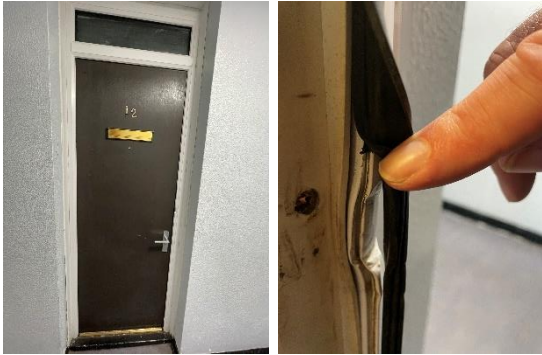
- e) Flat 12 – Door leaf is timber FD30 door that has been installed as a replacement door within the previous Permadoor frame. **The door has been installed with 3 hinges. There is a small area of the frame without intumescent where a 4<sup>th</sup> hinge was previously fitted. Damage is evident to the lock side of the frame where forced entry tools have previously been used. There's an 8mm gap between the door leaf and latch side of the frame. Replacement FD30s door and frame set required.**

7/19e	Flat 12 – New FD30s fire door set required ( <i>approximate frame measurements including transom 2280 x 795</i> ).

P3	Within 3-6 months Asset Management Fire Safety	
15/06	Build of waste the rear of Hans Cantonese Take-away to be removed.

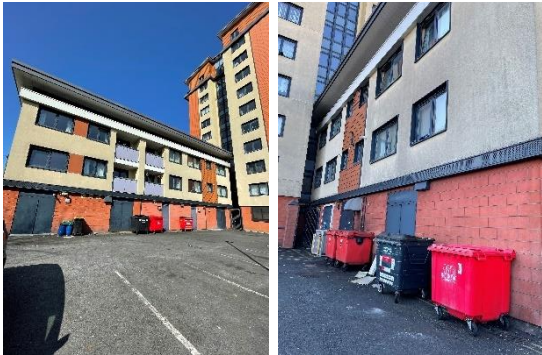
P2	Within 1-3 months Commercial Property Officer	
15/7	All waste containers for retail business are to be relocated to a designated area at a minimum safe horizontal distance of 6 metres from the building. This issue was raised within the

Within 1-3 months Commercial Property Officer
