# Fire Risk Assessment

## Lancaster House

**1-120, Oldbury Rd,  
Rowley Regis, B65 0QF.**

**Date Completed: 01/04/2026**

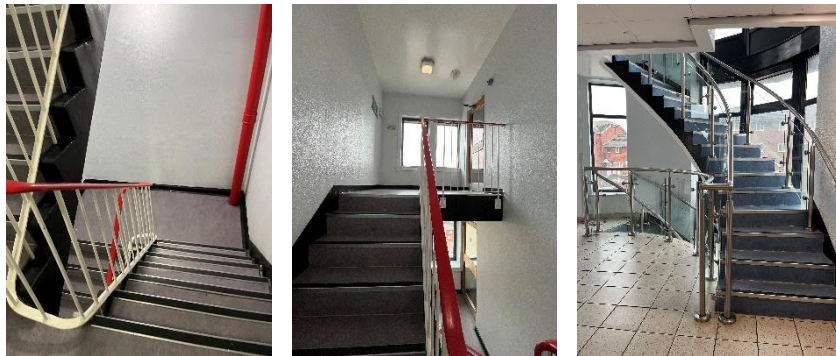
- 1) The block has two protected staircases that provide sufficient means of escape. Each staircase in width is 960mm from handrail to wall. There is a third (accommodation) staircase at the rear serving the lower ground, ground and 1<sup>st</sup> floor.

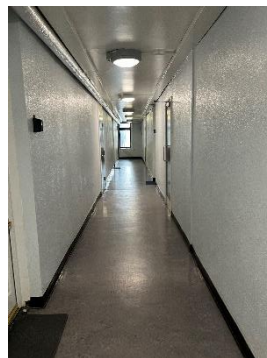
- 2) All corridors are of adequate width (at least 1050mm) and will be maintained clear to that width as a minimum.

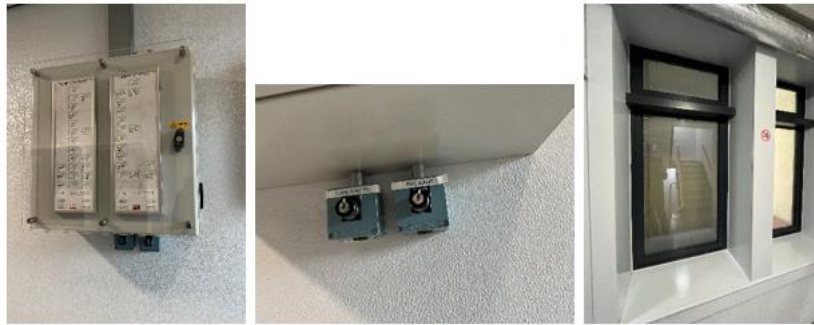
- 9) Automatic opening vents (AOV) are installed in the central atrium, corridors & stairwells. The main control panel, caretakers & firefighter override switch are immediately inside the front main entrance.

This is tested, inspected, and maintained by a competent procured contractor in accordance with BS7346. The frequency for the maintenance checks is twice per year. (April and October).

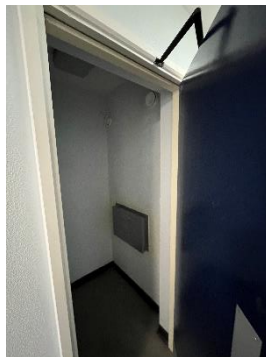
- 10) Refuse chute hoppers are fitted with seals. There are two hoppers per floor from the first floor upwards. All hoppers are in cupboards installed with a nominal timber FD30s self-closing doors and a ventilation pipe with intumescent liner.

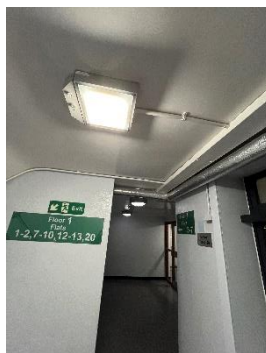
- 11) Emergency lighting is provided to communal lobbies and stairs. Checks are done monthly by Sandwell MBC in house electrical team or approved contractor.

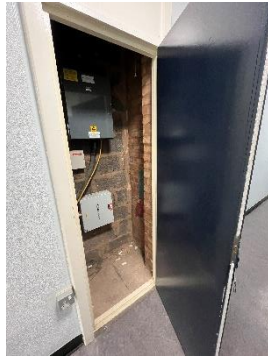
- 12) Residents' electrical supplies are situated in the cupboards on all floors, protected with nominal FD30s or FD60s doors.

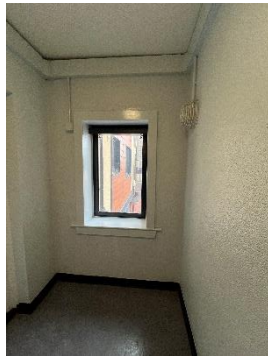
- 13) The surface coatings to the communal areas are a BS EN 13501-1 (Euroclass) system

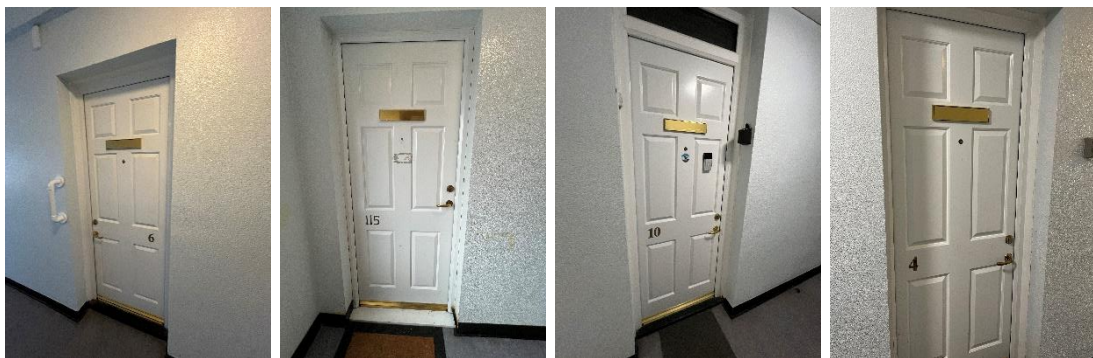
- 14) Individual flat entrance doors are predominately nominal FD30S rated composite fire doors.

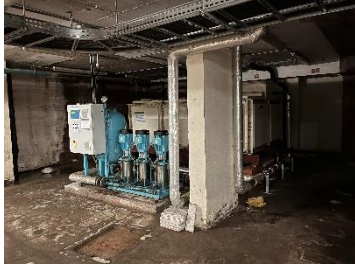
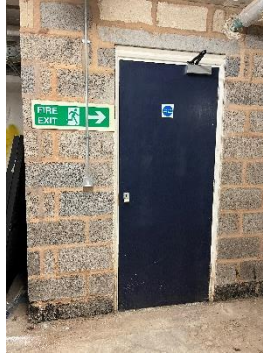
- 16) The fire escape door from the lower ground floor pump plant area requires a thumb-twist lock to be fitted to the inside to prevented persons being locked in this plant room. See action 7/16.

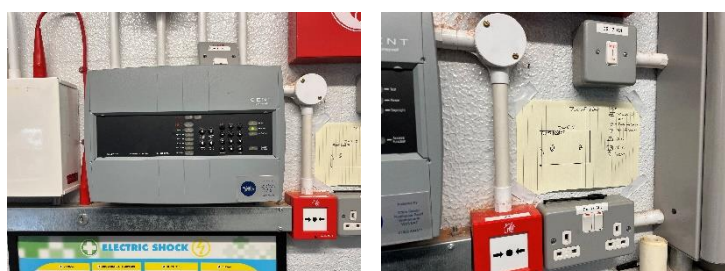
- 5) The server room on the lower ground floor has an automatic fire alarm system that appears to conform to BS5839. There are detector heads, sounders, a manual call point and a fire alarm control panel. This panel indicates that the alarm system is zoned, however, only a temporary zone plan is present. BS 5839-1:2025 states that zone plans are required on every system of any size to be compliant. It is required that a suitably compliant zone plan is provided near the fire alarm control panel. See action 8/5.

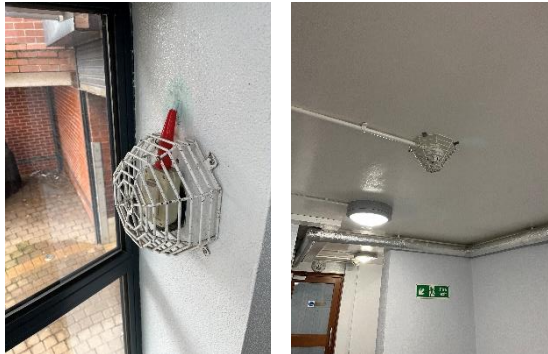
- 7) Smoke detectors linked to the automatic opening vents have been installed in the common areas. The vents in the stairwells will automatically open when smoke has been detected.

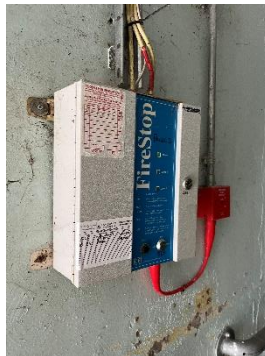
- 8) A deluge system is provided in each of the refuse chute bin stores. Detectors for actuation and the control unit are sited within the bin stores. An approved contractor maintains the system. The frequency for the maintenance checks is twice per year (April and October).

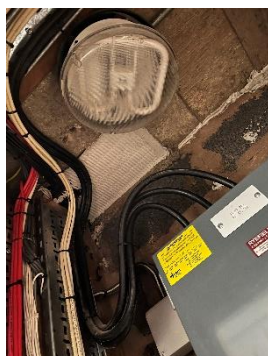
- 4) A variety of methods / materials have been used to achieve fire-stopping including Rockwool and intumescent pillows.

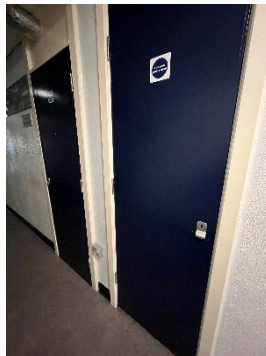
- 6) Service cupboards on all floors are notional FD30s and FD60s timber fire door sets. The keys are held centrally at SMBC Roway Lane, and within the firefighter's white box.

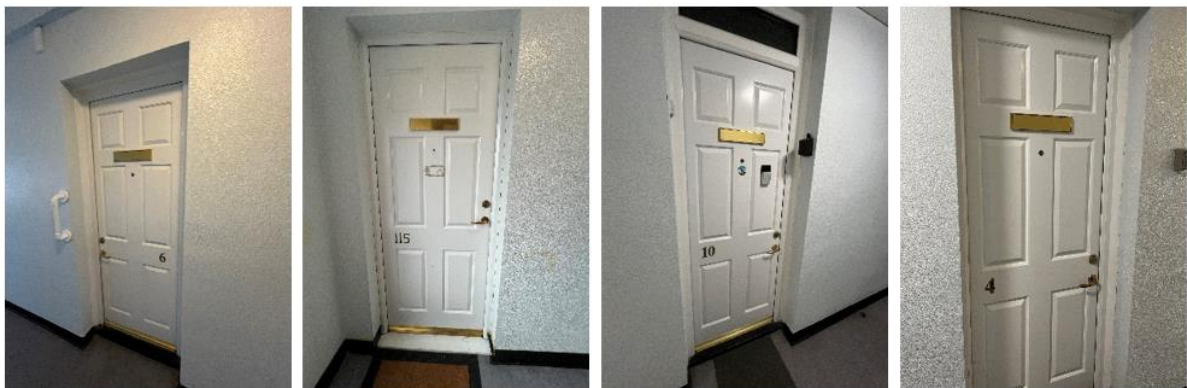
- 7) Individual flat entrance doors are predominately nominal FD30S rated composite fire doors.

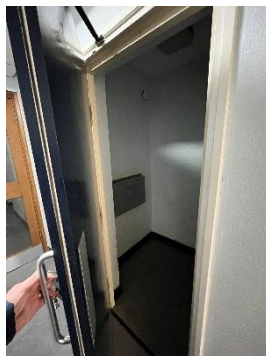
- 10) There are two hoppers per floor from the first floor upwards. All hoppers are in cupboards installed with a nominal timber FD30s self-closing door and a ventilation pipe with intumescent liner.

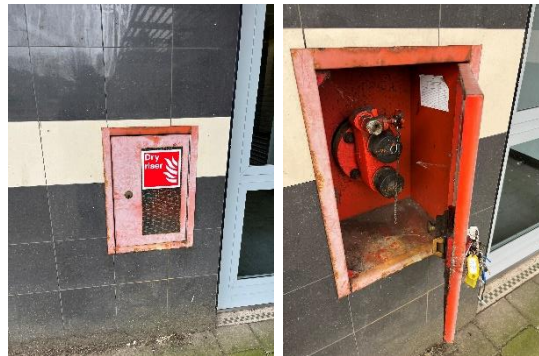
- 1) There are two dry riser systems at Lancaster House. The inlet cupboards are both to the front of the building adjacent the protected stairwell exits. The key for the inlets is within the firefighter's white box.

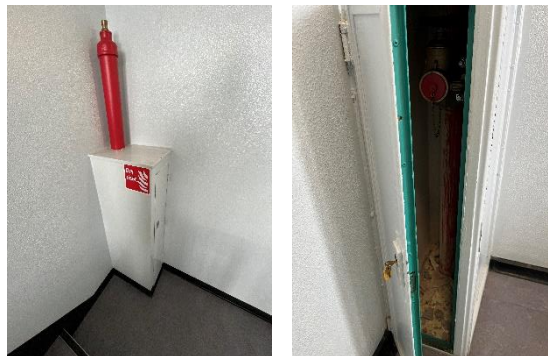
- 2) The dry riser outlets are available on each half landing in each protected stairwell (1st – 10th) within cupboards secured by suited cylinder key 1st – 9th floors & 54 key mortice locks on the 10th.

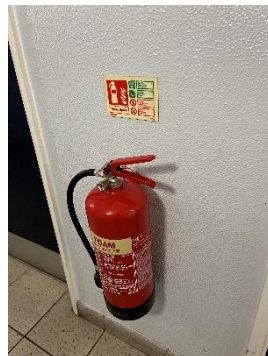
- 5) **A foam fire extinguisher is present in the lower ground floor common area. The presence of fire extinguishers in the common areas of residential high rise blocks is discouraged as it may encourage untrained residents to firefight instead of alerting the fire service and evacuating the block. The assessor requires this foam extinguisher to be removed. It could be re-sited in the fire Rapid Response Teams store on the lower ground floor. See action 11/5.**

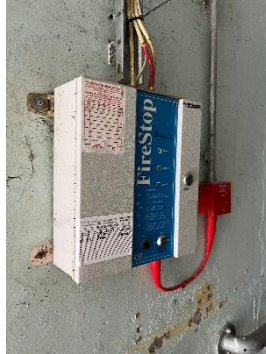
- 6) The bin stores are protected by a fire suppression system and serviced 6-monthly. The control panels are located on the wall within each bin store.

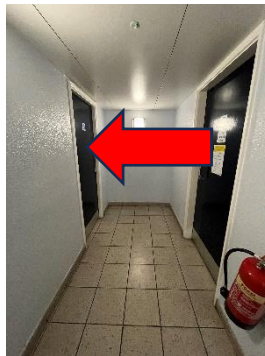
- 1) Fire doors display suitable signage where appropriate. However, a 'Fire Escape Keep Clear' sign is required to be fitted on the foyer side of the fire escape door from the lower ground floor pump room. See action 12/1.

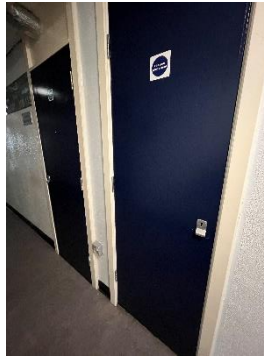
- 4) The electrical installation i.e. risers are contained within dedicated service cupboards that are secure and protected by nominal FD60s doors.

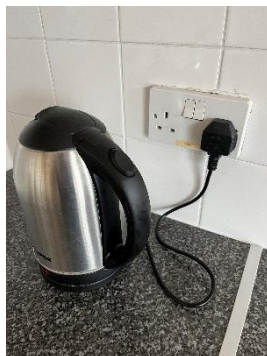
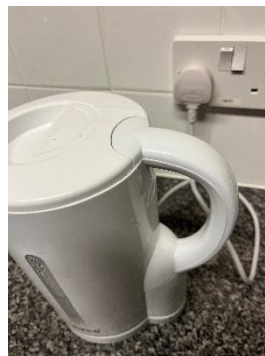
- 6) Portable heaters are not allowed in any common parts of the premises.
- 7) **Most sampled portable electrical equipment is in date. Electrical equipment used as part of the Caretaking / Cleaning regime is subject to annual PAT Testing. This information is held by the Estate Services Manager. However, there was no evidence of a PAT on the kettles in the 1<sup>st</sup> and ground floor community rooms. The items are required to be subjected to a PAT. See action 14/7.**
