Fire Risk Assessment

Lancaster House

1-120, Oldbury Rd, Rowley Regis, B65 0QF

Date Completed: 02/04/2025 Review Period: 12 months Officer: C. Hill Building Safety Manager Checked By: Adrian Jones Building Safety Manager

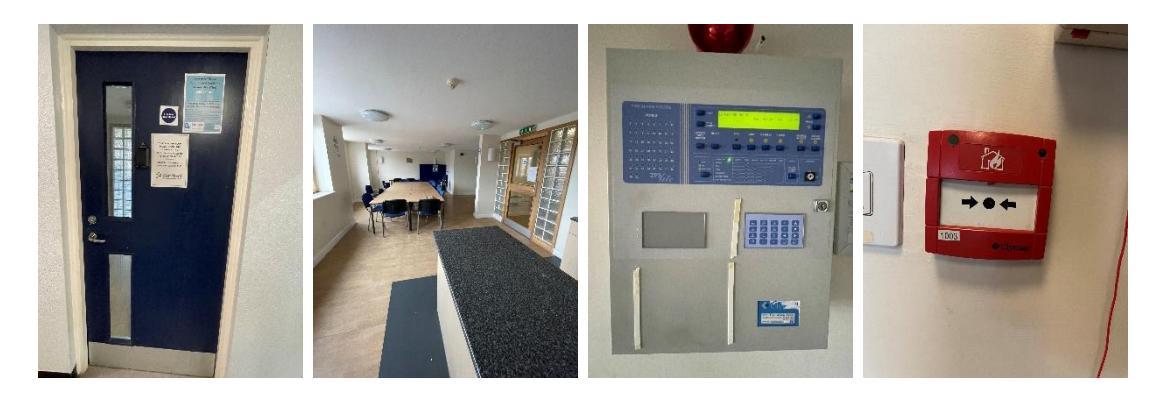
There is a community room with a small kitchenette on the 1st floor. The room benefits from an automatic fire alarm system which is independent to the rest of the building. Evidence of weekly testing was noted.

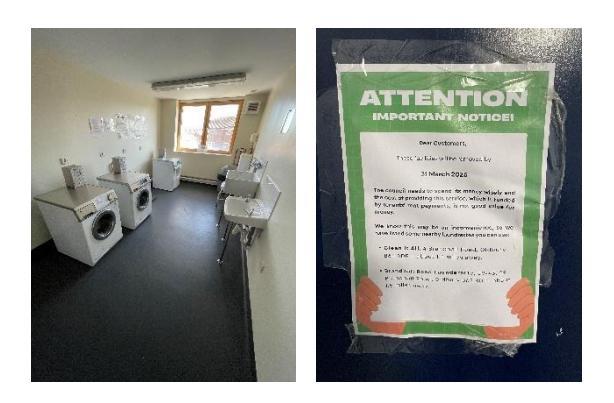
There is a communal laundry room with washing and drying equipment on the 1st floor. Each appliance has been annually tested in May and has an isolation switch above. A sign on the door informs the facility will be no longer available from 31st March 2025. It was noted that there is a wall mounted fan extraction and a Co2 portable fire extinguisher in the laundry room. The room is accessed by a fob system.

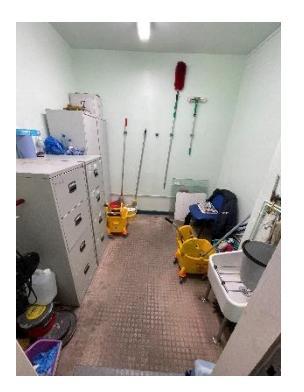
There is a storage room to the ground floor lobby which is used by residents to store and charge mobility scooters. The room is equipped with single gang socket, hardwired smoke detector and is secured with a locked nominal self-closing FD30s door with a thumb turn lock.

Evidence an extension lead has likely been used to charge multiple devices was noted. With multiple devices plugged in at once, potentially the maximum amperage of the extension lead could be exceeded and therefore lead to overheating and ignition. There is a sign on the door which informs residents to refrain from charging their devices by 30th April 2025.

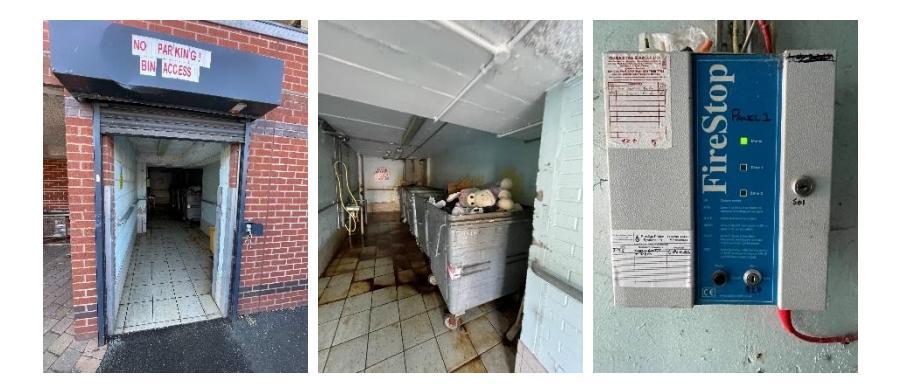
There are two bin stores which are accessed from the rear car park at lower ground level. Each store has a fire suppression system and chute closer plate with automatic closure function.

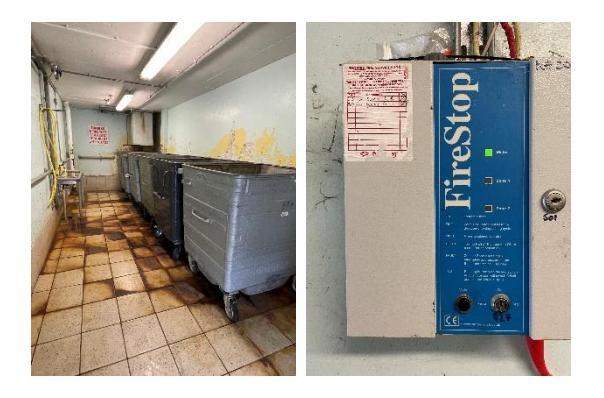
The two bin stores are at the rear of the building and are protected with fire suppression systems. The control panels are located on the wall in each store. Each chute is also protected with an automatic closure plate with manual override. The systems were last serviced October 2024.

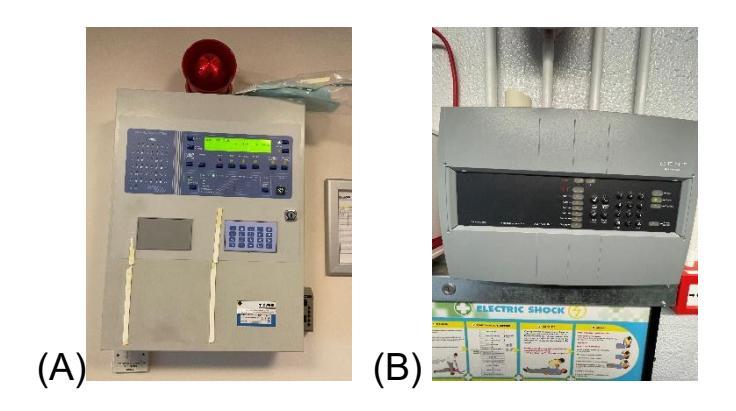
There is a fire alarm panel and detection system within the 1st floor community room (Image A). The system provides detection to the community room only.

There is a fire alarm panel and detection system to the lower ground floor server room (Image B). The system provides detection to the server room only.

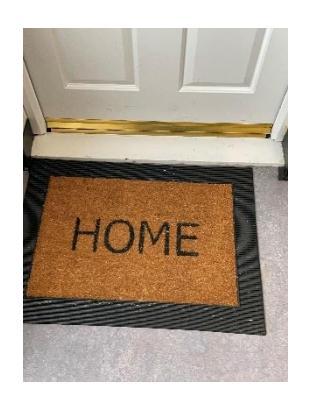
15) Individual floor mats were noted outside some flats. Fire rating of the mats is unknown but deemed to be of low risk.

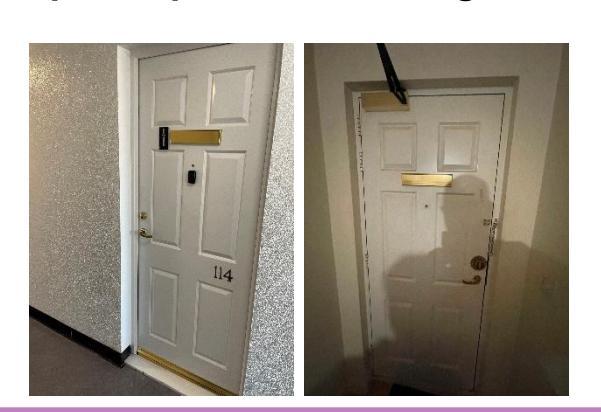
a) Flat 114 – Self-closing service requires adjustment to speed up the self-closing function.

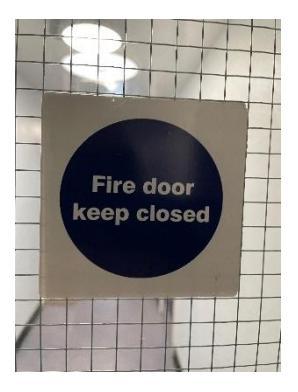
1) All fire doors display appropriate signage.

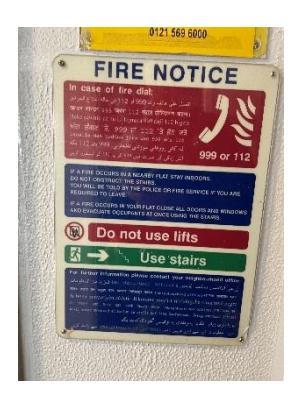
2) Fire Action Notices are displayed throughout the building.

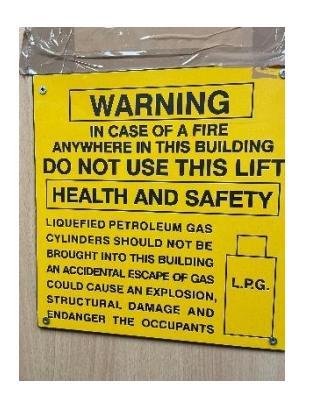
3) Yellow LPG warning signs are displayed within the lift cars.

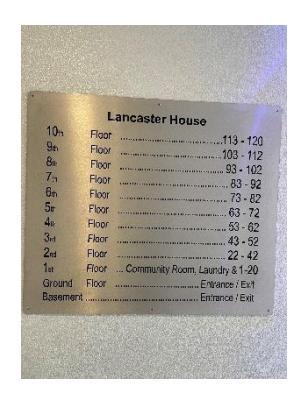
4) Signage depicting the floor location of each flat is fitted to the ground floor lobby wall.

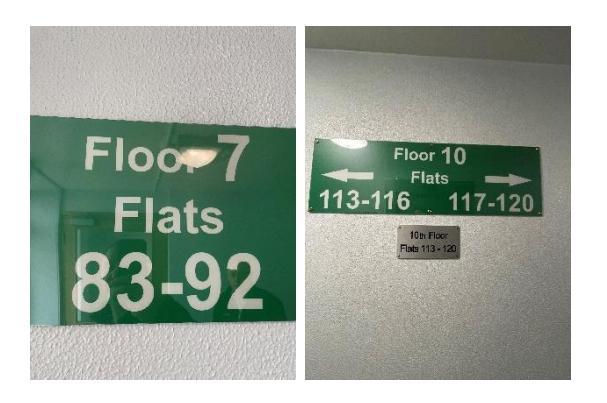
5) Photoluminescent wayfinding signage depicting floor level and flat numbers are fitted to the walls on all floors adjacent the lift car's and to the wall of each landing on the communal staircases. Signage that meets the requirement of ADB and Fire Safety (England) Regulations 2022.

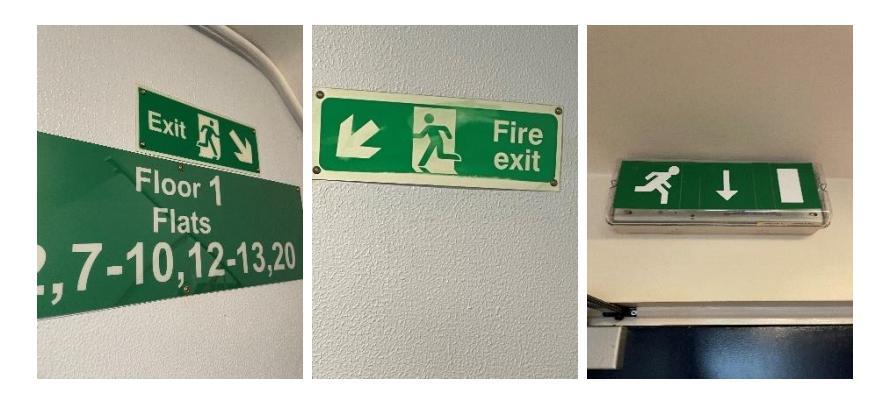
6) Fire escape routes on the 1st and 2nd floor wing staircases and community room have directional fire escape signage displayed.

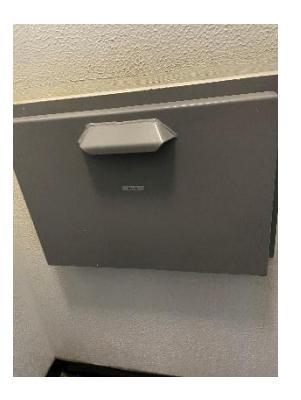
- 1) There is a regular Cleaning Service to the premises.
- 2) Refuse hoppers are accessed on each floor from 1st to 10th floor.

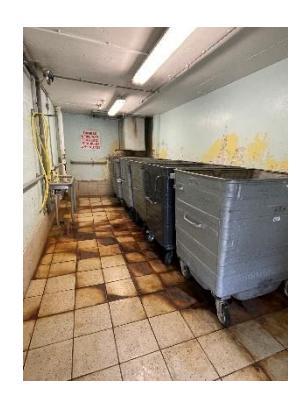
3) Refuse containers are contained in the two bin stores to the rear elevation.

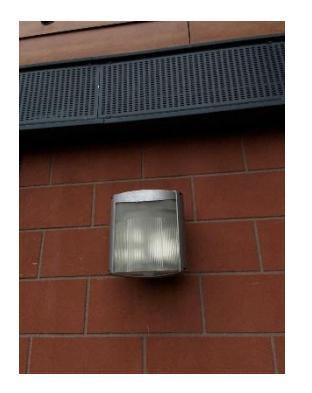
- CCTV is in operation covering the ground floors, lifts and external areas. The system is monitored 365 days per year by the centralised CCTV control room located at the Sandwell MBC Operations and Development Centre, Roway Lane, Oldbury, B693ES.
- 4) There is no current evidence of arson.
- 5) The perimeter of the premises is well illuminated.
