# Fire Risk Assessment

## Sheapcoate House

**Beaconview Road, West Bromwich,  
B71 3PP**

**Date Completed: 14/02/2025**

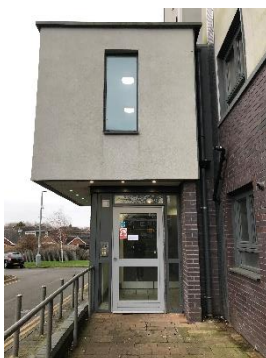
(Left side MAP)

There is an entrance/ exit to the left side elevation to the block with an additional entrance/exit to the right-side elevation (from the main road). The left side elevations entrance acts as the main access point to the block.

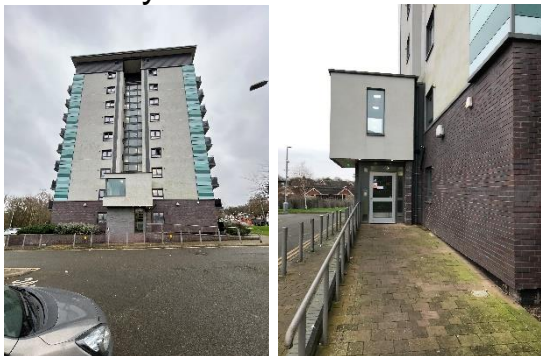
The fire fighters' white box is located to the right-hand side of the left side elevation (MAP) The location of service isolation points for gas, electricity and water are detailed on a plan located in the PIB.

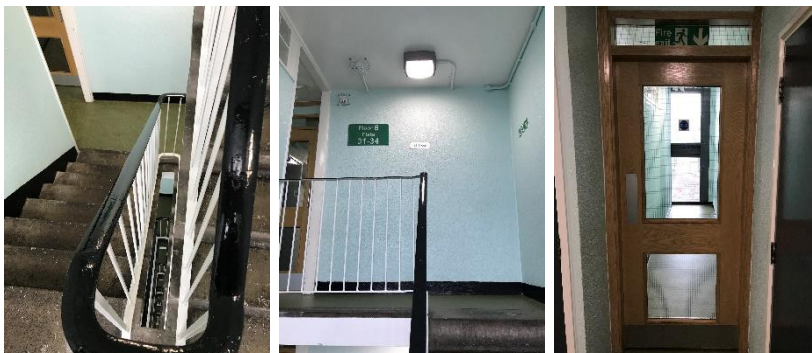
The block has a single protected staircase serving all floors of the block with floor identification numbers on the wall of each floor. The staircase is protected using nominal 44mm FD30s doors with combined intumescent and smoke seals.

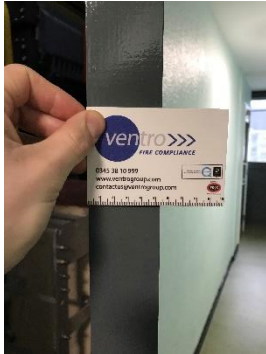
The block has lift access that serves from the ground to the 7<sup>th</sup> floor with the lift motor room being accessed via a full height nominal timber 54mm FD60s door secured with a pad lock and a suited lock.

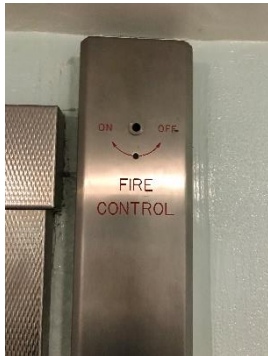
Lift has a fire fighter control switch located on the ground floor near the lift cart in the form of a drop latch system.

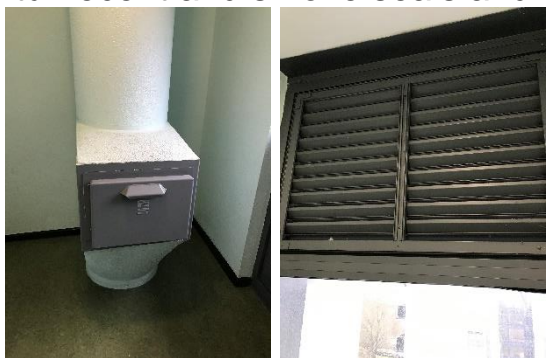
Residents have access to a bin chute system that serves every floor of the block secured behind nominal 44mm FD30s doors with combined intumescent and smoke seals and is naturally ventilated.

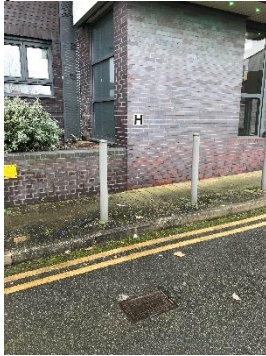
The fire hydrant can be located to the left hand side of the main access point of the block and can be found on the orientation plan located in the premise information box.

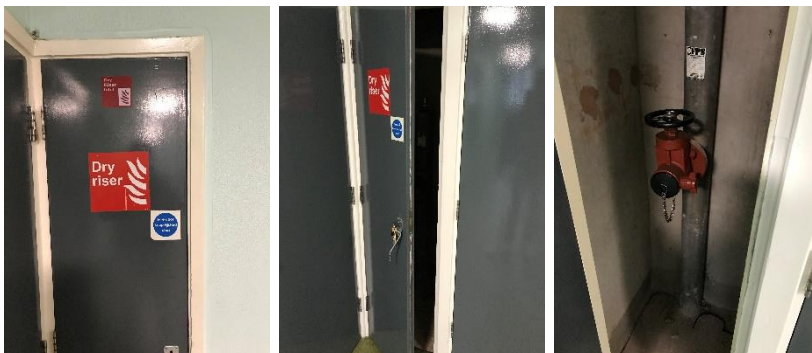
There is a dry riser that serves all floors of the block with a dry riser inlet cupboard located on the ground floor door that is adequately signed and secured, each floor of the block contains a dry riser protected via nominal 44mm FD30s doors with combined intumescent strip and smoke seals.

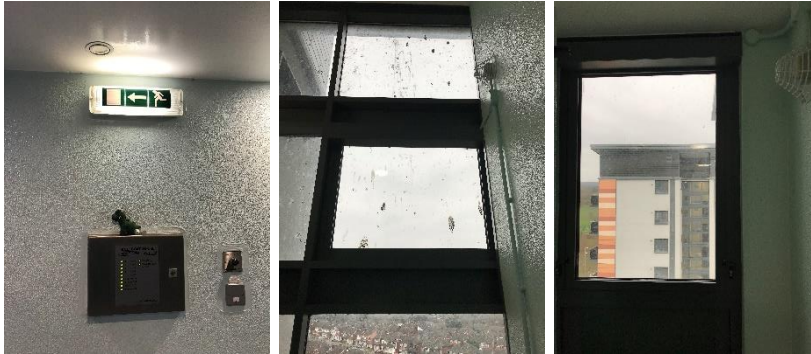
AOV's are in operation on all floors within the corridor nearest the bin chute and within the protected staircase with the control panel on the ground floor nearest the main entrance.

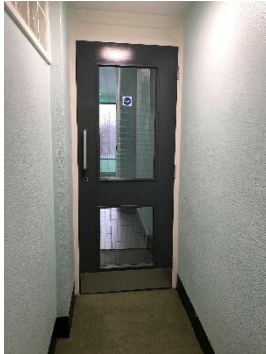
There is a “viewing pod” located on the 1<sup>st</sup> floor, this is secured with the use of nominal 44mm timber FD30s doors secured with a suited key.

- 15) The store cupboard located within the 1<sup>st</sup> floor veiwing pod is missing any intumescent strips and cold smoke seals, due to this door being a 44mm nominal FD30 timber door the regular checks by cleaning and caretaking services, additional nominal door protecting the vewing pod from the means of escape and level of risk being minimal this is deemed as tolerable however with future upgrades to the block some consideration should be made to upgrading the doors to fully certified FD30s door.

The store cupboard located within the 1st floor viewing pod is missing any intumescent strips and cold smoke seals, due to this door being a 44mm nominal FD30 timber door the regular checks by cleaning and caretaking services, additional nominal door protecting the viewing pod from the means of escape and level of risk being minimal

- 14) 5<sup>th</sup> floor had issues with glazing on the communal staircase, a temporary fix had been made and job raised with glazing repairs.
  - 15) Communal viewing pod located on the first floor secured with a 44mm timber nominal door with intumescent strips, cold smoke seals and vision panels is secured with a type 34 mortice lock that residents have access to this room remains relatively sterile with the cleaners cupboard also being within this area noted the cleaners cupboard is missing the addition of combined intumescent strips and smoke seals as this is a nominal door and the area being regularly accessed by cleaning / caretaking teams the element of risk is tolerable however with future improvements to the block it should be considered that this door is upgraded to a FD30s.

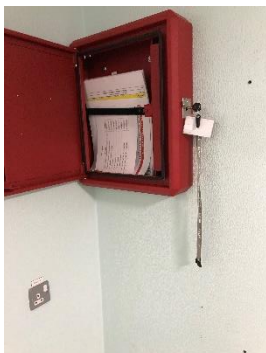
There is a Secure Premise Information Box (PIB) located in the lobby. It is a Gerda box that utilises a standard WMFS suited key. The PIB contains floor plans, vertical plans, orientation plans, information for WMFS and documents for those with vulnerabilities who may require additional consideration if there is a fire incident. Keys for WMFS will also be held within the PIB.

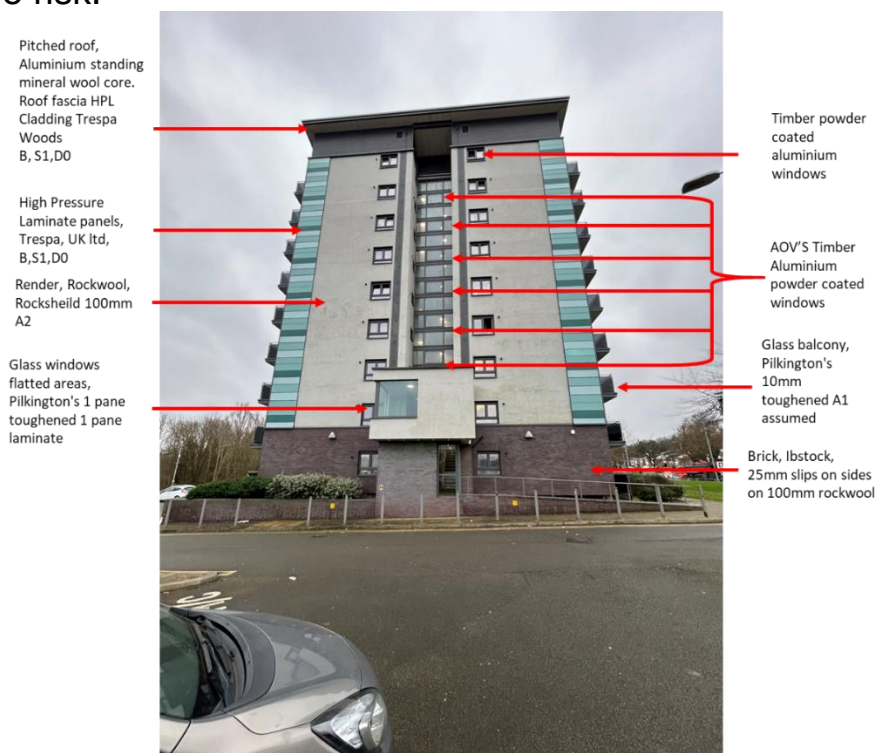
- 1) The block was constructed of concrete frame with masonry infill (Wates) last refurbished in 2015 with the addition of an external wall system the external facade consists of Brick/ Brick slips, high-density laminate board with Rockwool insulation (A1), rockwool insulated render.

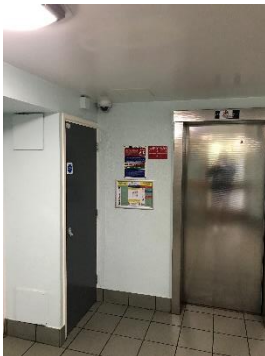
- 3) Yellow LPG warning signs are displayed within the lift car.

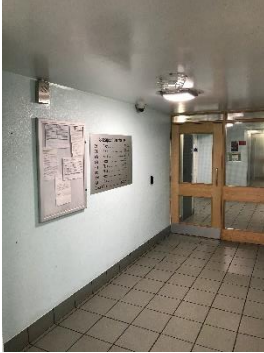
- 5) Wayfinding Signage depicting floor level and flat numbers are fitted to the wall adjacent to lift. They meet the requirements set out in the Fire Safety (England) Regulations 2022.

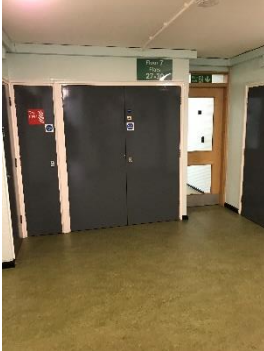
- 6) Wayfinding Signage depicting floor level and flat numbers are fitted to wall of each floor on the communal staircase(s). They meet the requirements set out in the Fire Safety (England) Regulations 2022.

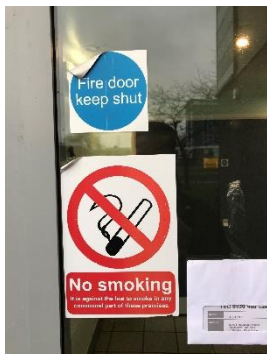
- 1) Smoking is prohibited within any communal parts of the building in line with Smoke Free England legislation.

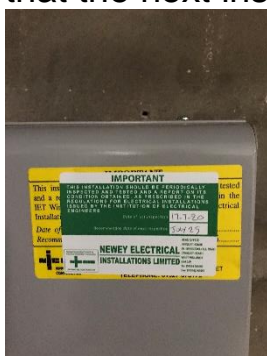
- 2) Hot working is not normally carried out. If essential maintenance requires the use of hot work processes, then corporate policies and procedures are to be followed.
- 3) Portable electrical equipment used as part of the Caretaking / Cleaning regime is subject to annual PAT Testing. This information is held by the Estate Services Manager Bryan Low.
- 4) The fixed electrical installation is tested and in date. It was noted that the next inspection date is due July 2025

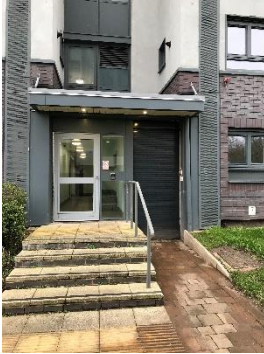
- 7) Portable heaters are not allowed in any common parts of the premises.
- 8) Gas appliances and pipework (where installed) are subject to annual testing and certification. This cyclical contract is managed by the in-house Gas Team. **Gas supplies are external secured behind perforated panels.**

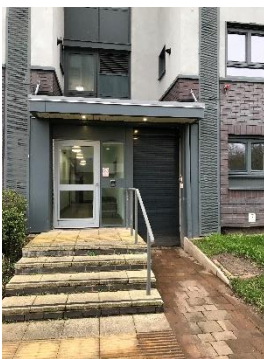
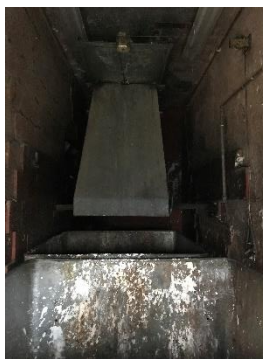
- 1) There is a regular Cleaning Service to the premises.
- 2) Refuse hoppers are accessed on each floor secured behind its own dedicated nominal 44mm 30-minute door with combined intumescent and cold smoke seals.
