# Fire Risk Assessment

## Sheapecoate House

**Beaconview Road, West Bromwich,  
B71 3PP**

**Date Completed: 12<sup>th</sup> February 2026**

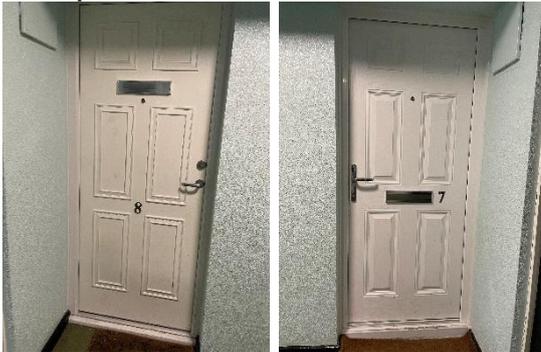
- 1) Individual flat entrance doors are predominantly nominal FD30S composite fire doors.

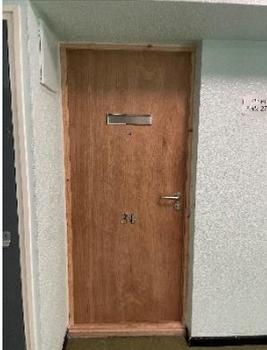
- 2) Flat 30 has a nominal FD30s timber flush door.

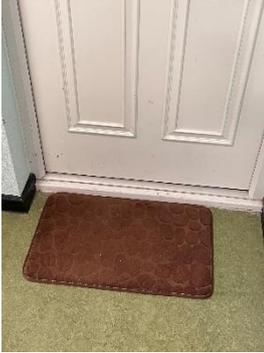
- 4) A number of flat entrance doors have door mats on the communal corridor side. The fire rating of the mats is unknown but deemed to be sufficiently low risk.

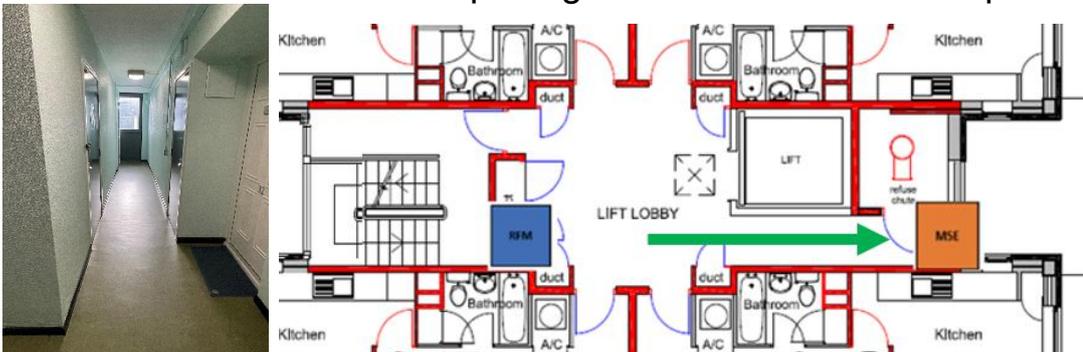
- 5) The means of escape are protected to prevent the spread of fire and smoke.
- 6) Emergency lighting is provided to the communal landings and stairs. Checks are done on a monthly basis by Sandwell MBC in house electrical team or approved contractor.
- 7) There are dead end corridors on all floors from the 1st to 8th. The dead end corridors are between the lift lobbies and the chute room. All are approximately 1050mm wide, 5.6 metres long and benefit from an Automatic Opening Vent therefore are acceptable.

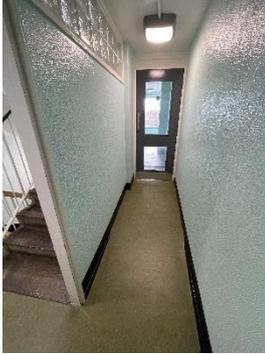
- 9) Surface coatings to the communal areas are Torrex Flameshield Ultimate 2015, class 0 rated. **The surface coating to ceilings is flaking in multiple areas across the protected stairwell and some refuse chute rooms. To be removed and re-painted with suitable product**

Removal and replacement of all flaking paint from multiple areas in the protected stairwell and several chute rooms. Re-paint with suitable euro class B-S3,d2 product.

Question/ Ref No	Required Action	Supporting photograph	Priority	Timescale and Person Responsible	Date Completed
7/9	Remove and replace all flaking paint from multiple areas in the protected stairwell and several chute rooms. Re-paint with suitable euro class B-S3,d2 product.

P3	Within 3-6 Months Repairs

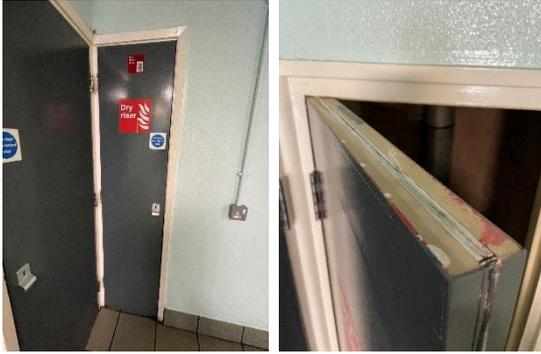
- 17) The dry riser cupboards are secured with locked nominal FD30s fire doors. **The combined intumescent / cold smoke seal strip to the head of the 1<sup>st</sup> floor cupboard is damaged and requires replacement. Door will need adjustment to accommodate replacement.**
-

10/17	Replace damaged cold smoke seal to head of 1 <sup>st</sup> floor dry riser cupboard. Door may need to be rehung to accommodate.

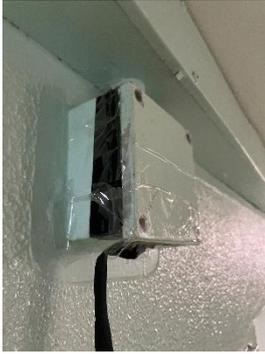
- 5) Trunking cover housing wiring is held on with adhesive tape adjacent flat 10.

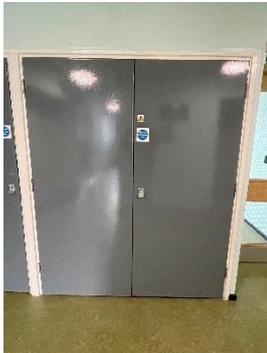
- 6) The electrical installation i.e., risers are contained within dedicated service cupboards that are secure and protected by means of a nominal FD60S door.

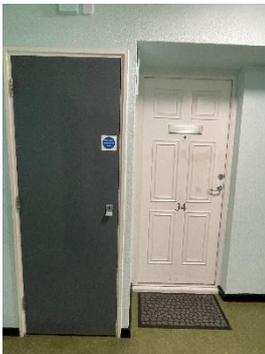
- 7) Residents' cupboards containing electricity metres are secured by FD30s doors.

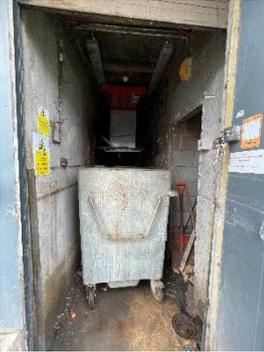
- 1) There is a regular Cleaning Service to the premises.
- 2) Refuse containers are emptied regularly.
