Fire Risk Assessment

Stanton House

**Beaconview Road, West Bromwich,
B71 3PW**

Date Completed: 4th March 2026

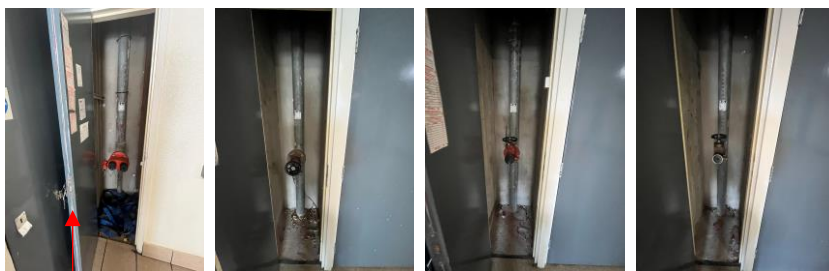
The dry riser outlet valves are installed on every floor above ground, each housed within a dedicated cupboard positioned directly above the corresponding inlet. These cupboards are secured behind FD30S fire doors and are accessed using a suited 54 key, which is available from the firefighter's key box, ensuring controlled and secure access for emergency personnel.

FD30s door and example of riser valves from floors, G,1,2,3,

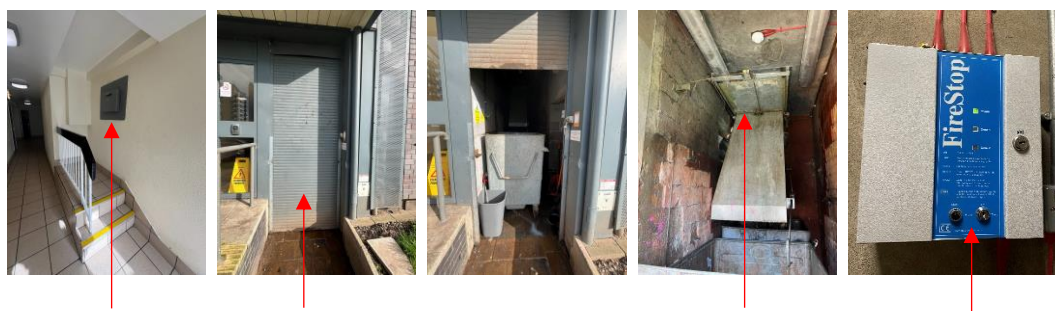
The refuse chute terminates in the bin store situated at the rear of the building. The bin store is equipped with a fire suppression system to mitigate the risk of fire within the refuse area. Additionally, it features an automatic refuse chute closure plate with a manual override function, allowing controlled operation in the event of an emergency. Access to the roller shutter securing the bin store is provided via the key held in the firefighter's key box, ensuring that emergency personnel can gain entry if required.

Bin chute, access via shutter, refuse chute closure plate and suppression system

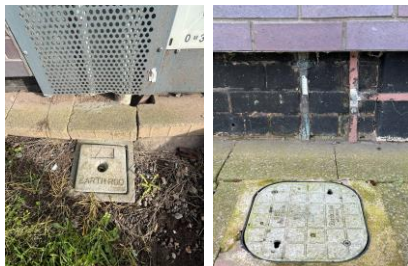
- 4) Lightning protection is installed to the block with earth rods positioned at various points around the block.

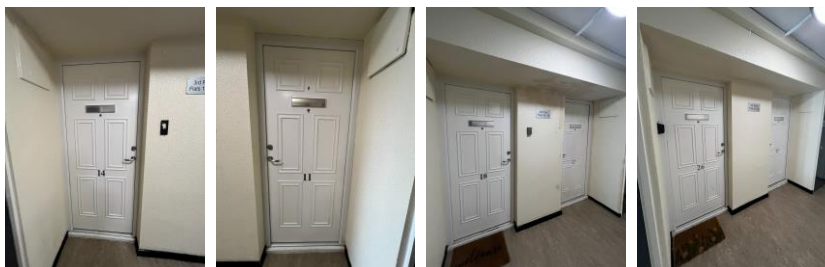
- 1) Individual flat entrance doors are predominantly nominal FD30S composite fire doors.

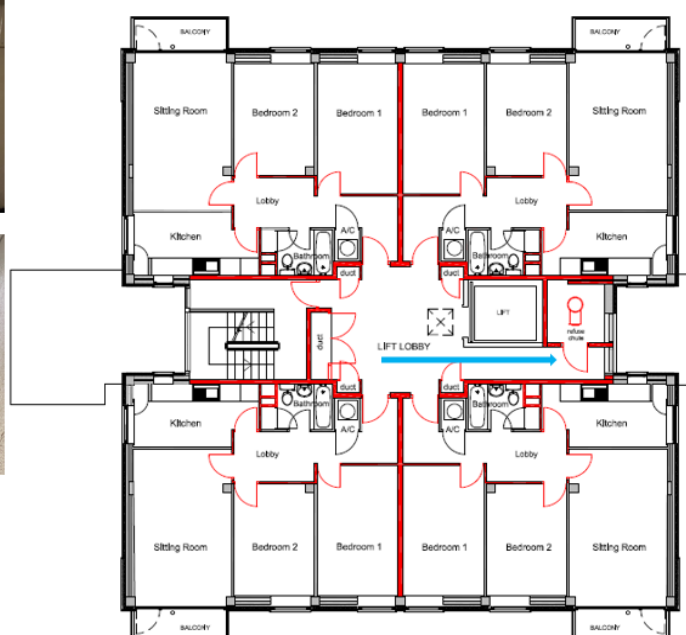
Example: Seventh Floor Plan

- 6) The means of escape are protected to prevent the spread of fire and smoke.
- 7) Emergency lighting is provided to the communal landings and stairs. Checks are done monthly by Sandwell MBC in house electrical team or approved contractor.
- 8) Dead-end corridor sections are present on all floors from Levels 1 to 8, located between the lift lobbies and the refuse chute rooms. Each corridor is approximately 1050 mm in width with a travel distance of 5.1 metres and is provided with Automatic Opening Vent (AOV) smoke control. On this basis, the arrangement is considered acceptable in accordance with relevant fire safety guidance.

Dead end corridor marked by blue arrow.

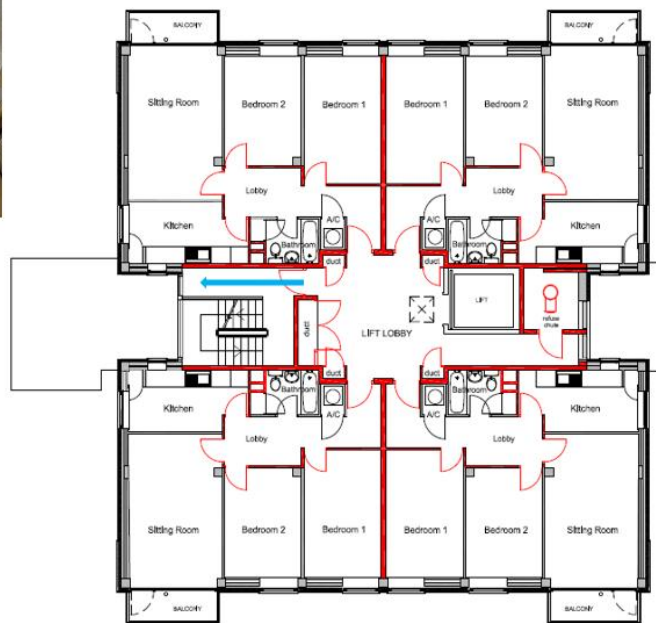
Example: Seventh Floor Plan

- 9) A secondary dead-end condition is present on each floor within the stair enclosure. The stairwell is provided with automatic opening vents (AOVs) for smoke control, appropriate emergency lighting, and each dead-end travel distance is less than 4 metres. As such, the arrangement is considered acceptable in accordance with relevant fire safety guidance.

Dead end corridor marked by blue arrow.

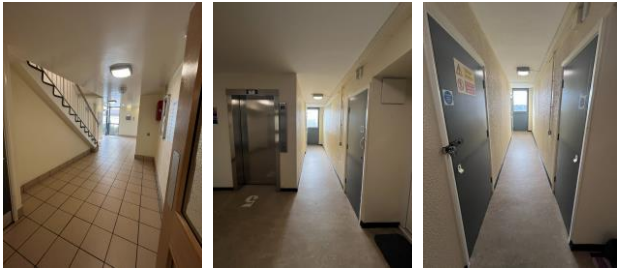
Ground, 5th and 8th floor corridors

- 11) All corridors are of adequate width and will be maintained clear.

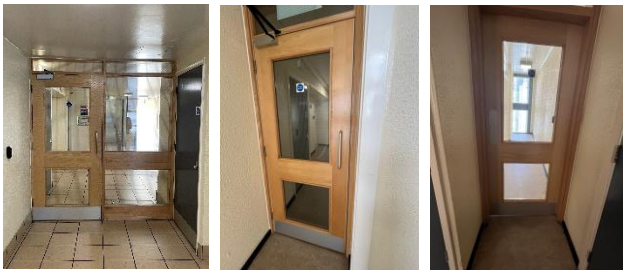
Ground, 5th and 7th floor communal lobby doors

- 12) The communal lobbies and staircases are protected by use of nominal self-closing FD30s fire doors.

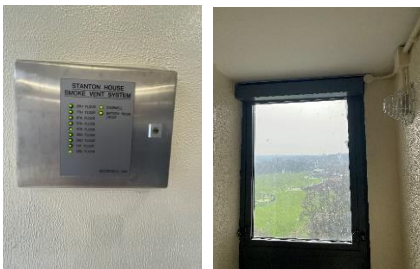
- 17) Automatic opening smoke vents have been installed within the stairwell serving floors 2/3,4/5,7/8, as well as in the battery room located within the roof void. The system status panel is situated in the main entrance foyer. These systems are inspected, serviced, and maintained by a suitably competent, appointed contractor in accordance with the relevant British Standard, BS 7346.

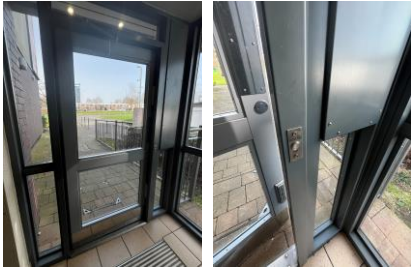
- 19) The final exit doors on the L/North and R/South side of the building have a door entry & exit system installed. These systems are designed to fail safe i.e., door unlocked in the event of a power failure. This prevents residents being locked in or out of the building.

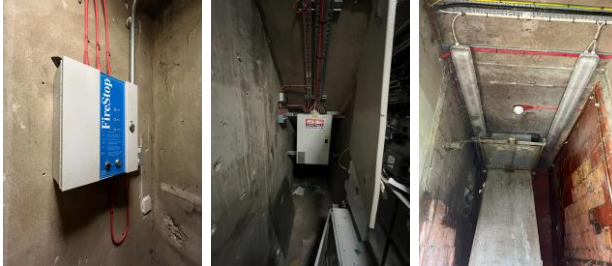
- 5) A deluge fire suppression system is installed within the refuse chute bin store to provide automatic fire control. The system is maintained by an approved contractor, with planned inspection and servicing undertaken biannually, typically in April and October each year, to ensure continued operational effectiveness.

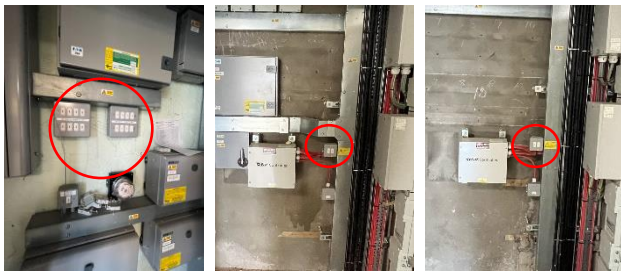
- 1) The premises have a sufficient emergency / escape lighting system in accordance with BS 5266 and has test points strategically located.

Ground, 2nd and 5th floor emergency light test switches

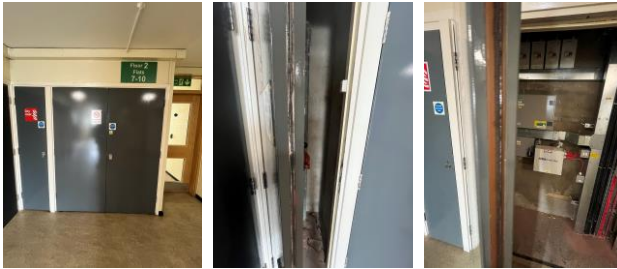
- 16) The dry riser cupboards are installed with FD30s (44mm) nominal doors electrical cupboards are secured with locked nominal FD60s (54mm) fire doors. The electrical risers on the 1st and 4th floor have had an additional hardwood strip added to the front of the doors, it is recommended that on any future refurbishment of the block that the doors be upgrade to certified fire doors. (*Recommended Observations*).

Dry Riser and electrical riser cupboards with nominal FD30 & FD60s doors

The electrical risers on the 1st and 4th floor have had an additional hardwood strip added to the front of the doors, it is recommended that on any future refurbishment of the block that the doors be upgraded to certified fire doors.

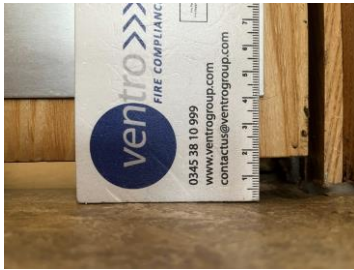
21) Nominal FD30s fire door located on the communal landing on the 2nd floor has excessive gap at the bottom of the door due to the angle of the floor

P3	Within 3-6 Months Repairs	
10/21	Excessive gap at the bottom of communal fire door on 2 nd floor. Requires a drop-down seal installed

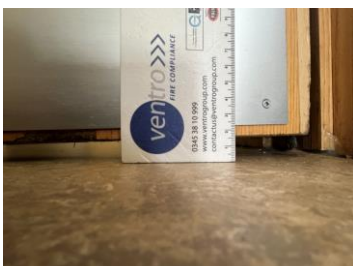
23) Nominal FD30s fire door located on the communal landing on the 5th floor has excessive gap at the bottom of the door due to the angle of the floor.

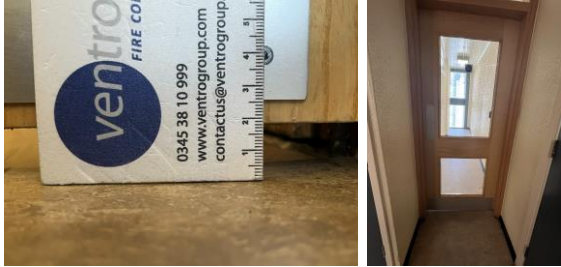
24) Nominal FD30s fire door located on the communal landing on the 7th floor has excessive gap at the bottom of the door due to the angle of the floor.

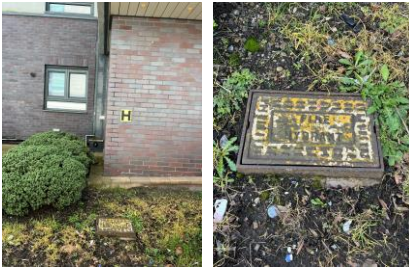
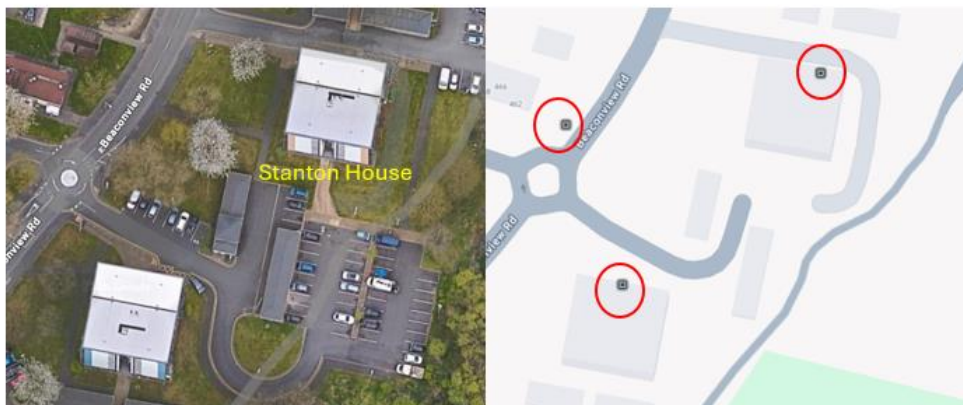
1) Fire hydrant is located on the L/East side elevation to the building

Hydrant locations marked within the red circles

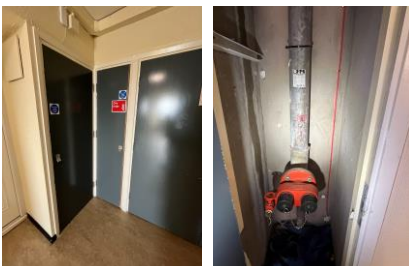
2) The building is provided with a dry riser system. The dry riser inlet is located within the ground floor lift lobby, inside a dedicated dry riser cupboard secured with a suited 54 key. The cupboard doors are clearly marked with appropriate dry riser signage.

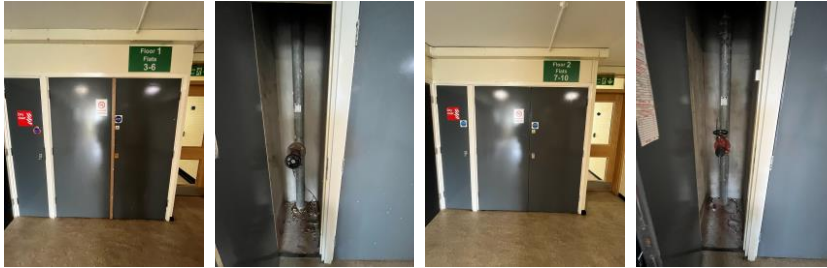
- 3) The Dry riser outlets serving the building are located on each floor above ground level within cupboards secured with a suited 54 key. The cupboard doors are clearly marked with appropriate dry riser signage. The dry riser system is subject to regular checks as part of the caretaker's duties.

Example of dry riser from 1st and 2nd floors

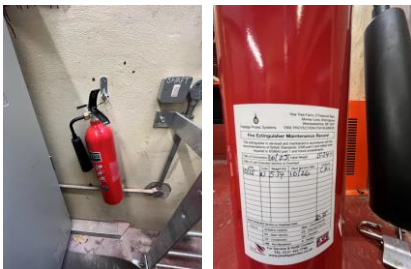
- 4) Maintenance contracts in place to service the valves twice per year (April and October) with a hydraulic test undertaken annually (October) to comply with the requirements of BS9990.
- 5) Lift motor room is equipped with a CO2 portable fire extinguisher. Service date shows that it is scheduled for a service for Oct 2026.

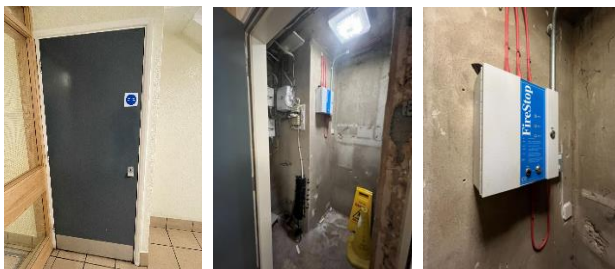
- 6) Bin room on the ground floor within the communal lobby is protected is by deluge/sprinkler system and serviced 6- monthly.

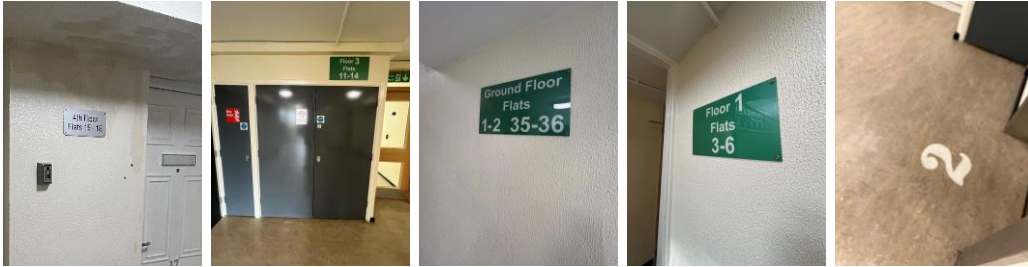
- 5) Photoluminescent wayfinding signage depicting floor level and flat numbers are fitted to the walls on all floors adjacent the lift car's and to the wall of each landing on the communal staircase. Additionally, floor numbers are also marked on the landing floor outside the lift doors for each floor. Signage meets the requirement of ADB and Fire Safety (England) Regulations 2022.

Floor signage in communal areas, adjacent to lifts and within staircas

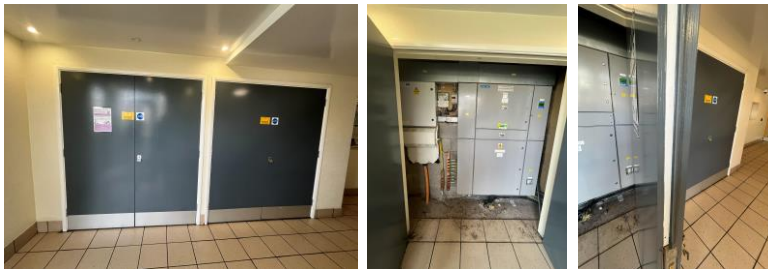
- 5) The electrical installation i.e., risers are contained within dedicated service cupboards that are secure and protected by means of a nominal FD60S door.

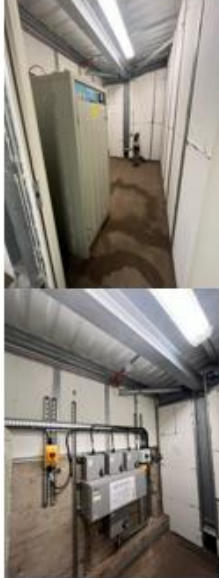
11) Central Battery system in roof space is inspected on a 6-month cycle.

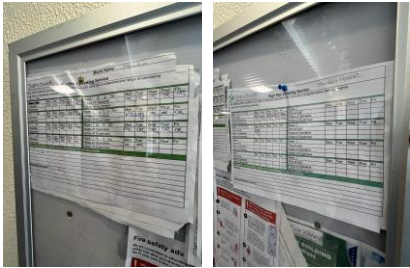
- 1) There is a regular Cleaning Service to the premises.

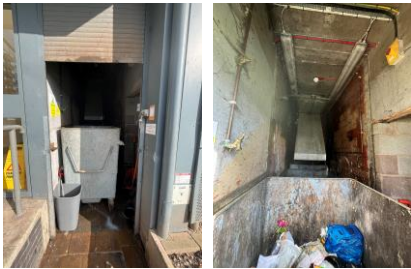
- 2) Refuse containers are emptied regularly.

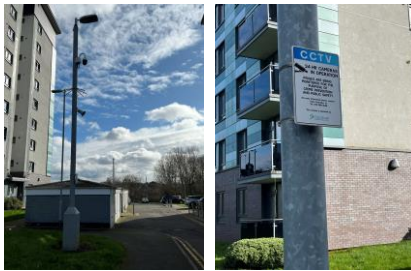
- 1) Regular checks are undertaken by Caretakers / Cleaning Team(s) 365 days per year which helps reduce the risk of arson.
- 2) Restricted access to the premises by means of a door entry system.
- 3) There is no current evidence of arson.
- 4) The perimeter of the premises is well illuminated with the use of street lighting and external lighting units installed on the building. The site is covered by CCTV which is manned 24/7

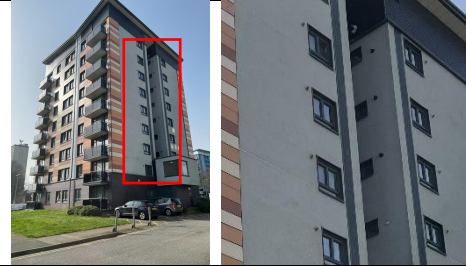
Due to proximity of glazing to flat kitchens to staircase a sprinkler installation should be considered to the flats as part of a future works programme.
