# Fire Risk Assessment

## Harry Price House

Hartlebury Rd, Oldbury,  
B69 1EQ

**Date Completed:** 15/05/2025.

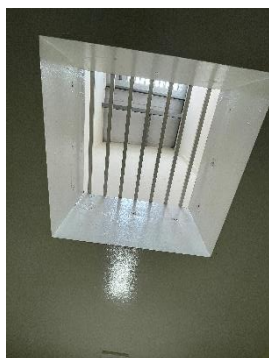
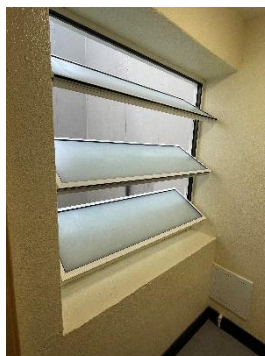
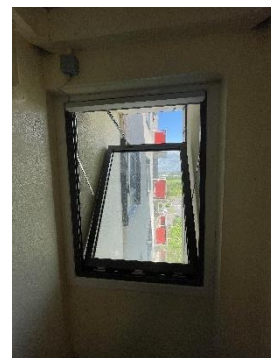
- 10) Automatic smoke ventilation is employed. This is tested, inspected and maintained by a competent procured contractor in accordance with BS7346. The frequency for the maintenance checks is twice per year (April and October) of each calendar year. Communal windows can only be opened by operating the automatic smoke vents.
- 11) Automatic opening vents have been installed to the head of protected staircase and in each corridor above the ground floor. It was noted that the opening vents in the 12<sup>th</sup> floor corridors are of a different design to other corridors within the building.

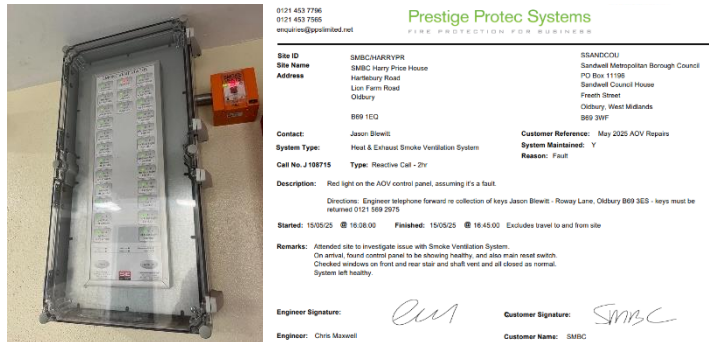
- 12) There is a repeater panel located on the wall of the ground floor lobby that provides the status of the system. At the time of the FRA, the AOV control panel was showing a red fault light. Email sent to Jason Blewitt 15-05-25. Visit by Prestige Protect Systems 15-05-24 System checked and re-set, system recorded as 'healthy'

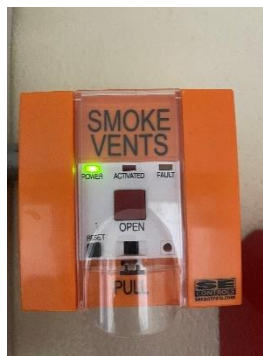
- 13) The manual override and master reset for the entire system is located next to the repeater panel.

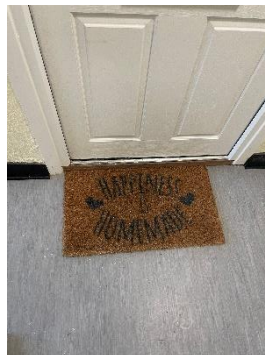
- 15) Communal areas are kept free of flammable items. The communal areas are checked on a regular basis by Caretaking / Cleaning teams 365 days per year and all items of rubbish are immediately removed. There is also an out of hour's service that allows combustible items of furniture / rubbish to be removed.
- 16) Individual floor mats were noted outside some flats. Fire rating of the mats is unknown but deemed to be of low risk.

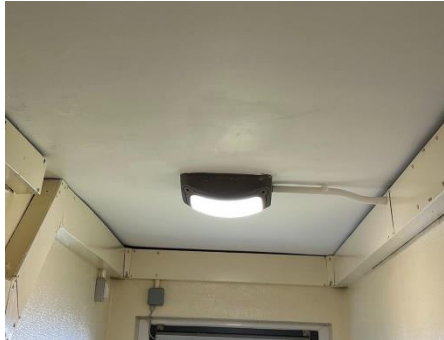
- 17) Emergency lighting is provided to communal landings and stairs. Checks are done monthly by Sandwell MBC in house electrical team or an approved contractor.

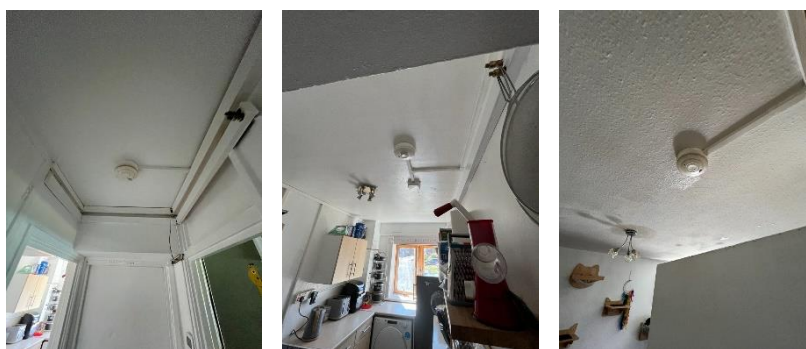
- 1) Early warning within flats is limited to hard wire or battery smoke alarms. The equipment is subjected to a cyclical test.
- 2) Based on the sample of properties accessed during the fire risk assessment the smoke alarms within resident's flats are installed to an LD2 Standard.

Flats sampled were 6, 7, 9, 15, 16, 25 and 43.

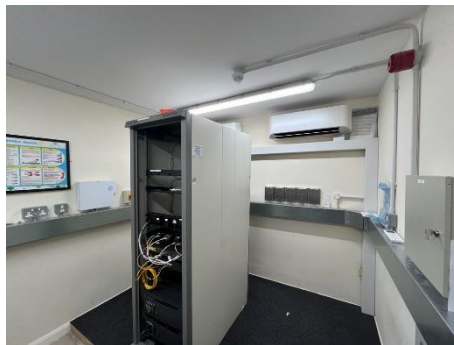
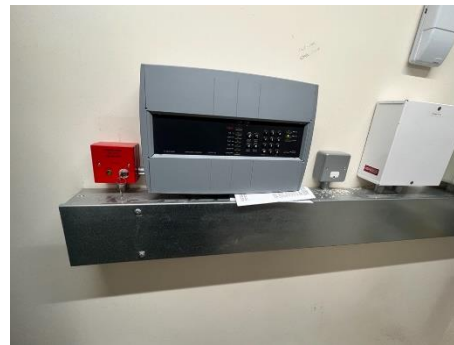
- 5) The server room is equipped with an automatic fire alarm system. The system protects the server room only and incorporates smoke detection and a break glass call point. The system sounds locally only however, there's a separate room temperature monitoring system that is remotely monitored and therefore will raise the alarm in the event of a fire. No evidence of routine testing and maintenance of the fire alarm system was available. Email sent to Jodie Howell, response, waiting for confirmation from Orton Electrical.

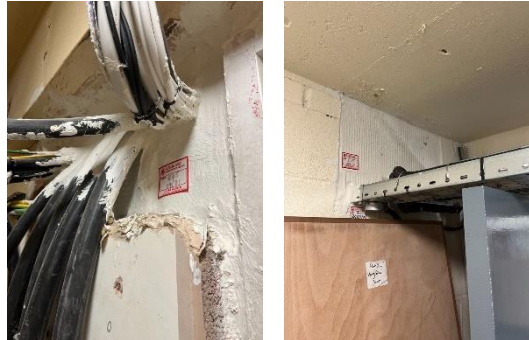
- 7) A variety of methods / materials have been used to achieve fire-stopping including Rockwool, fire rated sponge and Supalux boards.

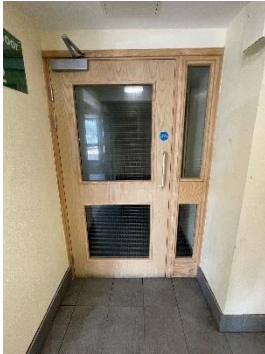
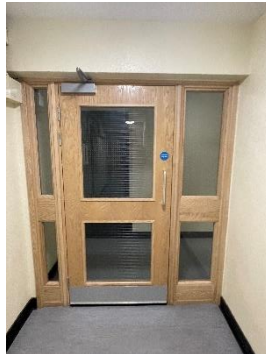
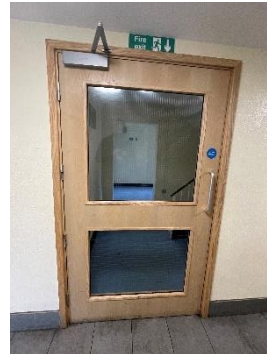
- 12) The communal corridor and staircase doors are nominal FD30s timber fire doors with vision panels.

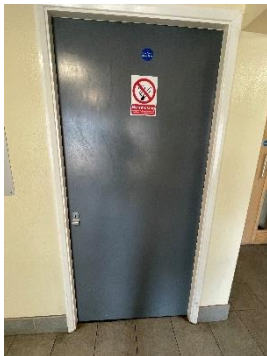
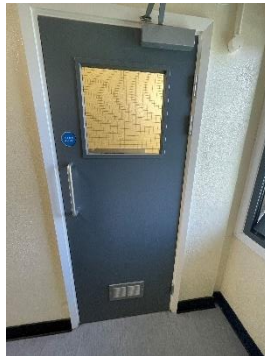
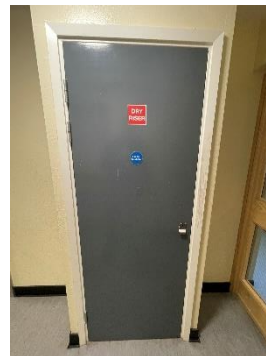
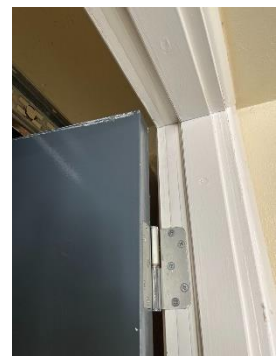
- 13) All cupboard doors to the dry riser, roof voids & cleaner's / caretakers' rooms & cupboards are nominal 44mm timber FD30s fire doors.

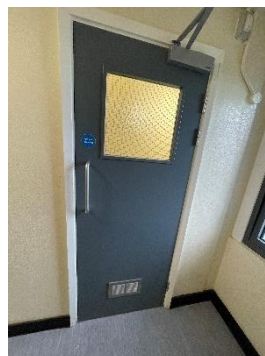
- 14) Doors to chute rooms are nominal FD30s with vision panels and ventilation grill with intumescent baffle.

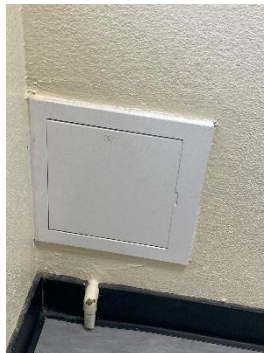
- 16) Access panels to stop taps are fixed to walls via timber rebate strips and found outside the flats of every floor.

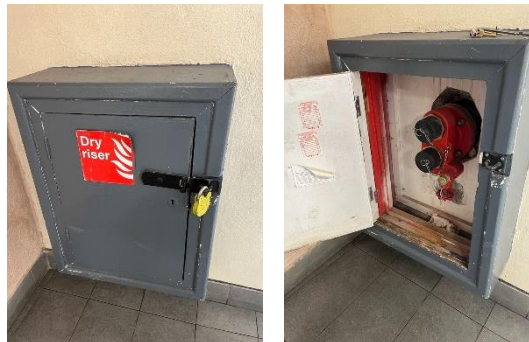
- 1) The riser inlet is located within the ground floor lobby, inside a dry riser cabinet and is secured with a firefighter's suited bridge door padlock.

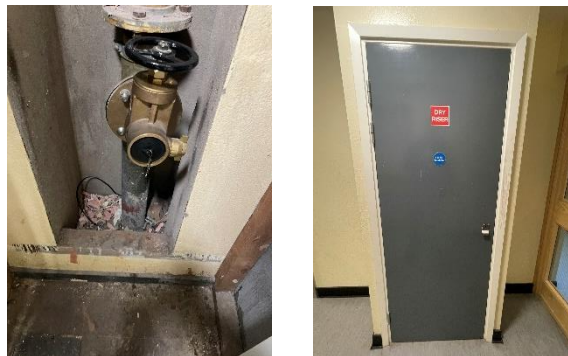
- 2) The Dry riser outlets are available in cupboards on each floor above ground adjacent the stairwell door. The cupboards are secured with a suited type 54 key mortice lock.

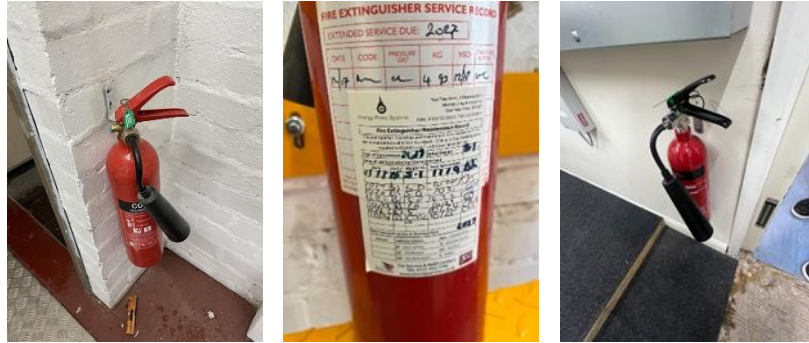
- 5) Portable fire extinguisher (CO2) is provided to the lift motor room & server room. Maintenance contracts in place for maintenance of the extinguisher. The frequency for the maintenance checks is once (October) of each calendar year. Last test October 2024.

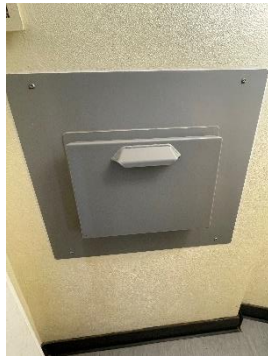
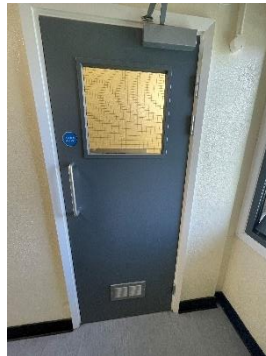
- 1) There is a regular Cleaning Service to the premises.
- 2) Refuse hoppers are accessed in each floor within the chute rooms.

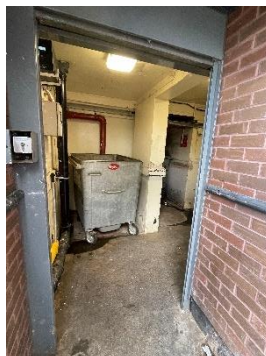
- 3) Refuse containers are in the bin store at ground level.

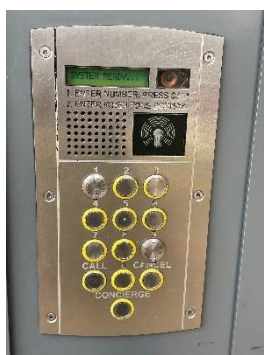
- 1) Regular checks are undertaken by Caretakers / Cleaning Team(s) 365 days per year which helps reduce the risk of arson.
- 2) Restricted access to the premises by means of a door entry system.

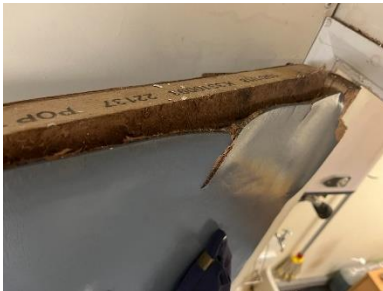
- 4) All communal fire doors are subject to a 12-week check by the Fire Safety Rapid Response Team. **At the time of the FRA the fire door in the caretaker's room was found to have a damaged door leaf requiring repair. See action 10/4.**

P2	Within 1-3 months Fire Rapid Response	
10/4	The fire door in the caretaker's room was found to have a damaged door leaf requiring repair.

P2	Within 1-3 months Fire Rapid Response

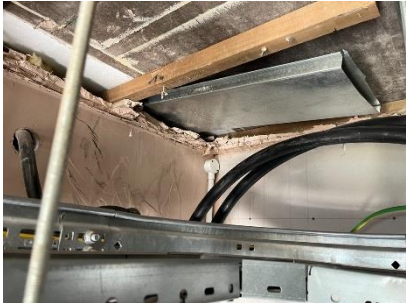
- 10) Fire stopping is inadequate in the main incoming electrical plant room (also containing the emergency lighting back up power supply) around cable penetrations, the ceiling and where the walls met the ceiling. This area requires adequate fire stopping to be fitted by a competent provider. See action 10/10.

10/10	Fire stopping is required in the main incoming electrical plant room around cable penetrations, the ceiling and where the walls met the ceiling. This area requires adequate fire stopping to be fitted by a competent person.

P3	Within 3-6 months Fire Rapid Response	
14/4	There are exposed electrical cables in the 12th floor electrical cupboard. These cables are required to be capped and secured.
