Fire Risk Assessment

Harry Price House

**Hartlebury Road, Oldbury
B69 1EQ**

Date Completed: 23rd September 2022

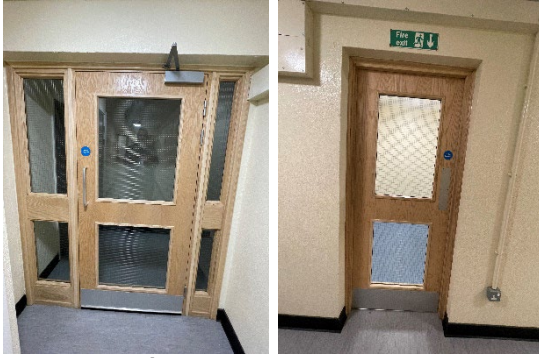
A. 11th floor - Communal door adjacent flat 66 excessive gap to hinge side.

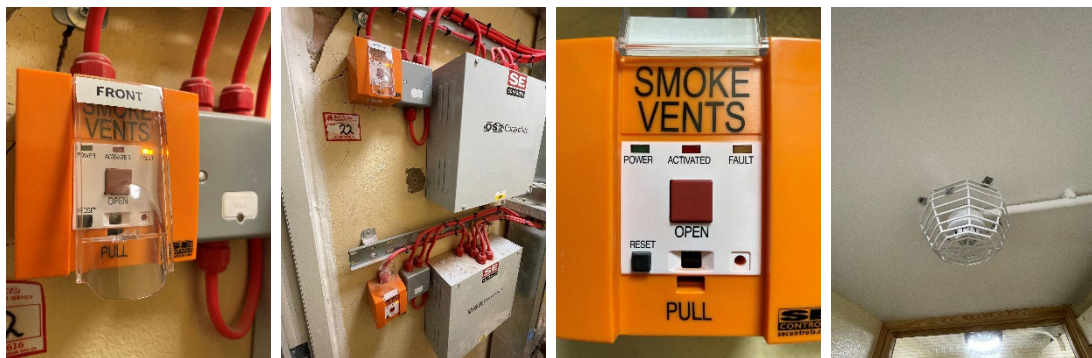
- 8) Automatic smoke ventilation is employed. This is tested, inspected and maintained by a competent procured contractor in accordance with BS7346. The frequency for the maintenance checks are twice per year (April and October) of each calendar year.
- 9) The controls are located in the service cupboard (single door secured with a 54 lock) on each floor. The controls allow for manual testing of the smoke vents. It should be noted that the system installed is fully automated and each vent is independently controlled by a localised smoke detector. Once smoke has cleared the system will automatically reset. **The controls in the 1st & 2nd floor service cupboards display fault.** *Fault reported to contractor 23/09/22*

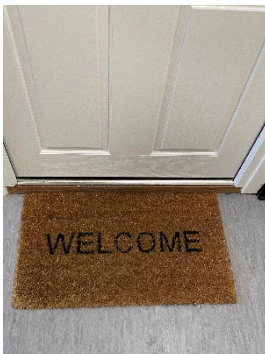
- 12) The fire rating of individual floor mats to flat entrance doors is unknown.

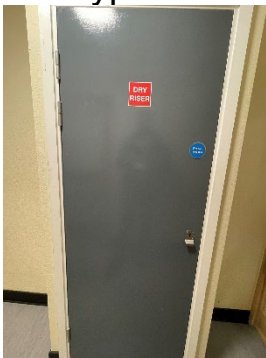
A. 12th floor riser cupboard – lock cover to be secured.

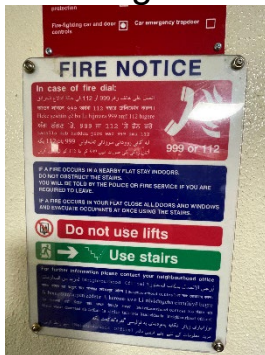
- 2) Fire Action Notices are displayed throughout the building. However, these are currently under review to align with S.M.B.C current guidance of “stay put unless”

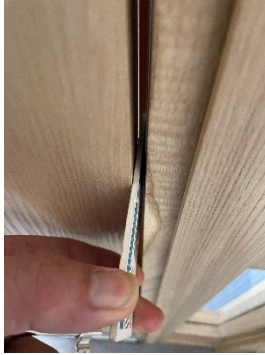
Question/ Ref No	Required Action	Supporting photograph	Priority	Timescale and Person Responsible	Date Completed
07/6a	11 th floor - Communal door adjacent flat 66 correct excessive gap hinge side.

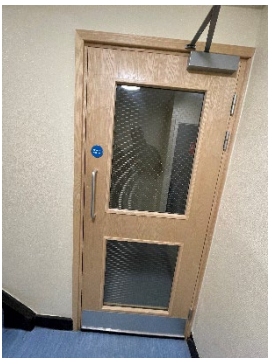
07/6b	9 th floor – communal door adjacent flat 54, tighten loose door handle.	 	P2	Within 1-3 months of assessment date. Fire Rapid Response JM9636287	06/10/2022
07/6c	8 th floor – communal door to stairwell correct excessive gap to handle side.

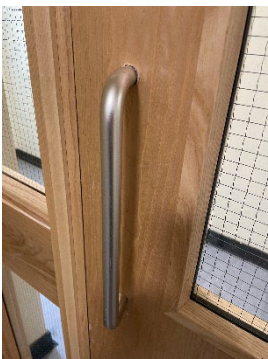
D. 8th floor – Handle to communal door adjacent flat 48 is loose.

P2	Within 1-3 months of assessment date. Fire Rapid Response JM9636295	06/10/2022
07/6d	8 th floor - communal door adjacent flat 48, tighten door handle.

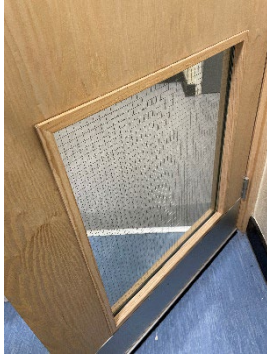
E. 6th floor – communal door to stairwell glazing to bottom panel is loose and moves behind beading.

07/6e	6 th floor – communal door to stairwell secure loose glazing within lower panel.

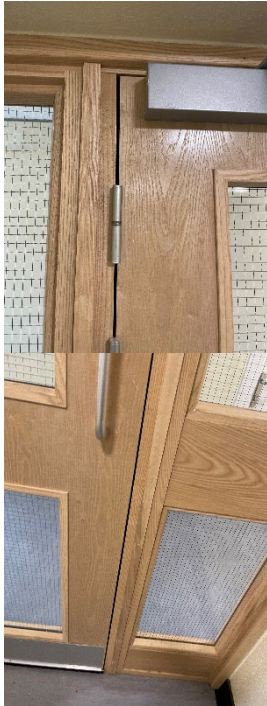
P2	Within 1-3 months of assessment date. Glazing Repairs JM9638075	07/10/2022
07/6f	5 th floor – communal door adjacent flat 27 correct excessive gap upper hinge side and lower handle side.

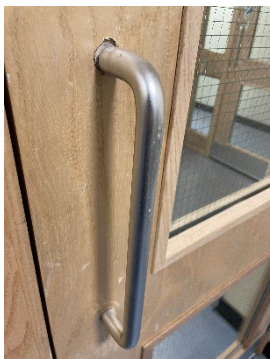
G. 2nd floor - Handle to stairwell door adjacent is loose.

07/6g	2 nd floor – tighten loose handle to stairwell door.

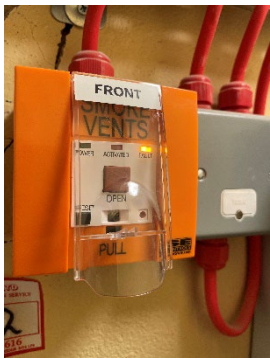
P2	Within 1-3 months of assessment date. Fire Rapid Response JM9636360	06/10/2022
07/09	Rectify faults to smoke control systems in 1 st & 1nd floor service cupboards.

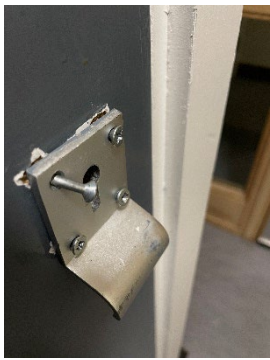
P1	Within 10 days of assessment date. Asset Management Team.	07/12/2022
07/15a	12 th floor dry riser cupboard, secure lock plate.

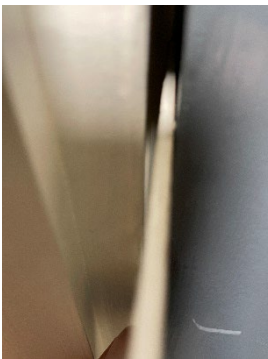
07/15b	10 th floor dry riser cupboard correct excessive gap on hinge side.

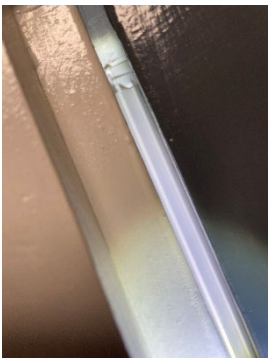
P2	Within 1-3 months of assessment date. Fire Rapid Response JM9660214	11/10/2022
07/15c	7 th floor dry riser cupboard correct excessive gap on hinge side.

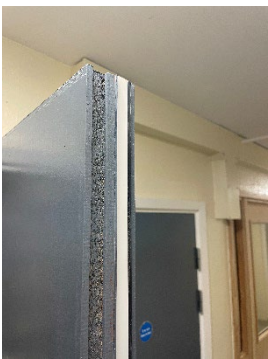
16) Service cupboard doors are FD30s rated, secured with type 54 suited mortice locks. 1st floor service cupboard with double doors is missing an intumescent strip.

P2	Within 1-3 months of assessment date. Fire Rapid Response JM9660254	11/10/2022
07/16	1 st floor service cupboard, replace missing intumescent strip to double door.

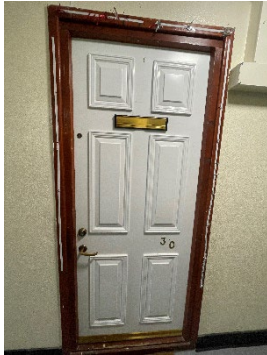
07/23a	Flat 30 entrance door (permadoor) requires cold smoke seal on lock edge.

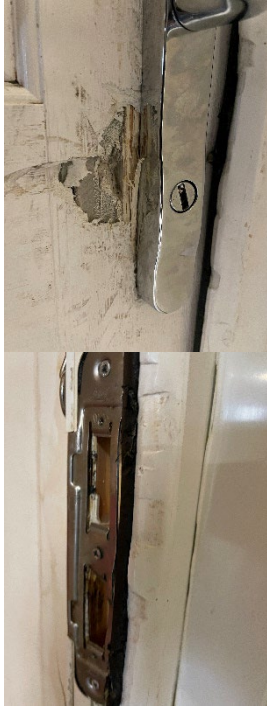
B. Flat 16 has signs of forced entry resulting in damage to door and frame around lock. Door does appear to form appropriate compartmentation however would recommend repairs to damaged surface or full door replacement if not possible.

P2	Within 1-3 months of assessment date. Fire Rapid Response JM9660380	11/10/2022
07/23b	Flat 16 entrance door repair surface with intumescent filler, should repair fail replace door.

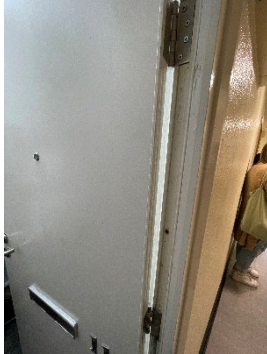
07/23c	Flat 11 entrance door requires intumescent strip / cold smoke seal to hinge side.

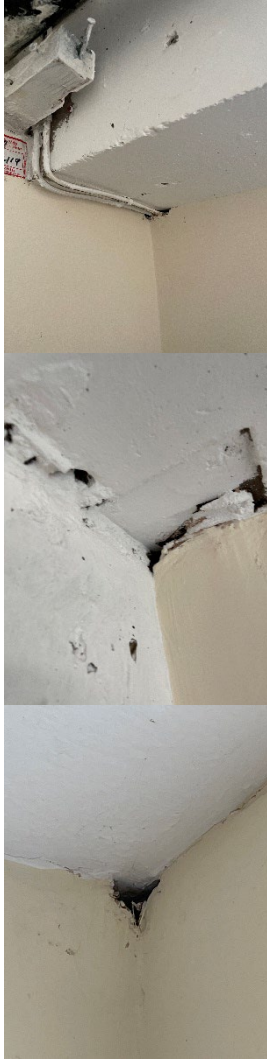
10/09	Caretakers office – fire stop 3 x small holes to wall that borders server room.

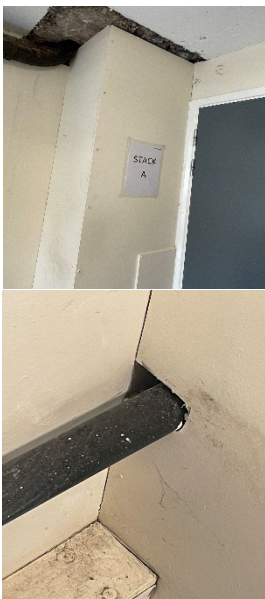
10/10	Caretakers office – fire stop gaps to stack A
