# **Fire Risk Assessment**

## **St Clements House 1-36**

**Hallam Street, West Bromwich,  
B71 4HB.**

**Date Completed: 09/03/2026**

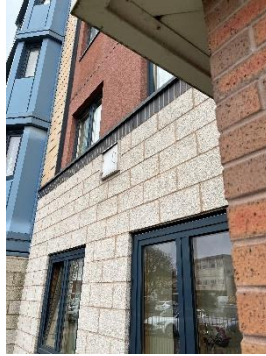
- Brickwork from ground to 1st floor. Fire classification A1.

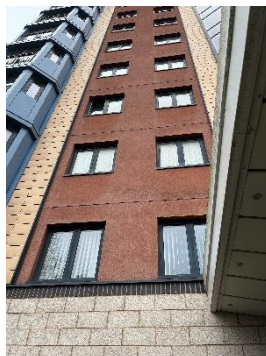
- Render system 1st to 8th floor. Fire classification A1.

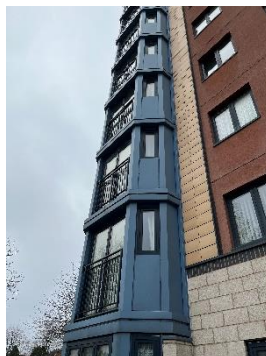
- Terracotta tiles. Fire classification A1.

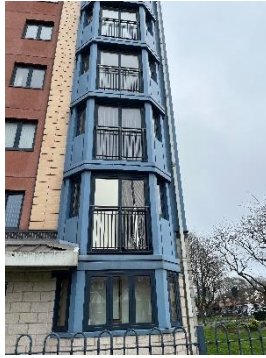
- Aluminium panels. Fire classification A2.

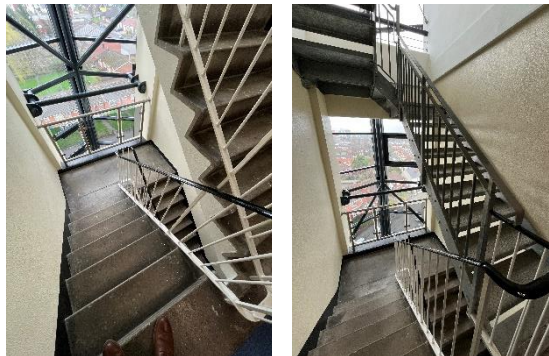
- 1) The building has two protected staircases that provide adequate means of escape. The staircases are 1030mm in width. The staircases are of concrete construction from the ground floor up to top floor at the rear and from the ground floor to the 8th floor at the front. The staircase from the 8<sup>th</sup> to the 9<sup>th</sup> at the front is of steel construction.

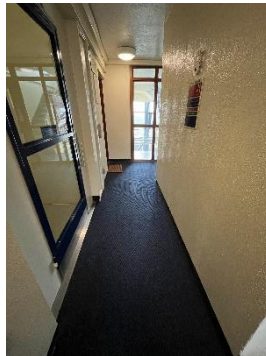
- 2) All corridors are of adequate width (at least 980mm) and will be maintained clear to that width as a minimum.

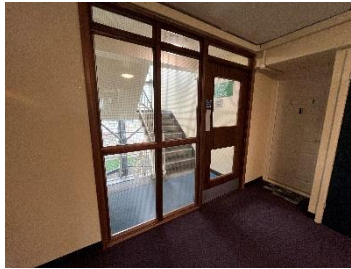
- 6) The communal landing / staircases are protected by use of nominal FD60s fire doors with vision panels.

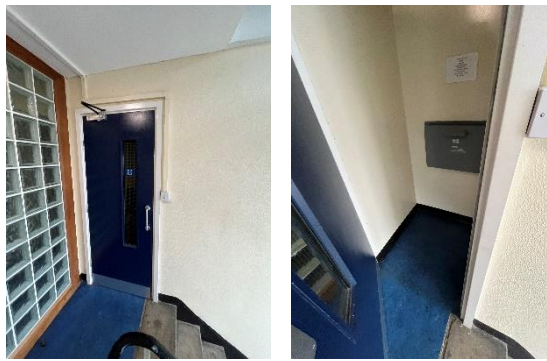
- 11) Refuse chute hoppers are available on each floor, protected by FD60s doors. The chute system is connected to the bin store at the rear of the building.

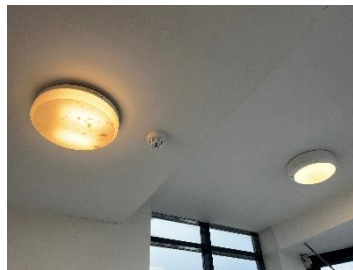
- 12) Emergency lighting is provided to communal lobbies and stairs. Checks are done monthly by Sandwell MBC in house electrical team or approved contractor.

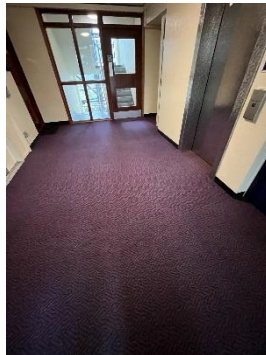
- 15) It was noted that landing floors are fitted with carpet. It is understood that carpets have been procured in accordance with BS 5287: 1988 specification for assessment and labelling of textile floor coverings and & BS 4790 Fire Test to Textile Floor Coverings. These carpets have been procured by SMBC utilising third party approved contractors. Therefore, it is understood that carpets fitted meet the approved standard.

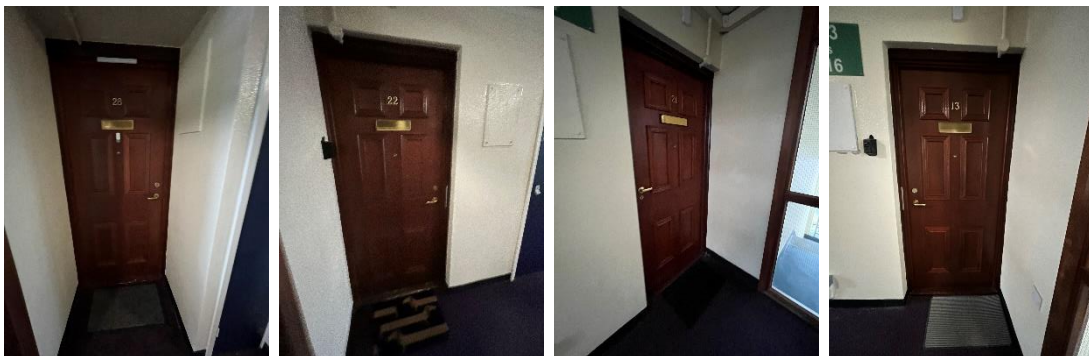
- 16) Individual flat entrance doors are predominately nominal FD30S rated timber fire doors.

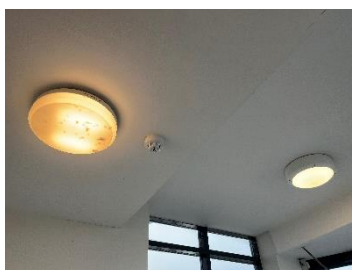
- 3) There is no means for detecting an outbreak of fire to the remaining communal areas. Automatic fire alarm systems are not usually required in the common areas of residential blocks as this can compromise the 'Stay Put' evacuation policy.
- 4) Smoke detectors linked to the automatic opening vents have been installed on stairwell and landing lobbies. The vents in the stairwells will automatically open when smoke has been detected.

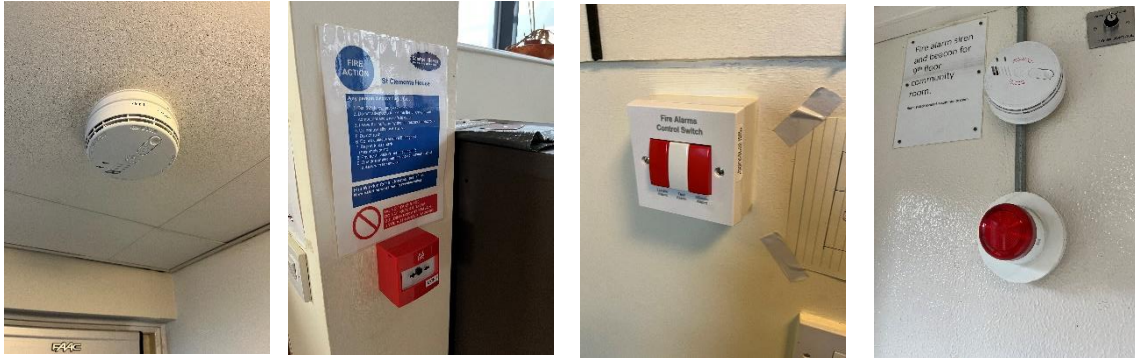
- 5) The communal room on the top floor has an automatic fire alarm system that appears to conform to BS5839. There are detector heads, manual call points and a fire alarm control switch within the communal room. There is also a repeater siren and beacon for this system in the front ground floor entrance foyer.

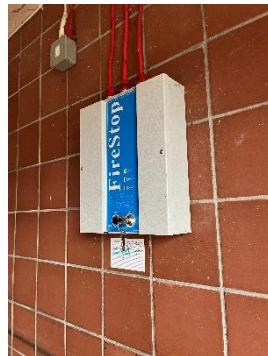
- 6) A deluge system is provided in the refuse chute bin store. Detectors for actuation and the control unit are sited within the bin store. An approved contractor maintains the system. The frequency for the maintenance checks is twice per year (April and October).

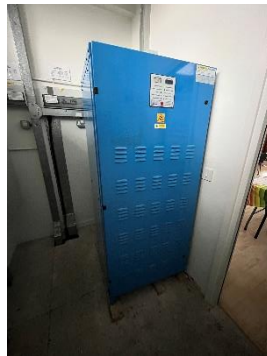
- 1) The premises has a sufficient emergency / escape lighting system in accordance with BS 5266. The emergency lighting is a central battery system, the central battery is situated in the cupboard in the communal room.

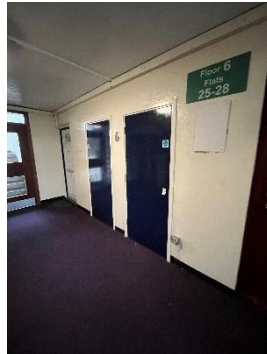
- 6) All floor service cupboards are nominal FD30s or FD60s timber fire door sets. The keys are held centrally at SMBC Roway Lane, and within the firefighter's white box.

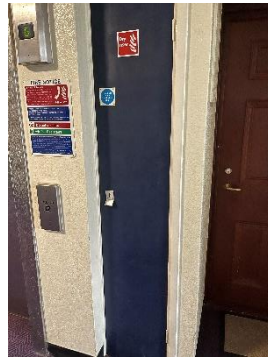
- 7) Dry riser cupboards on all floors are behind upgraded FD30s fire doors.

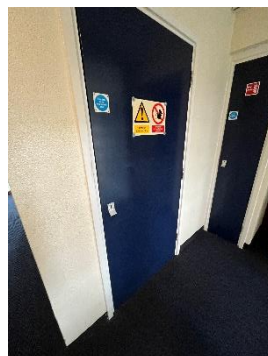
- 8) The lift motor room door is a nominal FD60s timber fire door set. The keys are held centrally at SMBC Roway Lane, and within the firefighter's white box.

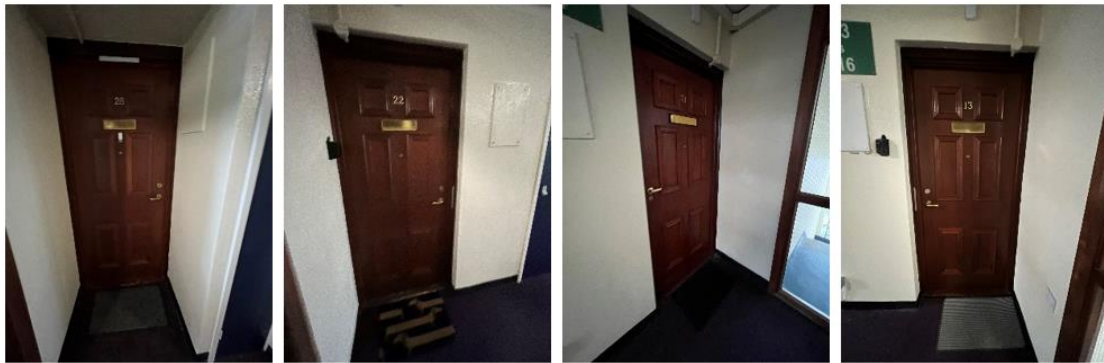
- 9) Individual flat entrance doors are predominately nominal FD30S rated timber fire doors.

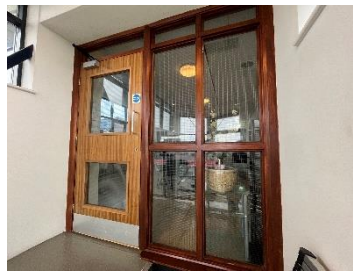
- 10) The communal staircase, lobbies and corridors are protected by use of nominal FD60s self-closing timber fire doors with vision panels. The vision panels are Georgian wired glass.

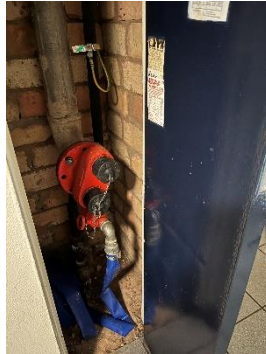
- 1) The dry riser inlet is internal, within a cupboard in the ground floor lift lobby. Secured with a type 54 suited mortice lock.

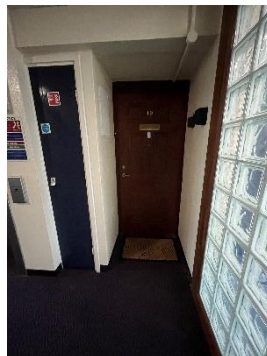
- 2) The dry riser outlets are located within cupboards on floors 1 to 8, secured with a type 54 suited mortice lock. The dry risers are checked regularly as part of the caretakers' duties.

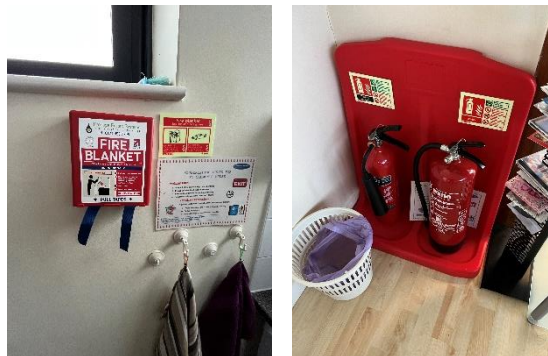
- 5) There is a fire blanket, a water and a CO2 extinguisher in the communal room.

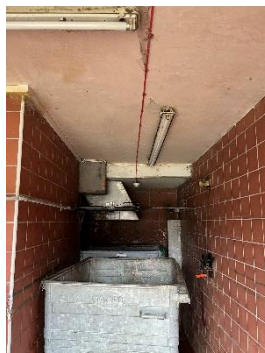
- 6) A deluge system is provided to the refuse chute bin store. The control unit is situated in the ground floor electrical cupboard. An approved contractor maintains the system. The frequency for the maintenance checks is twice a year (April and October).

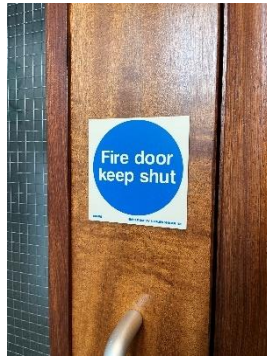
- 1) Fire doors display suitable signage where appropriate.

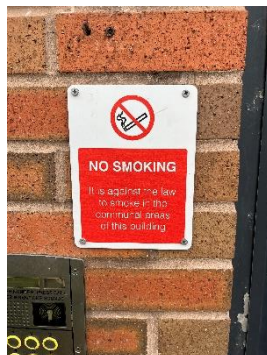
- 2) No smoking (Smoke Free England) signage is displayed throughout the premise.

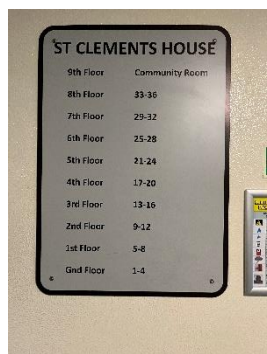
- 3) Signage depicting the floor location of each flat is fitted to the ground floor lobby wall.

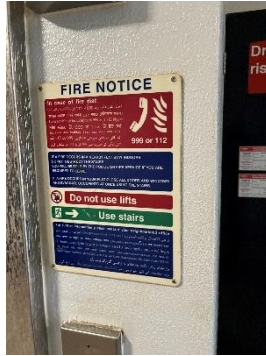
4) Fire Action Notices are displayed throughout the building.

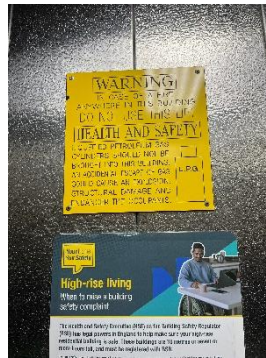
5) Yellow LPG warning signs are displayed within the lift cars.

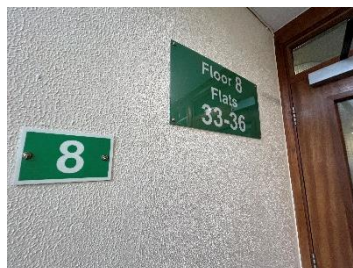
6) Photoluminescent wayfinding signage depicting floor levels and flat numbers has been installed. The signage meets the requirement the Fire Safety (England) Regulations 2022.

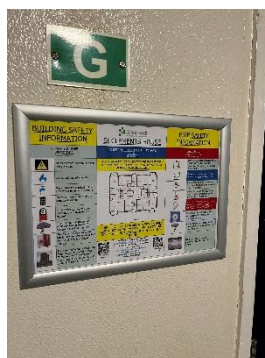
- 1) All Caretaking / Cleaning Employees have undertaken fire safety training. This includes use of bespoke 'Fire Safety in High / Low Rise Flatted Accommodation' Video. There are no employees permanently based in the premise.
- 2) All employees are encouraged to complete 'In the line of fire' training on an annual basis.
- 3) Caretaking Teams are not currently trained in the effective use of fire extinguishers. The only extinguishers are located within the lift motor room. Caretaking Teams are not expected to tackle fires in this area.
- 4) Building safety and evacuation notices are displayed in common areas and lift cars.

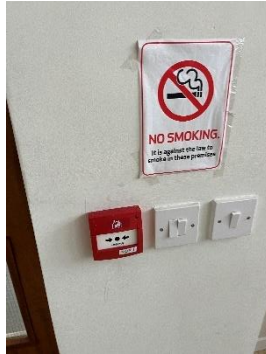
- 1) Smoking is prohibited within any communal parts of the building in line with Smoke Free England legislation.

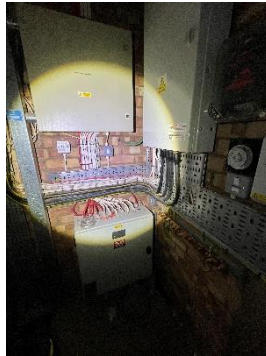
- 4) The electrical installation i.e. risers are contained within dedicated service cupboards that are secured with locked FD60s fire doors.

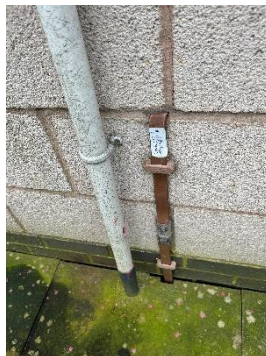
- 5) There is a lightning protection system installed to the building. Maintenance contracts are in place for lightning conductor testing in accordance with BS 6651.

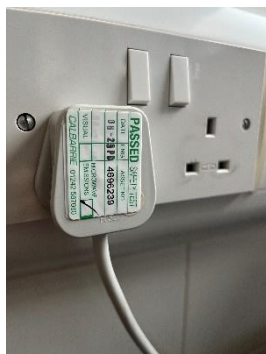
- 6) Portable heaters are not allowed in any common parts of the premises.
- 7) Sampled portable electrical equipment in the communal room was in date. Electrical equipment used as part of the Caretaking / Cleaning regime is subject to annual PAT Testing. This information is held by the Estate Services Manager.

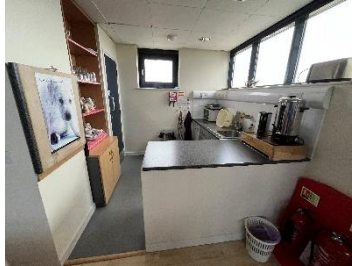
- 8) There is a small kitchenette within the communal room. This kitchenette is to be used for the reheating and cold preparation of food only.

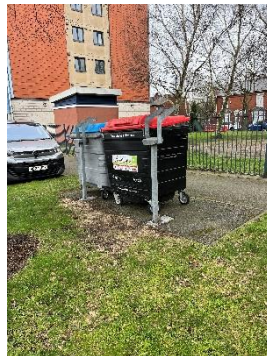
- 1) There is a regular cleaning service to the premises.
- 2) Refuse & recycling containers are emptied regularly. Refuse containers are in the bin store which is at the rear of the block. Recycling containers are kept away from the block.

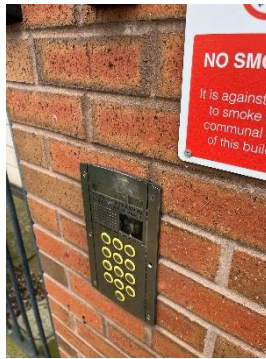
- 1) Regular checks are undertaken by Caretakers / Cleaning Team(s) 365 days per year which helps reduce the risk of arson.
- 2) Restricted access to the premises by means of a door entry system.
