# Fire Risk Assessment

## Astbury Court

**Hereford Road, Oldbury,  
B68 0QG**

**Date Completed: 11/04/25.**

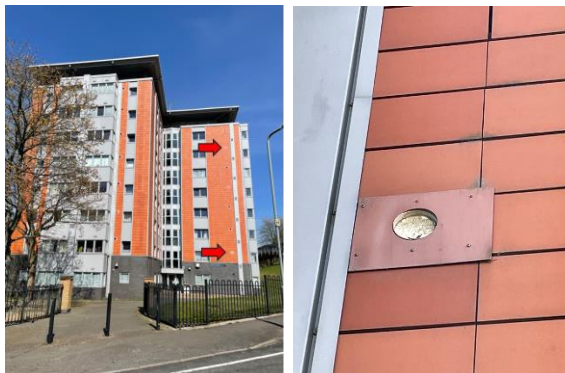
4. Windows to flats are composite timber framed with external powder coated aluminium finish. Communal windows are powder coated aluminium.
5. Blanked sleeves penetrating the external walls were noted adjacent some flat kitchen windows. It is believed this work was undertaken during the 2007 refurbishment in preparation for potential gas flue installations. It was not possible to identify the materials used to seal the penetration. Further investigation will take place during the scheduled PAS 9980 FRAEW.

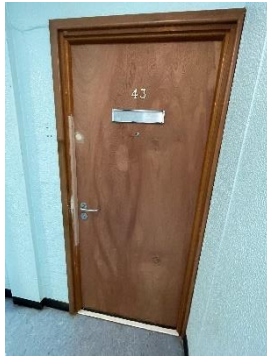
A. Flat 43, access not gained, minor repairs noted to the stop and where the cylinder lock has been replaced, door is sufficient.

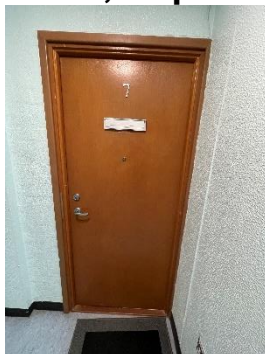
**D. Flat 7, requires an overhead self-closing device fitting.**

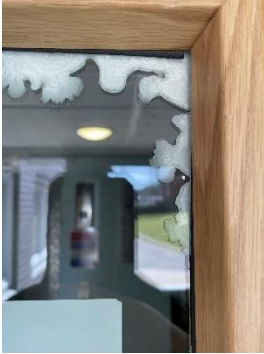
- 7) A ground and 7<sup>th</sup> floor lobby door both show small signs of staining within the vision panel. This does not adversely affect the doors integrity or ability to see through the panel. The doors are regularly monitored as part of the 12-weekley communal door checks.

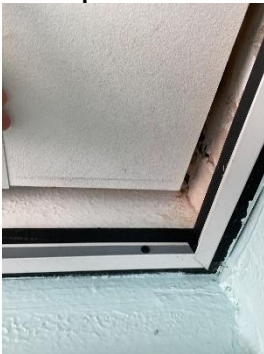
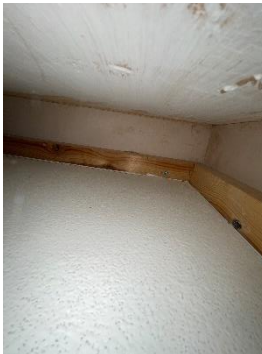
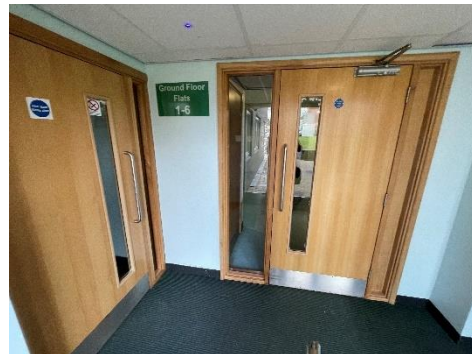
- 8) All communal doors are fitted with automatic closing devices that are checked on a regular basis by Caretaking Teams as part of their checks. Defective closing devices are replaced either by the Caretaking Team(s) or the in-house repairs team(s).
- 9) All communal fire doors are subject to a 12-week check by the Fire Safety Rapid Response Team.
- 10) A sample of false ceiling tiles were removed to ensure compartmentation continues above communal doors / walls. Compartmentation was sufficient.

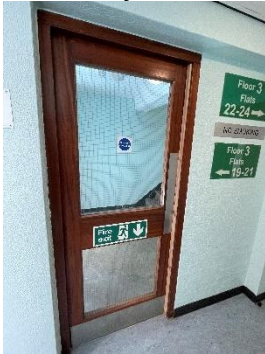
- 11) The communal staircase is protected by use of a nominal 54mm FD60 timber fire door with vision panels to the ground and 7<sup>th</sup> floor. All other floors benefit from notional upgraded FD30s timber fire doors with vision panels. It is recognised that these doors do not meet today's benchmark of a certified FD30s fire door install however, because they were installed at the time of the building's construction and to the standard of that time they are deemed as acceptable so long as the doors are free of damage and function as they were intended to do so which is evident at Astbury Court.

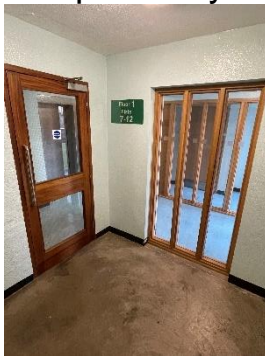
*Image taken from stairwell landing.*

- 12) There are glazed partition walls / screens in hardwood frames to lift lobbies and stairwell landings. These are etched with Schott Pyran S 6mm EN13054-1 & EN12600 1C1. At the time of the FRA sufficient information was not available to determine precise classification with regards to integrity and thermal insulation. However, with automatic opening vents throughout these areas of the building, the management processes & procedures that SMBC have in place, the level of risk is acceptable. In addition, a retrospective fire strategy has been commissioned which will be completed by Firntec Building Compliance.

The responsible person may wish to consider replacing the glazing in the glazed partition walls / screens that are in hardwood frames to the 1<sup>st</sup> floor chute room, lift lobbies and stairwell landings with a product that's precise fire classification including thermal insulation can be evidenced in line with the principles of the golden thread. Although these are etched with Schott Pyran S 6mm EN13054-1 & EN12600 1C1 the precise classification with regards to integrity and thermal insulation where not known during the assessment.

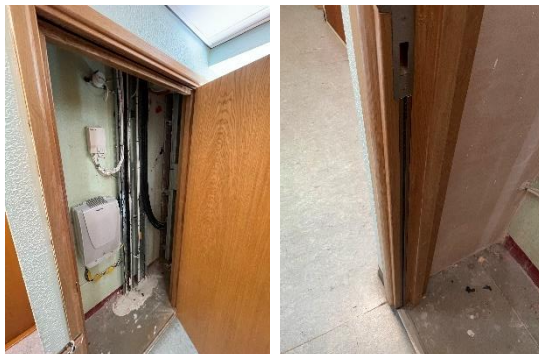
- 14) 4<sup>th</sup> floor service cupboard by flat 25 requires replacement section of combined intumescent strip / cold smoke seal.

P2	Within 1-3 months Fire Rapid Response	
10/14	4 <sup>th</sup> floor service cupboard door by flat 25 – replace missing section of intumescent strip / cold smoke seal.

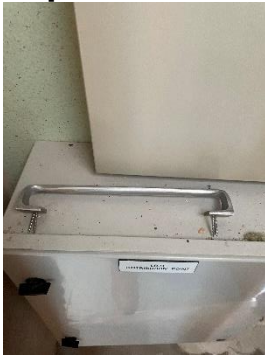
- 16) **2<sup>nd</sup> floor cupboard by flats 14 and 15 requires door handle re-fixing. The handle has been placed in the adjacent service cupboard.**

P2	Within 1-3 months Fire Rapid Response	
10/16	2 <sup>nd</sup> floor cupboard by flats 14 & 15 – refit door handle. Handle placed in adjacent storage cupboard.

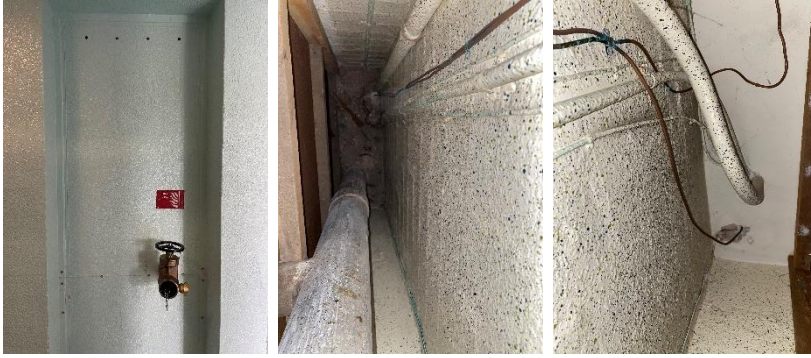
21) Ventilation holes were noted in access panels housing the dry rising main on each floor above ground. Adequate firestopping to the penetration was confirmed by removing an access panel to the 7<sup>th</sup> floor shaft. The Fire Safety, Facilities & Premise manager T. Thompson confirmed that all dry riser penetrations in the shaft were fire stopped in approximately 2017/18. The small ventilation holes in each panel are to prevent condensation when the rising main has been charged.
