# Fire Risk Assessment

## Astbury Court

**Hereford Road, Oldbury,  
B68 0QG**

**Date Completed: 26<sup>th</sup> May 2022**

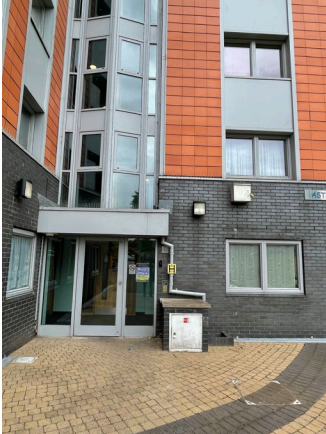
The high-rise block was built in 1964 of concrete & brick construction. The block was refurbished in 2007 and clad up to 1<sup>st</sup> floor with blue class B engineering brickwork. Above the 1<sup>st</sup> floor there is solid Alumet 3mm aluminium panel cladding system and Lockclad terracotta tile system. The cladding was installed in 2018. There is a laminate clad and steel frame clad roof and the block has a main entrance/exit to the front elevation.

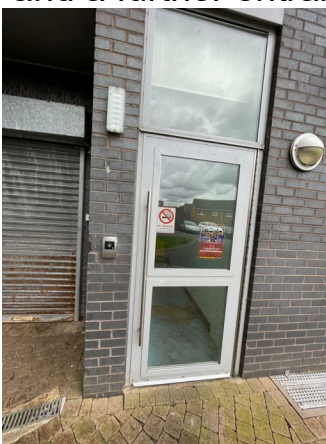
and a further entrance/exit located on the rear elevation.

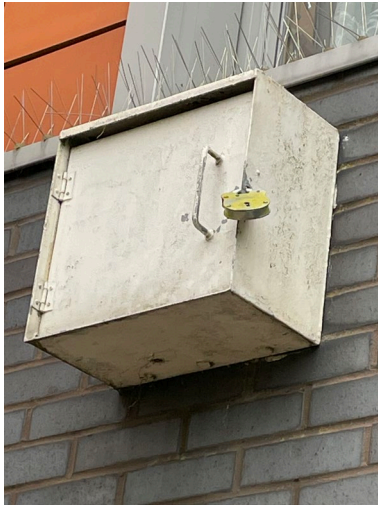
The firefighter's white box is located to the right-hand side of the front main entrance. The location of service isolation points for gas, electricity and water are detailed on a plan located in the fire fighters white box.

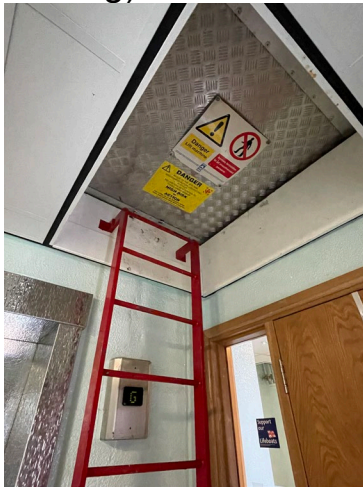
Access to the motor room is located on the 7<sup>th</sup> floor; via steel vertical ladder that gives access into motor room through a trap (top floor landing).

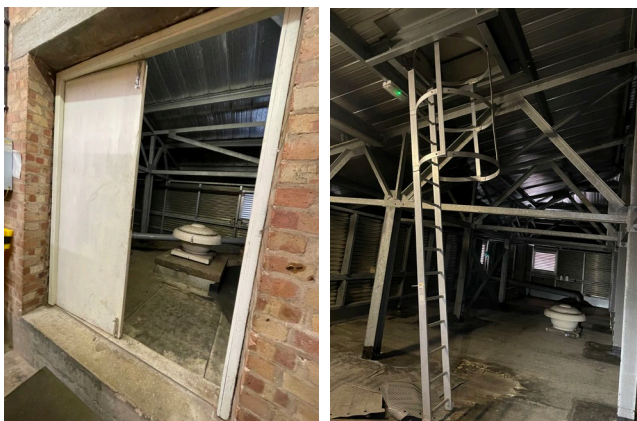
A full height double door then allows access into the roof void. A further metal ladder allows access onto the main roof.

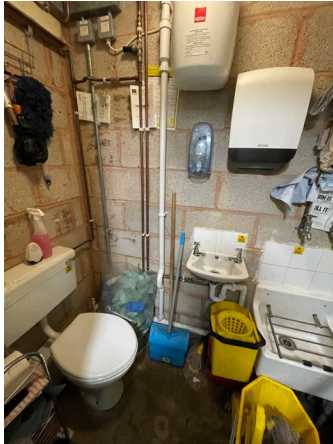
A staff WC and storage room for cleaning products and utensils are located on the ground floor and secured by means of a locked FD30s rated timber door.

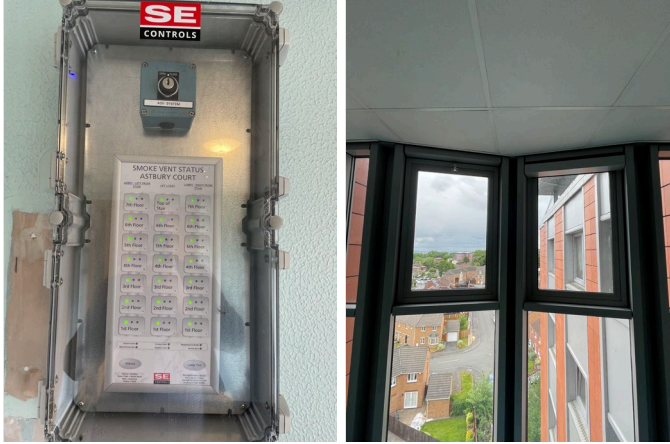
- 8) Automatic smoke ventilation is employed. This is tested, inspected and maintained by a competent procured contractor in accordance with BS7346. The frequency for the maintenance checks are twice per year (April and October) of each calendar year. Communal windows can only be opened by operating the smoke vents.

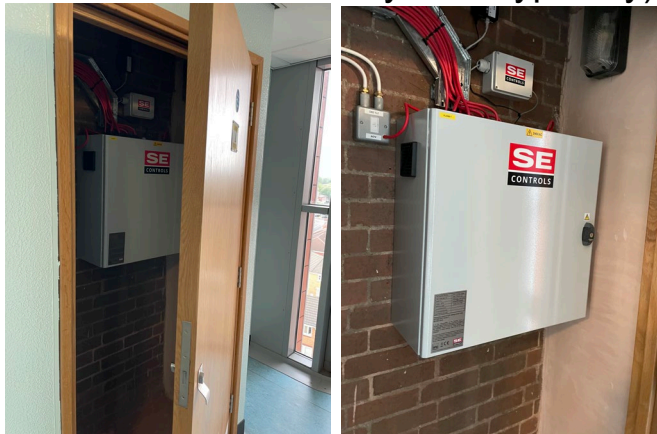
- 9) The controls are located in the service cupboard (single door secured with a suited cylinder type key) on each floor.

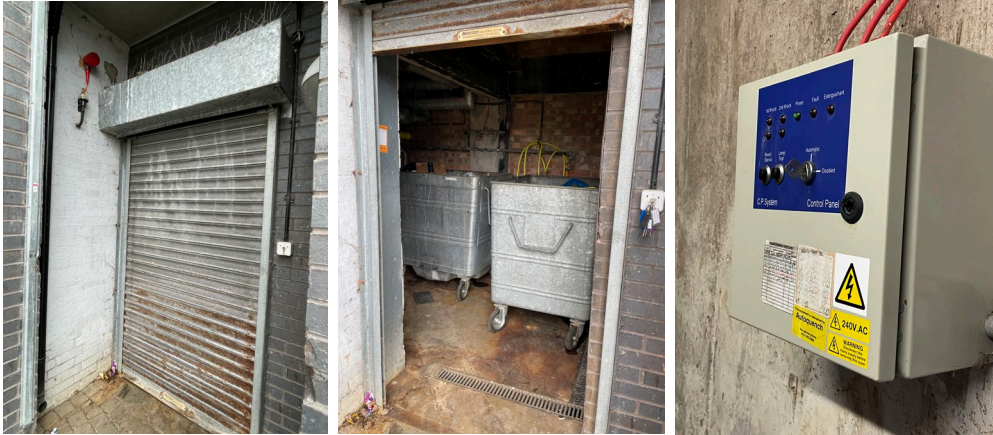
- 5) The control panel for the bin room sprinkler system is located within the bin store. that can be accessed via the roller shutter that has a suited cylinder type key.

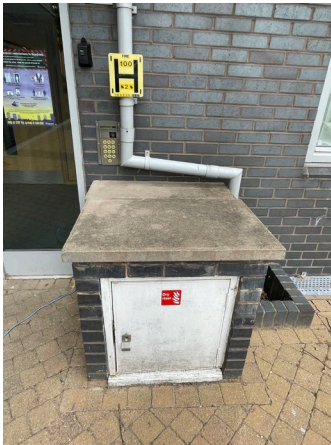
- 1) The dry riser inlet is located to the right-hand side of the main entrance housed within a purpose built brick shelter with a small door secured with a type 54 suited mortice lock.

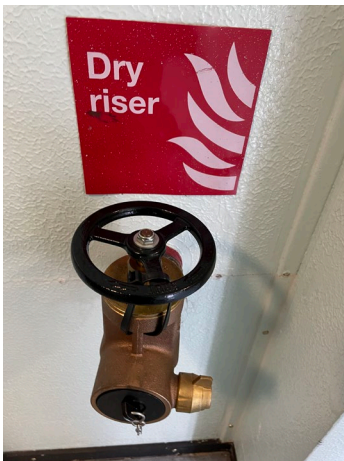
- 2) There is a dry riser that serves the building. The outlets are exposed and located on the communal landing of each floor. Each exposed valve is secured with a cable tie. The caretakers check the cable tie is intact as part of their weekday inspections.

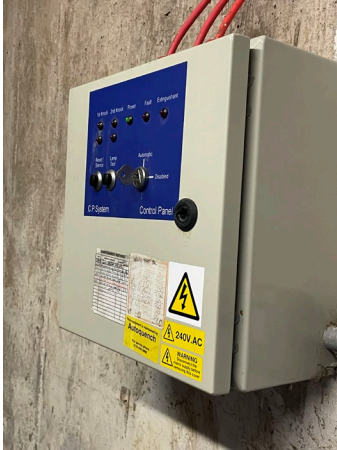
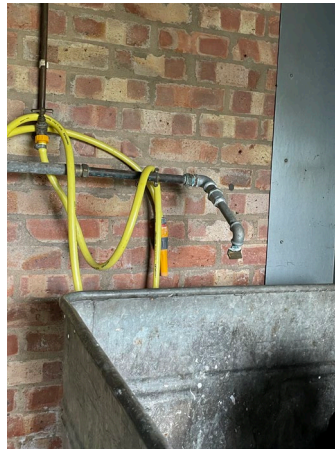
- 5) Portable fire extinguisher (CO2) is provided to the lift motor room. Maintenance contracts in place for maintenance of the extinguisher. The frequency for the maintenance checks are once (October) of each calendar year.
- 6) Bin room is protected by Deluge/sprinkler system and serviced 6-monthly.

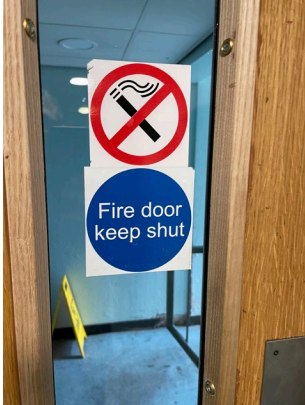
- 1) All fire doors display “Fire Door Keep Shut” where appropriate.

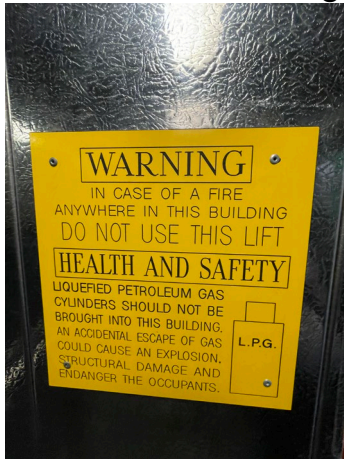
- 3) Yellow LPG warning signs are displayed within the lift cars.

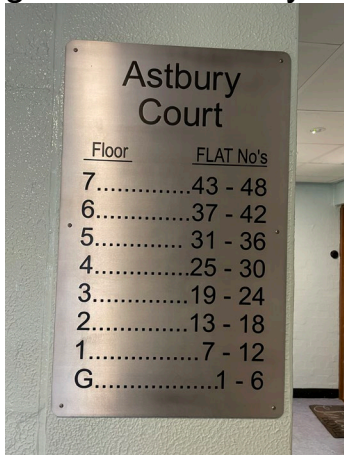
- 4) Signage depicting the floor location of each flat is fitted to the ground floor lobby wall.

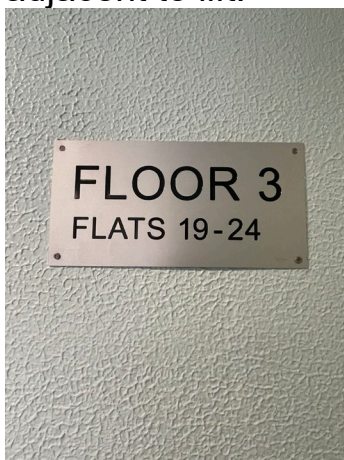
- 5) Signage depicting floor level and flat numbers fitted to wall adjacent to lift.

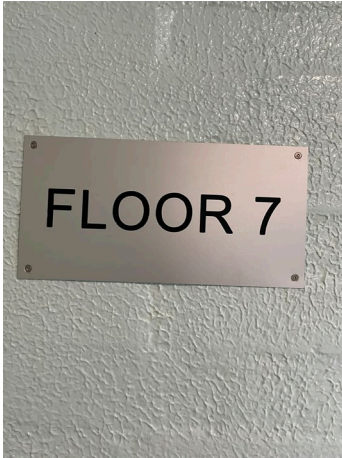
- 6) Floor indicator numbers are fitted to the wall of each floor on the communal staircase.

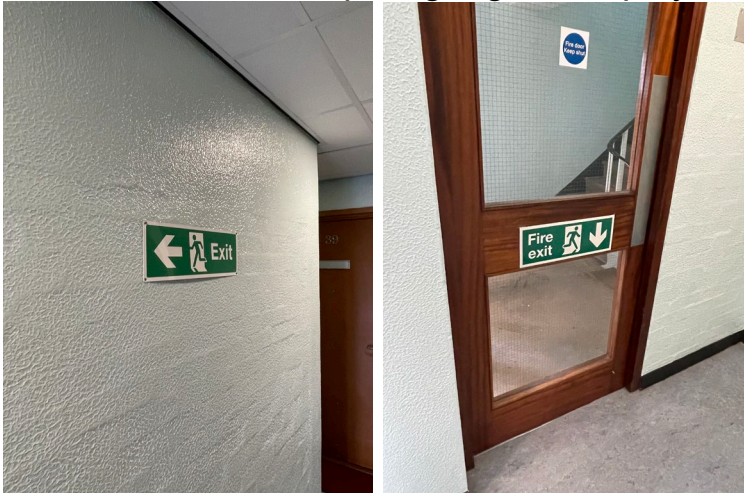
- 7) Directional Fire escape signage is displayed.

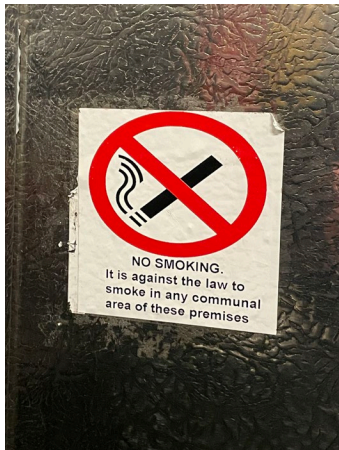
- 1) Smoking is prohibited within any communal parts of the building in line with Smoke Free England legislation.
