Fire Risk Assessment

Russell House

**Holyhead Road,
Wednesbury, WS10 7BA**

Date Completed: 05/11/2025.

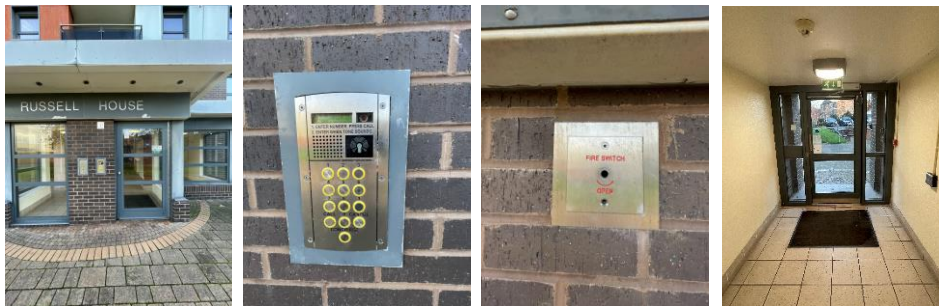
The main entrance to the front elevation has a door entry system with a fob reader installed. The front elevation also has a firefighter override by use of a drop latch key. The entrance to the rear and side elevation can be accessed by the installed fob reader.

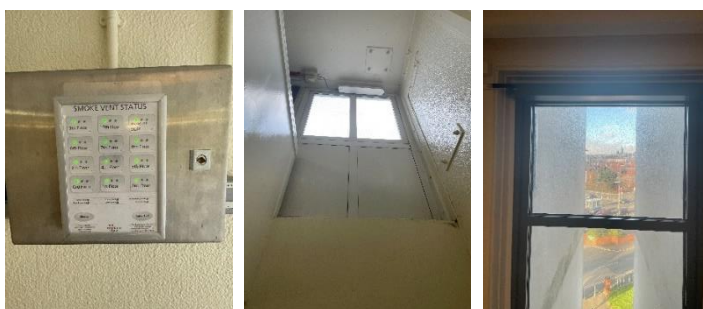
- 8) Automatic smoke ventilation (AOV's) have been commissioned. These systems are tested, inspected and maintained by a competent contractor in accordance with BS7346. The frequency for the maintenance checks is twice per calendar year.

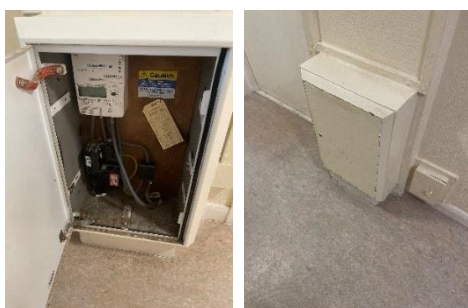
- 13) Electric meter cupboards are fibreglass modular units fitted with budget locks, located outside each property on the communal landing.

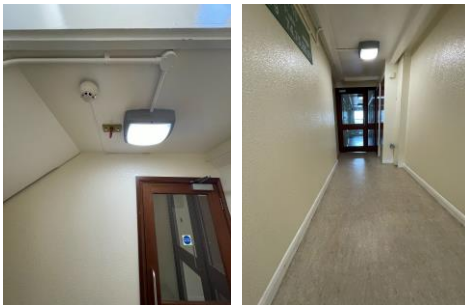
- 1) The premises has sufficient emergency / escape lighting system in accordance with BS 5266 and has test points strategically located.

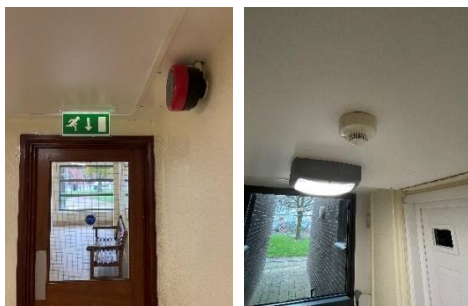
- 2) The self-contained units are provided to the communal landings, stairs and lift motor room.

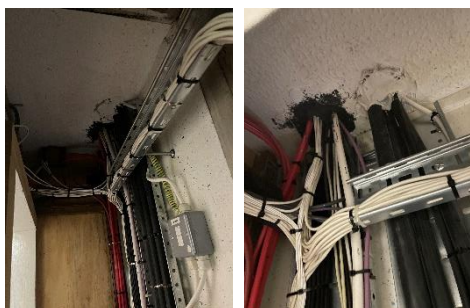
- 4) All communal fire doors are subject to a 12-week check by the Fire Safety Rapid Response Team.
- 5) A variety of methods / materials have been used to achieve fire-stopping including Rockwool, fire rated sponge and intumescent pillows.

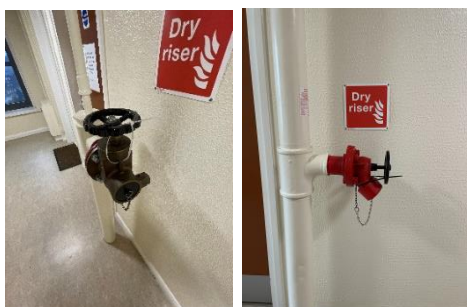
- 2) There is a dry riser that serves the building. The outlets are exposed and located on the communal lobby of each floor. Each exposed valve is secured with a cable tie.

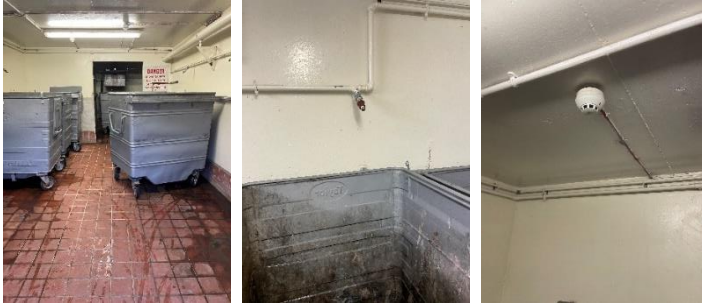
- 6) Bin room is protected by Deluge/sprinkler system and serviced 6-monthly.
