Fire Risk Assessment

Neale House

**Glover Street,
West Bromwich, B70 6DZ**

Date Completed: 05/12/2025

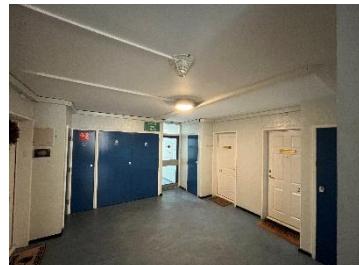
- 4) The communal landing / staircases are protected by the use of notional self-closing 44mm 30-minute timber fire doors with vision panels. All doors have been upgraded with intumescent strips / cold smoke seals.

Observations.		
Some communal notional fire doors show signs of wear and tear due to age. Consideration should be given to upgrade these doors with certified FD30s door sets & combination frames as part of any future work programme.

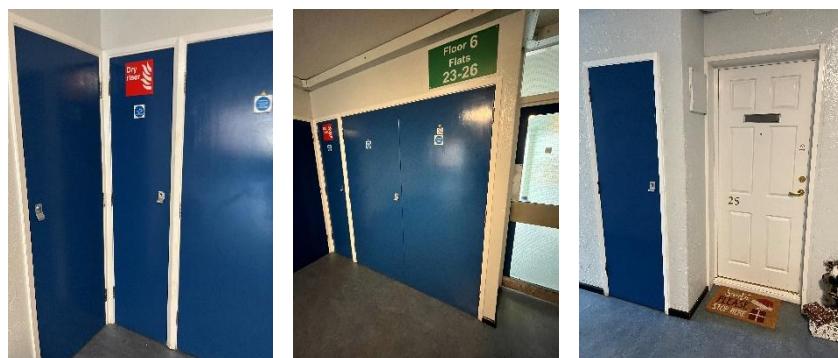
- 14) The service cupboards on all floors contain residents' electrical meters, from 1st to 8th floors. These cupboards have double nominal FD60s 54mm doors secured with a suited 138 key mortice lock. All floors have dry riser outlet cupboards in the lift lobbies, with 44mm nominal FD30s doors, secured with a 54 suited mortice lock. All floors have one resident's storage cupboard per flat. Residents own the keys to their storage cupboards and therefore these storage cupboards do not form part of this fire risk assessment.

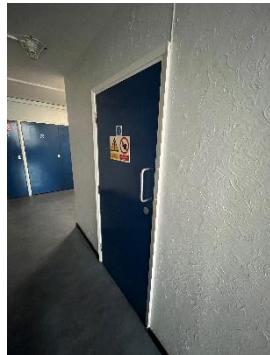
- 9) The landings & staircase from the first floor up, are protected by use of notional self-closing 44mm 30-minute timber fire doors with vision panels. It is recognised that these doors do not meet today's benchmark of a certified FD30s fire door install. However, because they were installed at the time of the building's construction and to the standard of that time they are deemed as acceptable so long as the doors are free of damage and function as they were intended to do so. It has been recognised that all the landing / staircase notional doors in this block have been upgraded with combined intumescent strips & cold smoke seals to enhance their original design and minimise departures from today's standards.

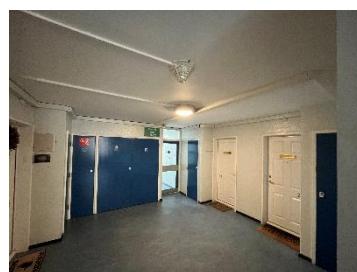
- 10) Communal timber doors to the ground floor lobby are nominal 44mm to FD30s standard. These doors were installed during the 2007/8 refurbishment.

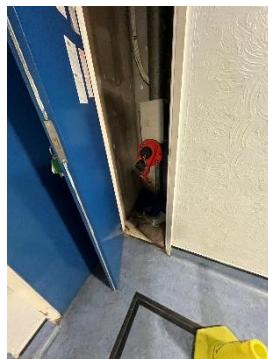
- 2) There is a dry riser outlet on each floor lift lobby, secured within a riser cupboard, the cupboards are locked with a suited 54 key.

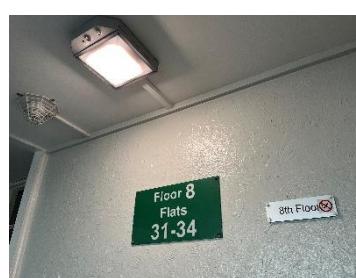
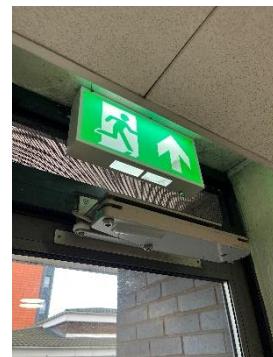
- 6) Photoluminescent wayfinding signage depicting floor level and flat numbers and directional fire escape signage has been installed. The signage meets the requirement the Fire Safety (England) Regulations 2022.

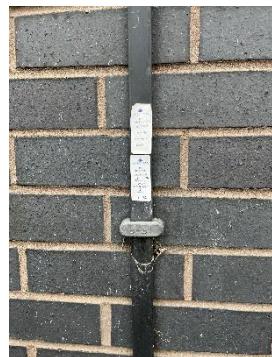
- 5) Portable heaters are not allowed in any common parts of the premises.
- 6) Gas appliances and pipework (where installed) are subject to annual testing and certification. This cyclical contract is managed by the in-house Gas Team. Gas supply pipework is internal to the building.
