# Fire Risk Assessment

## Hamstead House

**Coniston Crescent,  
Great Barr, B43 5NT**

**Date Completed: 06/11/2025**

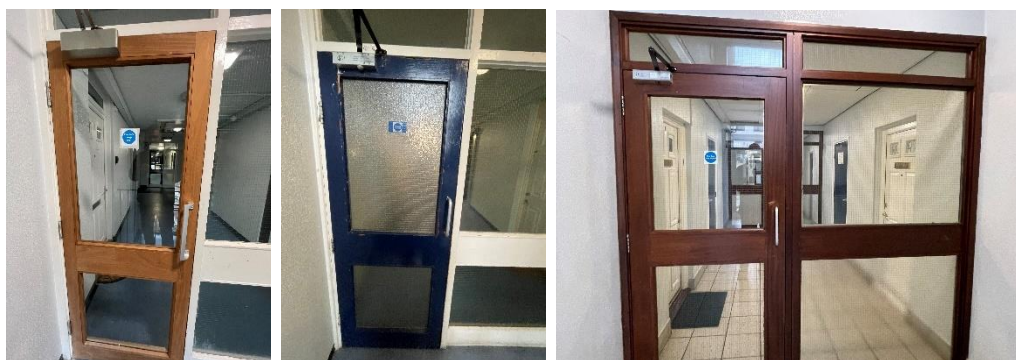
- 4) None of the corridors that form part of the means of escape are dead ends.
- 5) The communal corridors and staircases are protected by use of notional FD30s timber cross corridor fire doors with vision panels. It was noted on the 10<sup>th</sup> floor that a replacement nominal FD30s timber fire has been installed.

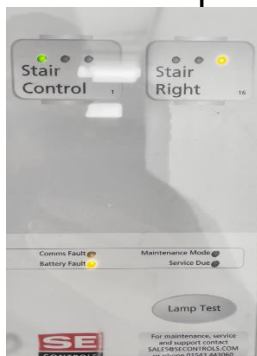
- 8) The maximum travel distance from a flat entrance door to the nearest protected stair is 5.5 metres.
- 9) Automatic smoke ventilation is employed within the building. AOVs are located between the 1<sup>st</sup>/2<sup>nd</sup> and 5<sup>th</sup>/6<sup>th</sup> stairwell floors. The system status panel is located in the entrance foyer. These systems are inspected, serviced, and maintained by a competent procured contractor in accordance with the relevant British Standards, BS 7346.
- 10) A battery fault light was noted on the AOV panel indicating a defect with the back-up batteries in the right-hand stair units. The service contractor has been commissioned to replace the defective batteries as soon as practically possible.

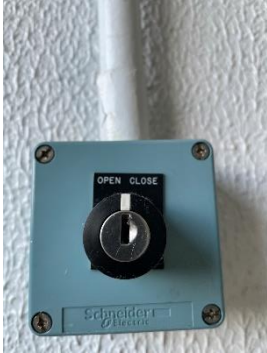
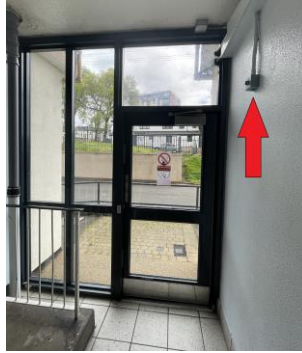
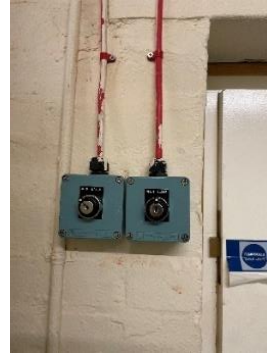
- 11) There are control switches located in the caretaker's office (auto / manual & open/close) and on the ground and 9th floor stairwells (open/close).

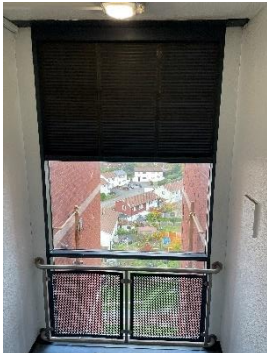
- 12) There is a louvre vent to the top of each stairwell.

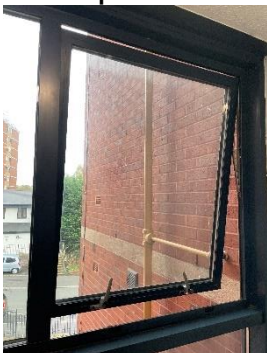
- 13) There are communal windows on multiple floors in both stairwells some are not openable because of handles missing and have been screwed shut. Signage states windows have been secured for safety. This is not a fire safety concern as smoke control is still present via AOV's between floors 1<sup>st</sup> / 2<sup>nd</sup> & 5<sup>th</sup> / 6<sup>th</sup> and a louvre vent system to the top of each stairwell.

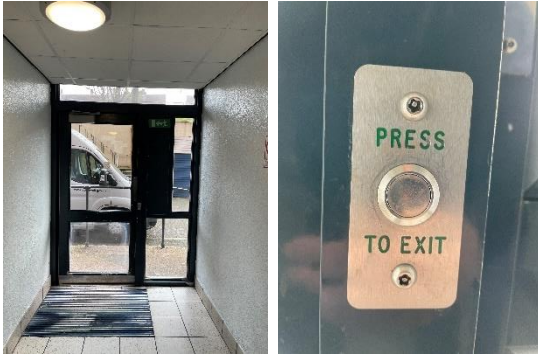
- 14) The final exit doors have door entry systems installed. These systems are designed to fail safe i.e. door unlocked in the event of a power failure. This prevents residents being locked in or out of the building. The doors are open via a push button system when exiting the building.

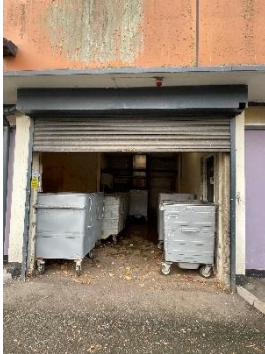
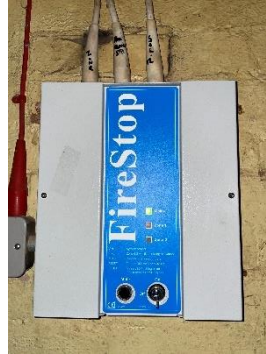
- 5) A fire suppression system is provided to the refuse chute bin store. The system is inspected, serviced, and maintained by a competent person/contractor. The panel is located in the ground floor cleaner's cupboard.

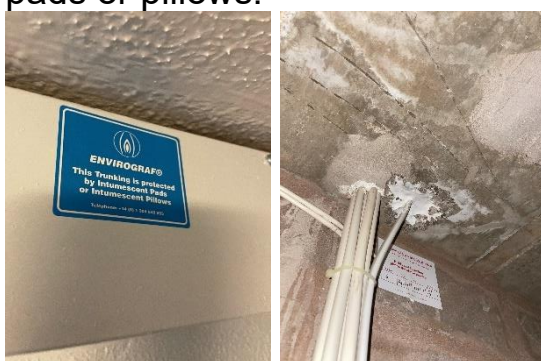
- 5) A variety of methods / materials have been used to achieve fire-stopping including Rockwool, intumescent mastic and intumescent pads or pillows.

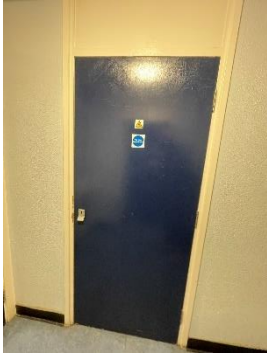
- 10) All service cupboards in communal areas are nominal FD30s fire doors secured with mortice locks.

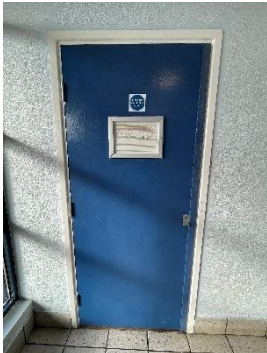
- 11) The service cupboard within the main entrance foyer is secured with a nominal FD60s timber door.

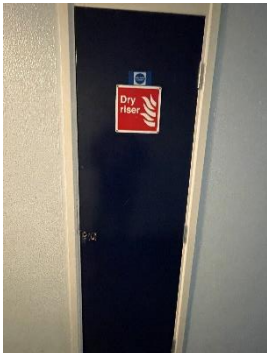
- 12) Riser cupboard doors are nominal FD30s fire doors secured with mortice locks

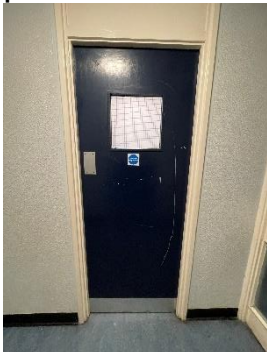
- 13) Doors to chute rooms are nominal FD30s timber doors with vision panel.

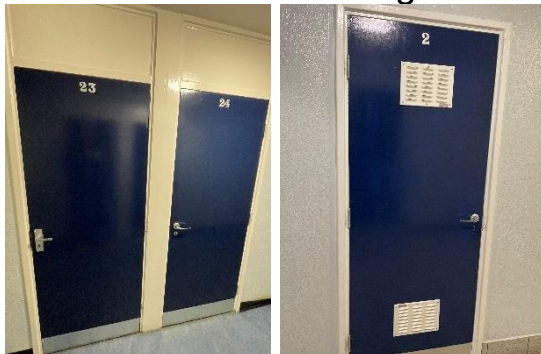
- 14) Residents have access to individual storage cupboards within the communal corridors. Cupboards are secured with nominal FD30s timber doors. The cupboard accessed via flat 2 has Envirograf intumescent ventilation grills installed.

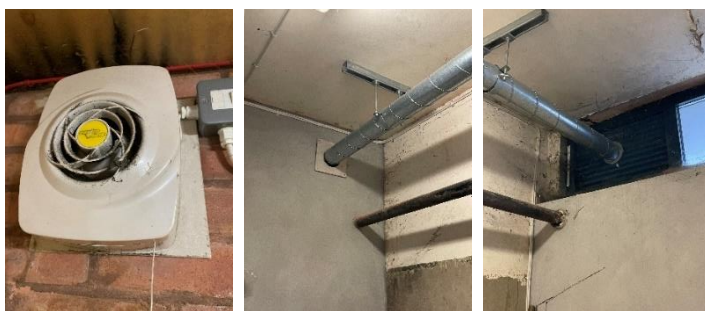
- 16) The Environment extraction unit within the cleaner's cupboard is mounted on Supalux board and coupled to steel ducting that penetrates the wall to an electrical intake room (within the bin store) before venting to the outside. Supalux has also been to the reverse.

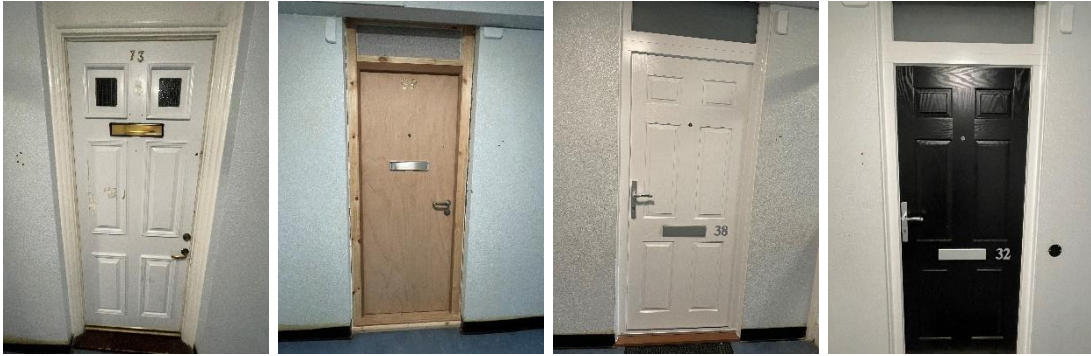
- 17) Individual flat doors are FD30s composite door set manufactured by Permadoor, Nationwide, IG or Shelforce. Flats 16, 17 & 37,69 have timber flush FD30s entrance doors.

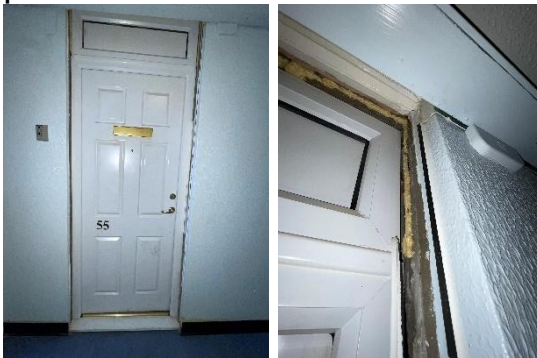
- 18) Individual flat doors are scheduled for inspection by SMBC's Fire Rapid Response team on 10/11/25 & 14/11/25. The inspections will be completed on a best endeavour basis inline with The Fire Safety England Regulations 2022.
- 19) Flat 55 entrance door was noted as damaged due to a likely forced entry. Further investigations have revealed a replacement FD30s door has been delivered and will be installed as part of the voids process.

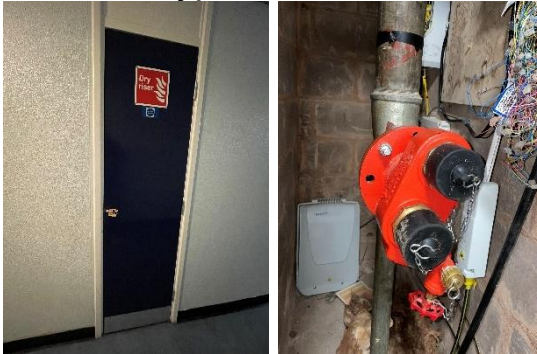
- 1) The dry riser inlet cupboard is located within the ground floor adjacent the service cupboard and community room and is secured with a suited 54 type mortice lock.

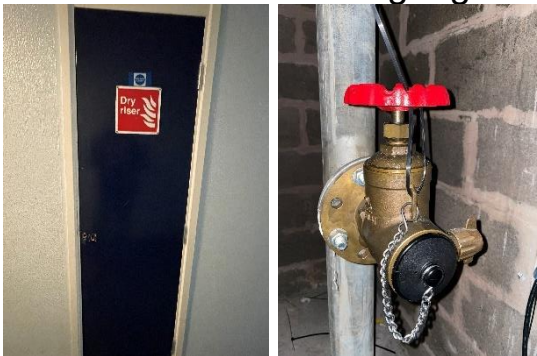
- 2) The dry riser outlets that serve the building are located on each floor above ground within cupboards secured by a suited 54 type mortice lock. The doors have signage illustrating dry riser.

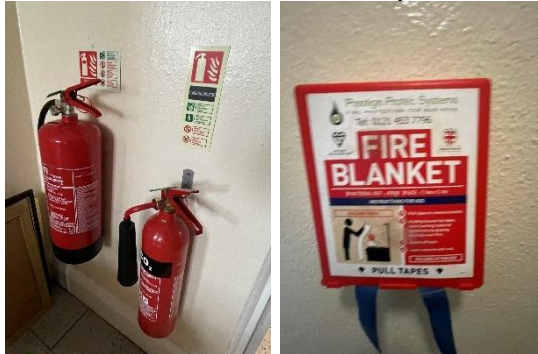
- 5) Portable fire extinguisher (CO2) is provided to the lift motor room and caretakers office. A further CO2 plus Foam fire extinguisher has been provided to the community room along with a fire blanket to the community room kitchen. Fire extinguishers and associated equipment are inspected, serviced, and maintained by a competent person/contractor in accordance with the relevant British Standards, BS5306-3. The next inspection is scheduled for November 2025.

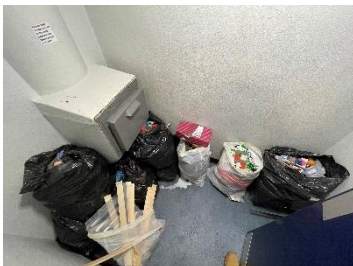
- 3) Regular checks by Caretakers minimise risk of waste accumulation.
- 4) A number of bags containing rubbish were discarded in the 5<sup>th</sup> floor chute room. Staff on site cleared the waste during this assessment.

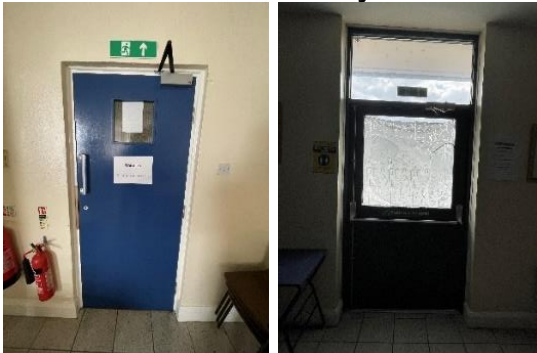
- 7) There are 2 exits from the room, one is operated by a push bar and measures approx. 1000mm, this leads to a place ultimate safety. The other exit door is approx. 750mm and opens inwards. This leads to a place of relative safety (protected communal corridor). Because the inward opening door does not open in the direction of escape the flow rate for the community room is limited to 60 persons.

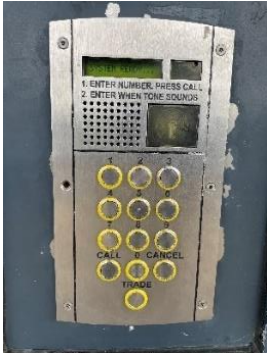
- 1) Regular checks are undertaken by Caretakers / Cleaning Team(s) 365 days per year which helps reduce the risk of arson.
- 2) Restricted access to the premises by means of a door entry system.

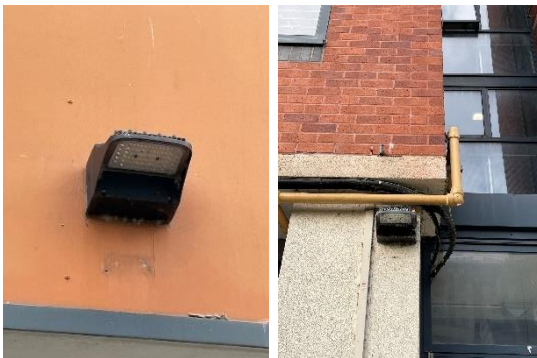
- 3) There is no CCTV system in place.
- 4) The perimeter of the premises is well illuminated.

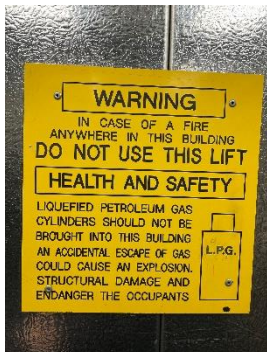
- 1) Residents instructed not to bring L.P.G cylinders into block.

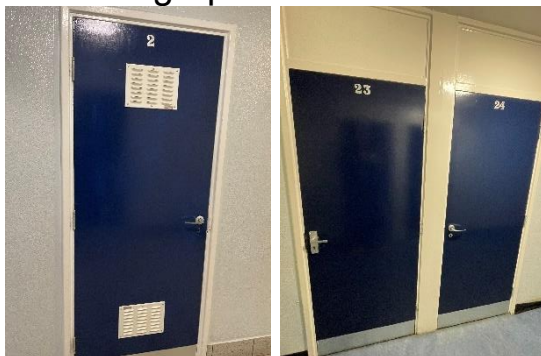
- 2) The tenancy conditions, Section 7 – Condition 5.6 stipulates “If you live in a flat or maisonette, you, people living with you and any visitors to your property must not keep or use paraffin oil, petrol, bottled gas appliances or any other explosive, FLAMMABLE, or dangerous material in the property. This restriction also applies to any storage facility situated in or attached to the block, which has been provided for your use.”
- 3) No Flammable liquids stored on site by Caretakers / cleaners.
- 4) All store cupboards are kept locked.
- 5) There are no flammable liquids or gas cylinders stored on site.
- 6) Each flat has access to a storage cupboard on the same floor. Cupboard doors are nominal FD30s timber doors and secured by mortice lock. The storage cupboard allocated to flat 2 has the addition of Envirograph intumescent vents fitted.
