# Fire Risk Assessment

## Hackwood House

Hartlebury Rd, Oldbury,  
B69 1EG

**Date Completed:** 09/05/2025.

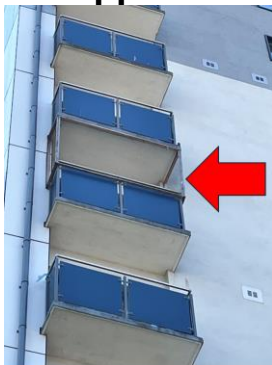
However, the presence of anti-bird netting to 2 x flat balconies and timber screening to 1 x balcony could, potentially support the external spread of flame and therefore is an unnecessary risk.

- 5) Flat 47 / 8<sup>th</sup> floor – Installed netting to balcony has the potential to support the surface spread of flame.**

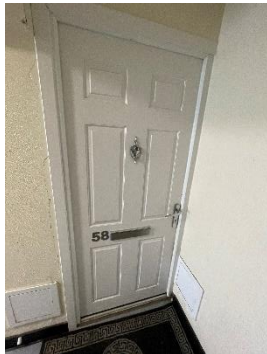
d) Flat 58 door – Entrance door was correct.

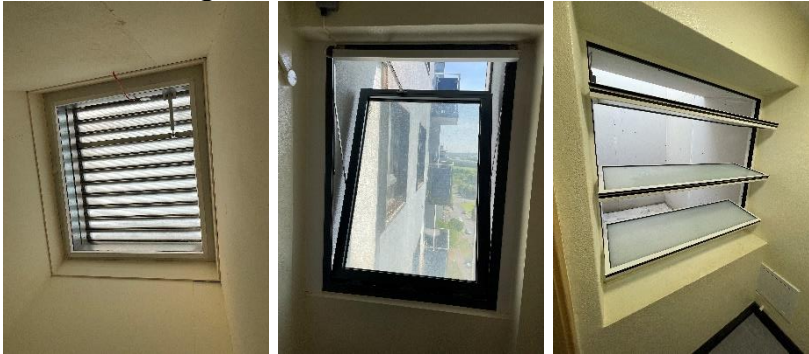
- 13) Automatic opening vents have been installed to the head of protected staircase and in each corridor above the ground floor. It was noted that the opening vents in the 12<sup>th</sup> floor corridors are of a different design to other corridors within the building.

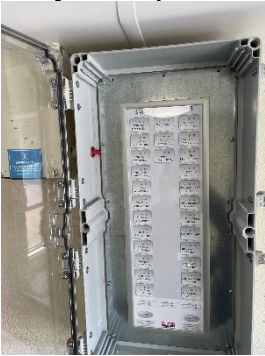
- 14) There is a repeater panel located on the wall of the ground floor lobby that provides the status of the system.

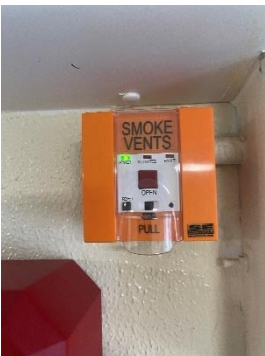
- 15) The manual override and master reset for the entire system is located next to the repeater panel.

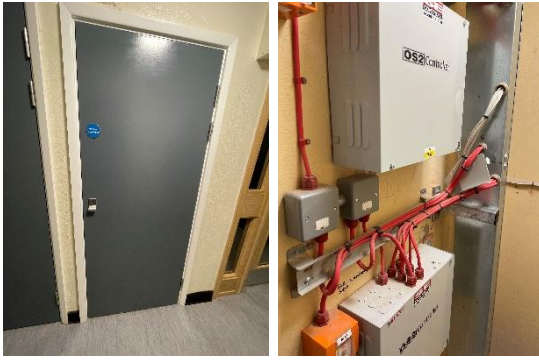
- 16) Individual override / reset controls for each corridor AOV are located in service cupboards on each floor (single door secured with a 54 lock). It should be noted that the system installed is fully automated and each vent is independently controlled by a localised smoke detector. Once smoke has cleared the system will automatically reset.
-

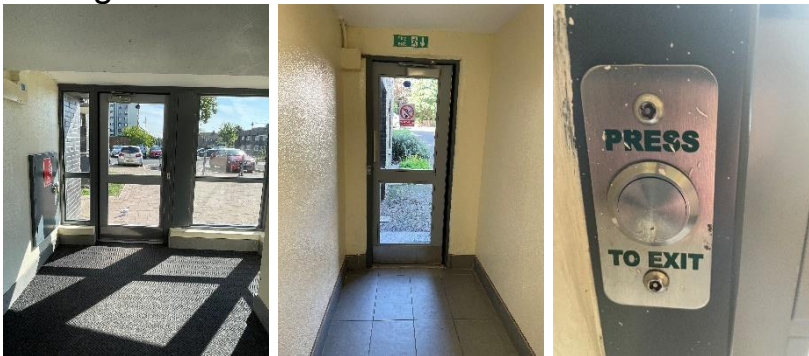
- 17) The final exit doors has a door entry system installed. These systems are designed to fail safe i.e. door unlocked in the event of a power failure. This prevents residents being locked in or out of the building.

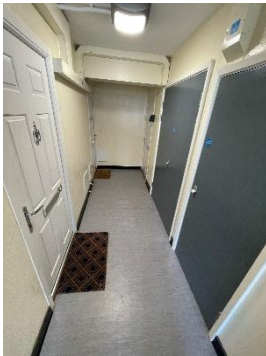
- 19) Individual floor mats were noted outside some flats. Fire rating of the mats is unknown but deemed to be of low risk.

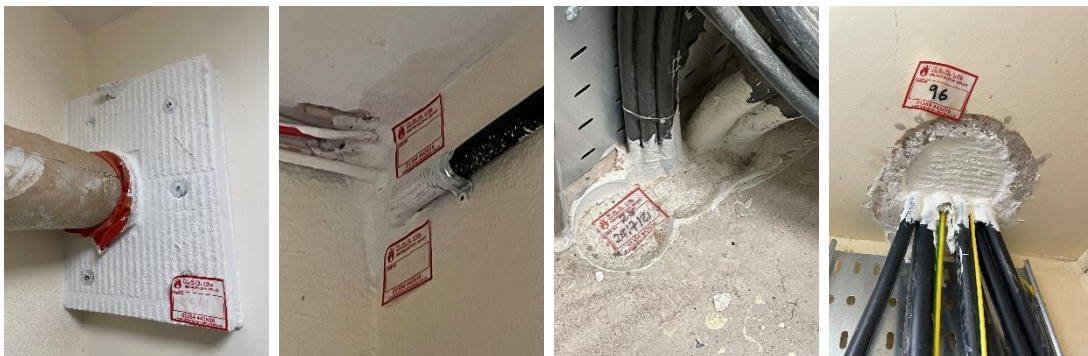
- 1) The building is designed to provide as a minimum 1-hour vertical fire resistance and 1-hour horizontal fire resistance around flats stairwells and lift shafts. All doors are a minimum 30-minute fire resistant with intumescent strips & cold smoke seals, including those in 1-hour rated walls.
- 2) The premise has sufficient compartmentation to limit the travel and effect of smoke and flame in event of a fire. Whilst the existing fire stopping is fit for purpose, there is a cyclical programme to ensure fire stopping as not been compromised by third parties and where applicable enhance the fire stopping.
- 3) A variety of methods / materials have been used to achieve fire-stopping including ablative batt, intumescent wraps & intumescent mastic.

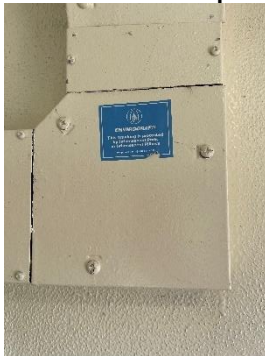
- 7) It was noted that cabling is run through metal trunking protected by intumescent pads or pillows.

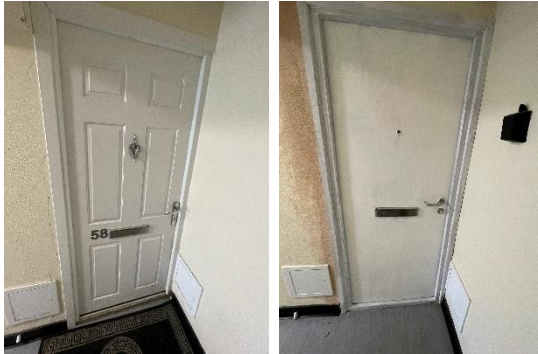
- 13) Individual flat doors are predominantly nominal FD30s composite fire door sets. Flats 8, 13 & 49 have nominal FD30s timber fire doors.

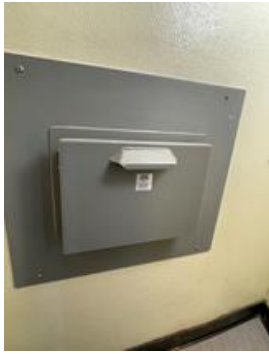
- 16) Refuse hoppers on all floors are Dartford Metalcrafts type LC conforming to BS1703: 2005 with 4 ¼ hours fire rating to BS476 part 22 and smoke containment to BS476 part 31.1. The hoppers were installed 23/02/23.

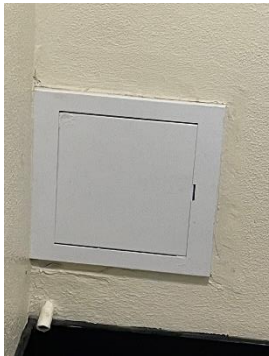
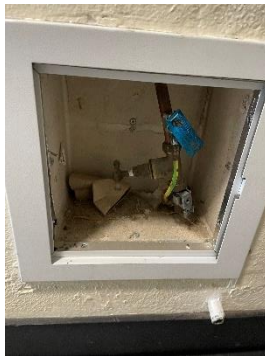
- 17) Access panels to stop taps are fixed to walls via timber rebate strips and found outside the flats of every floor.

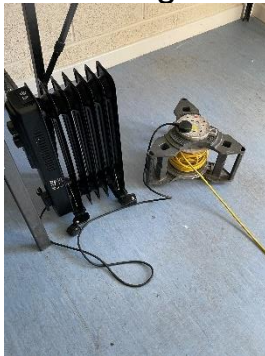
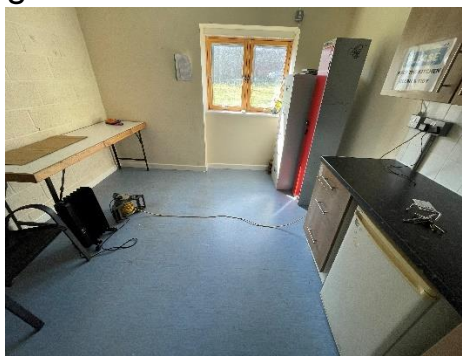
- 6) There is lightning protection installed to the block. Maintenance contracts are in place for lightning conductor testing in accordance with BS 6651.
- 7) Portable heaters are not allowed in any common parts of the premises.
- 8) A portable heater had been in use powered via an uncoiled extension lead. This was within a caretakers room; immediate action take to remove the risk. Subsequently, an email was sent to the caretaking manager to raise awareness.

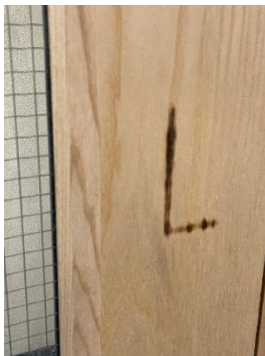
- 3) CCTV is in operation covering the ground floors, lifts and external areas and surrounding areas. The system is monitored 365 days per year by the centralised CCTV control room located at the Sandwell MBC Operations and Development Centre, Roway Lane, Oldbury, B693ES.
- 4) There is some evidence of arson within the building (scorching).

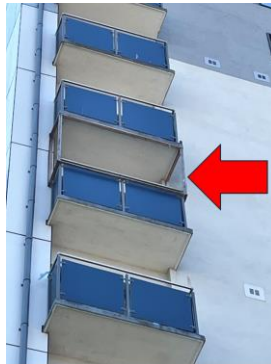
Question/ Ref No	Required Action	Supporting photograph	Priority	Timescale and Person Responsible	Date Completed
6/5	Flat 47 – Remove netting from balcony.

P2	Within 1-3 months Housing Manager

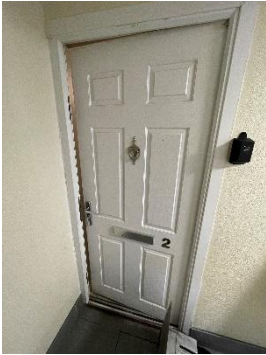
7/2a	Flat 2 entrance door – requires adjustment to ensure reliably self-closes.

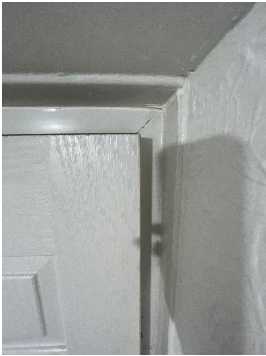
P2	Within 1-3 months Rapid Fire Team	
7/2b	Flat 17 entrance door – requires adjustment ensure reliably self-closes.

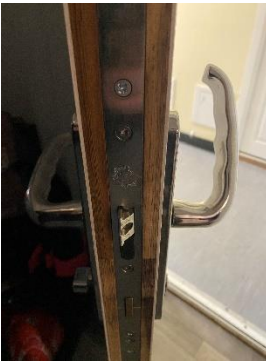
P2	Within 1-3 months Rapid Fire Team	
7/2c	Flat 38 entrance door - requires adjustment ensure reliably self-closes. Also, door handle requires attention / levers sticking, not moving simultaneously.

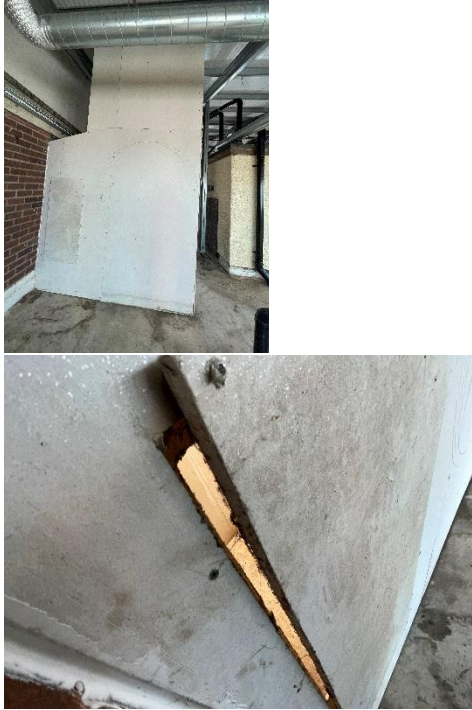
- 8) **12<sup>th</sup> floor Automatic Opening Vent smoke shaft in roof void, adjacent flat 70. The shaft has previously been accessed to facilitate repair to the AOV however, the access panel hasn't been suitably reinstated. This could potentially cause some smoke logging to this side of the roof void in the event of a fire.**

10/8	12 <sup>th</sup> floor roof void adjacent flat 70 – Re-fit or replace AOV shaft panel to prevent the leakage of smoke into the roof void.

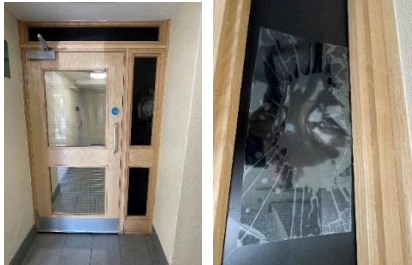
- 10) Cracked glazing to ground floor communal door near flats 1 & 2 to be replaced with suitable fire resistant glass. Protective film has been applied as a temporary repair.**

P2	Within 1-3 months Rapid Fire Team	
10/10	Ground floor communal door adjacent flats 1 & 2 – Replace damaged fire resistant glazing within fire door frame.

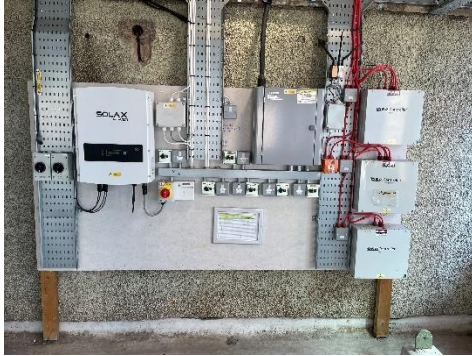
14/10	<p>There are no service records available for the servicing and maintenance of Solar Equipment provided for this building. A robust servicing and maintenance programme should be put in place for this equipment.</p>

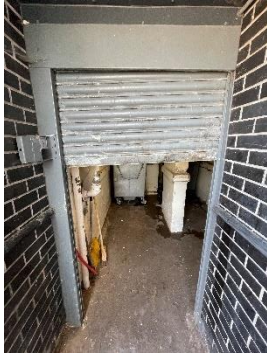
- 3) **Refuse containers are located in the bin store at ground level. The roller shutter door was noted as defective and requires repair. The bin store should be secured.**

P4	<p>Programmed Work Electrical Compliance Manager.</p>	
15/3	<p>Bin store roller shutter door defective and requires repair. (Also reported by caretaker).</p>
