# Fire Risk Assessment

## Thompson Gardens

**1-89, Hales Lane,  
Smethwick, B67 6RX**

**Date of Inspection: 16<sup>th</sup> September 2026**

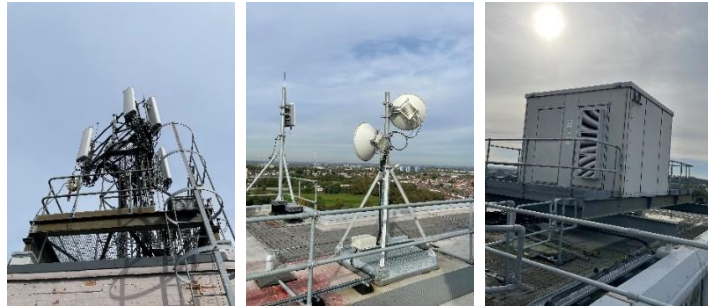
- 4) Telecommunication devices are located on the roof of the building, no access during this FRA, photos taken from previous FRA.

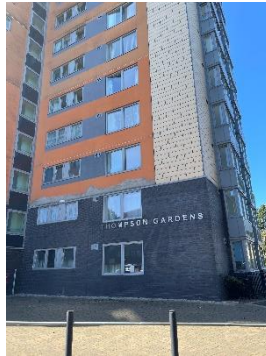
- 5) All windows are double glazed units housed in timber frames with an external powder coated aluminium face.

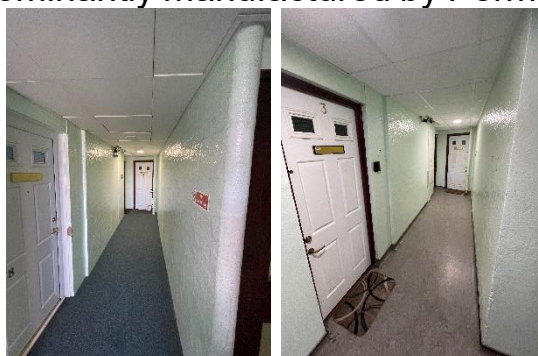
- 1) Individual flat doors are predominantly nominal self-closing 30-minute composite fire door sets with intumescent strips, cold smoke seals. Doors are predominantly manufactured by Permadoor or Nationwide.

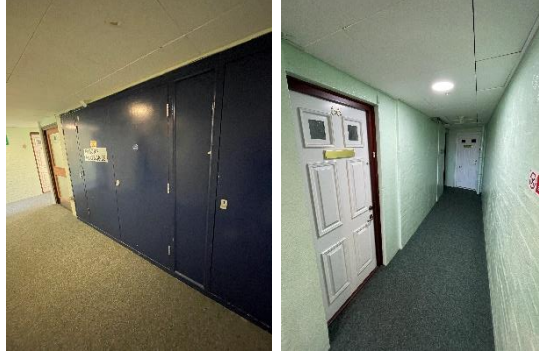
- 3) All corridors are of adequate width (at least 1050mm) and will be maintained clear to that width as a minimum. Dead end scenarios are present within the corridor along the means of escape however travel distances from the furthest flat entrances door to relative place of safety (staircase) are within 7.5m and therefore sufficient.

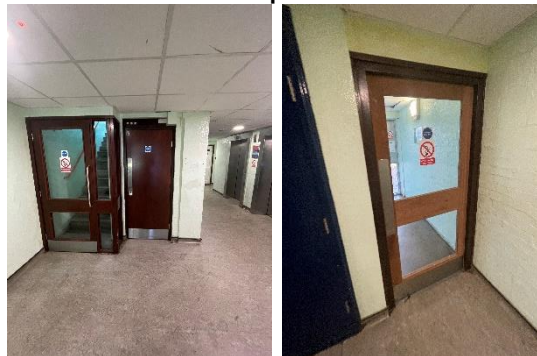
- 4) The communal landing / staircases are protected by use of self-closing 44mm notional or nominal timber 30-minute fire doors with vision panels & intumescent strips / cold smoke seals.

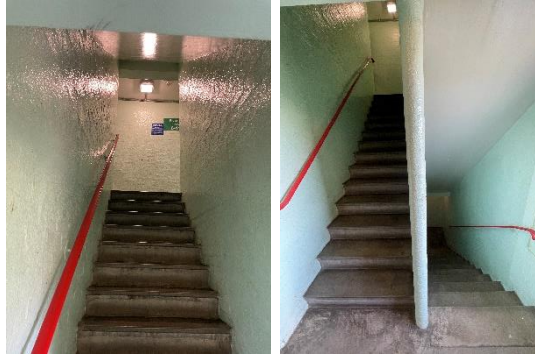
- 6) The site has 2 protected staircases that serve all floors providing adequate means of escape. Each staircase in width is 955mm from handrail to wall & 1040mm from wall to wall. Ventilation is provided via AOV systems in the stairwell.

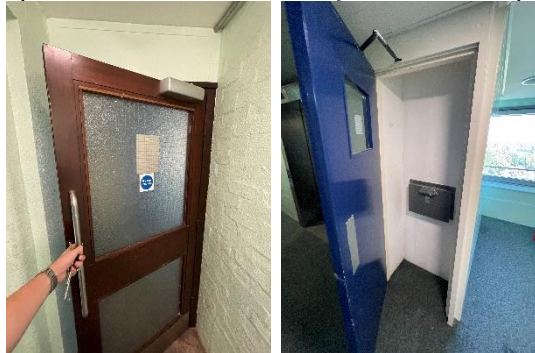
- 7) All communal doors are fitted with automatic closing devices that are checked on a regular basis by Caretaking Teams as part of their checks. Defective closing devices are replaced either by the Caretaking Team(s) or the in-house repairs team(s).

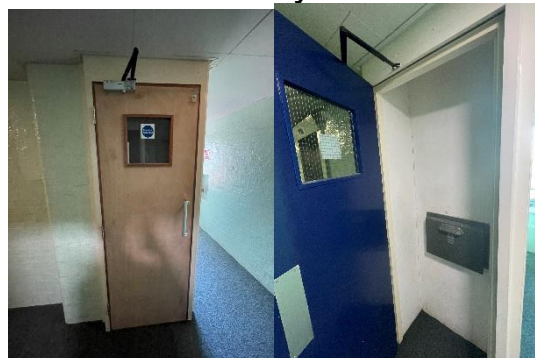
- 8) All communal fire doors are subject to a 12-week check by the Fire Safety Rapid Response Team.
- 9) The chute room doors on each floor are 44mm nominal 30-minute fire doors with combined intumescent strips & cold smoke seals and overhead self-closing devices. Chute room on ground floor can be locked however all others are always accessible.

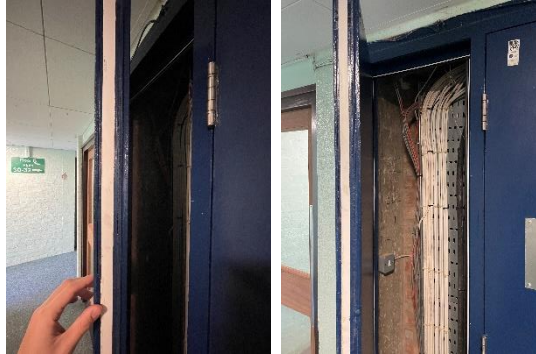
- 10) Service cupboards are 54mm notional fire doors with intumescent strips and cold smoke seals, secured with type 138 suited mortice locks to allow residents access to their electricity meters. The service cupboard to the ground floor is 54mm and lined with Superlux fire resistant board. The service cupboard to floor E is also lined with Superlux. Evidence of fire stopping taking place within service cupboards.

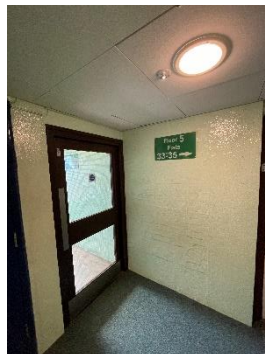
- 11) Emergency lighting is provided to communal landings and stairs. Checks are done on a monthly basis by Sandwell MBC in house electrical team or approved contractor.

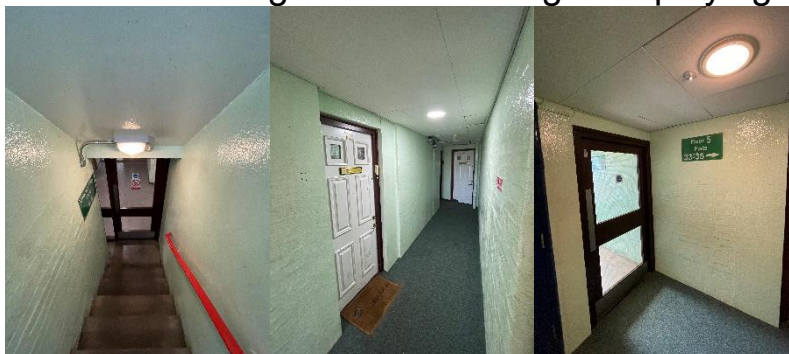
- 1) The premises has a sufficient emergency / escape lighting system in accordance with BS 5266 and has test points strategically located. Some units were flashing upon first visit however upon additional visits these lights were no longer displaying this issue.

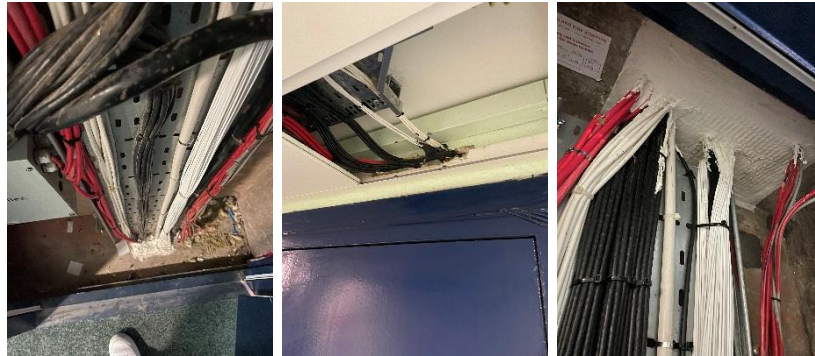
- 6) A variety of methods / materials have been used to achieve fire-stopping including Rockwool, fire rated sponge and intumescent pillows.

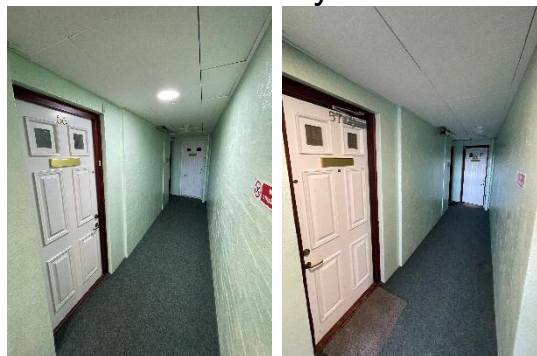
- 7) The fire stopping / compartmentation is subject to a 12-week check by the Fire Safety Rapid Response Team.
- 8) Any remedial works arising from the fire stopping / compartmentation check(s) will be actioned immediately by the Fire Safety Rapid Response Team.
- 9) Individual flat doors are a combination of certified or nominal 44mm self-closing fire doors of composite construction with intumescent strips, cold smoke seals and self-closing devices. These doors are manufactured by Permadoor or Nationwide.

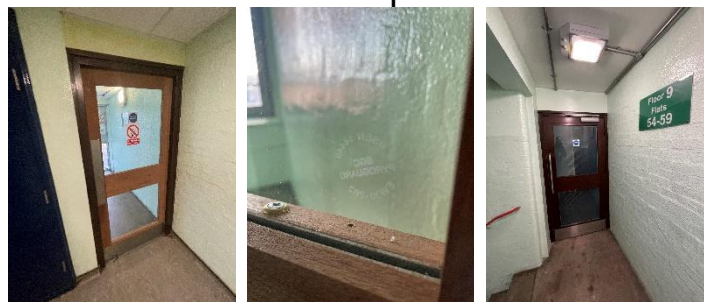
- 10) Communal fire doors within the means of escape are a mixture of notional or nominal FD30s doors with vision panels. Many doors were picked up in the previous FRA remediations have since taken place and these doors are now to an acceptable standard.

Some communal stairway doors show signs of wear and tear due to age. Consideration should be given to upgrade all doors with certified FD30s door sets as part of future programmed works.

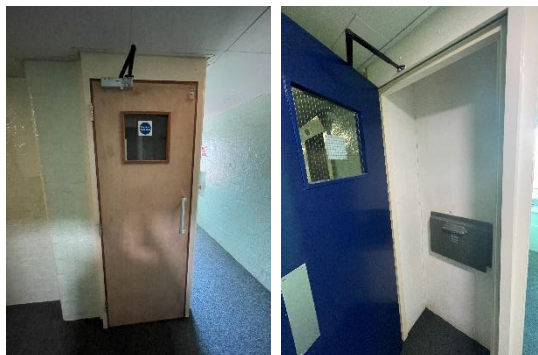
- 11) The service cupboards in this building are secured by locked notional FD60s fire doors.
- 12) The doors to chute rooms are a mixture of nominal or notional FD30s door sets

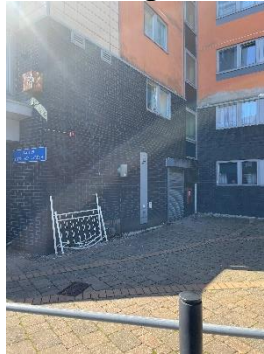
- 1) The dry riser inlet cabinet is located to the side elevation to the right-hand side of the front main entrance adjacent the bin room. The cabinet is secured with a budget lock.

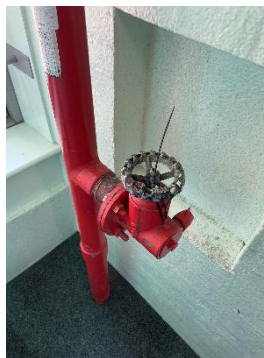
- 2) There is a dry riser that serves the building. The outlets are exposed and located on the communal lobby of each floor. Each exposed valve is secured with a cable tie. The caretakers check the cable tie is intact as part of their weekday inspections.

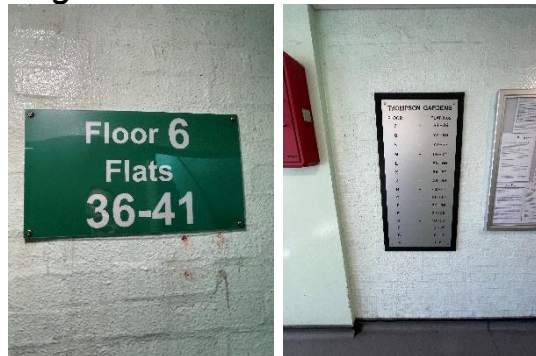
- 7) Photoluminescent wayfinding signage depicting floor level and flat numbers are fitted to the walls on all floors and to the wall of each landing on the communal staircase. Signage that meets the requirement of ADB and Fire Safety (England) Regulations 2022. the wayfinding signage is inconsistent with the elevator call buttons, smoke control vent panel, and the main sign in the main entrance lobby, which uses letters rather than numbers. this could cause confusion. Signs should read the same to keep consistency throughout the block. *This was raised on the previous FRA and is yet to be amended. Fire services are aware of the designs in the block and following the audit these were deemed acceptable.*
