Fire Risk Assessment

Thompson Gardens

**1-89, Hales Lane,
Smethwick, B67 6RX**

Date Completed: 23/09/2025.

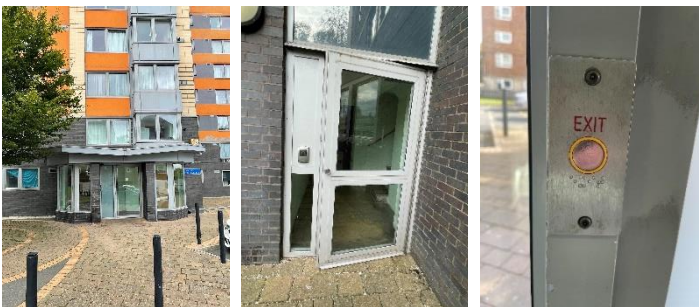
- 9) Automatic smoke ventilation is employed. This is tested, inspected, and maintained by a competent procured contractor in accordance with BS7346. The frequency for the maintenance checks are twice per year (April and October) of each calendar year.
- 10) It was noted that an AOV sensor on the fourth floor staircase landing was not working. This has been raised with Prestige Protect to carry out a repair. (Confirmation email received).
-

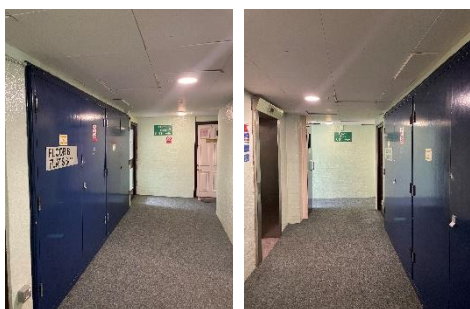
- 18) Electrical service cupboard doors are 54mm nominal fire doors with individual intumescent strips and cold smoke seals, secured with type 54 suited mortice locks.

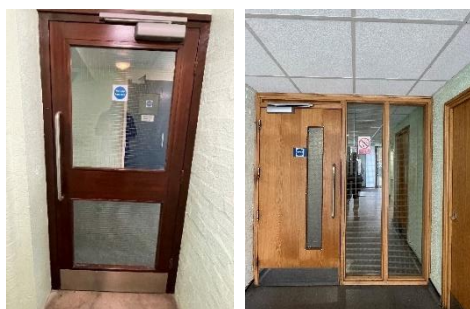
- 7) It has been recognised that all of the landing / staircase notional doors in this block have been upgraded with combined intumescent strips & cold smoke seals to enhance their original design. There were minor shortcomings that have been identified, and actions have been created for corrective works or replacement.
- 8) **Floor L (10) – Communal door to stairwell by flat 63, leaf is warped and requires replacement. This is a newly fitted door, unfortunately it is a poor fit & bounces off the door frame.**

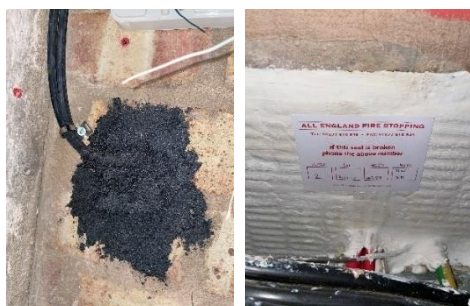
- 16) A variety of methods / materials have been used to achieve fire-stopping including Rockwool, fire rated sponge and intumescent pillows.

19) At the time of the assessment there were several electrical cupboards where fire stopping should be enhanced. These were: -

- a) M 11th Floor, remove foam and replace with appropriate fire stopping materials.
- b) K 9th Floor, electrical cupboard needs some work regarding compartmentation, there are clear voids where cable penetrations come into the cupboard.
- c) L 8th Floor, electrical cupboard needs further work regarding compartmentation.

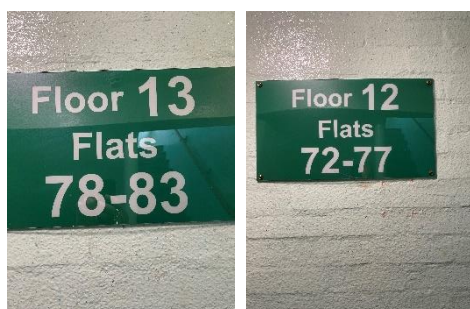
- 6) Photoluminescent wayfinding signage depicting floor level and flat numbers has been fitted to wall of each floor on the communal staircase(s).

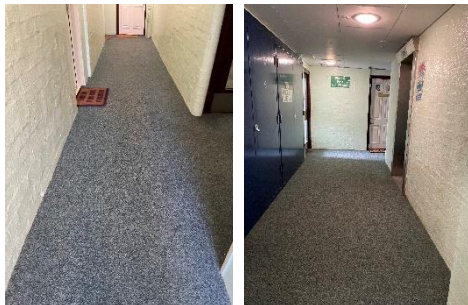
- 9) At the time of the assessment, it was noted that landing floors were fitted with carpet. It should be confirmed that carpets have been procured in accordance with BS 5287: 1988 specification for assessment and labelling of textile floor coverings and & BS 4790 Fire Test to Textile Floor Coverings.

Due to these carpets being fitted by SMBC, it's assumed that it meets the necessary standard set out above. See section 7/ 24 for further information. N.B, this has been recorded in the action plan.

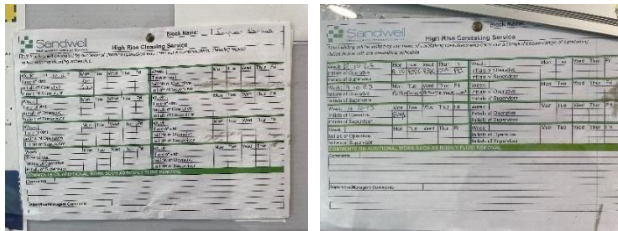
- 1) There is a regular Cleaning Service to the premises.

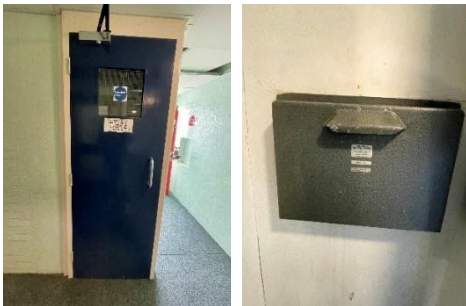
- 2) Regular checks by Caretakers minimise risk of waste accumulation.
- 3) Residents can access refuse hoppers on each floor.
