Fire Risk Assessment

St Mary's House 1-64

**Summer Street, West Bromwich,
B71 4HZ.**

Date Completed: 11/03/2026

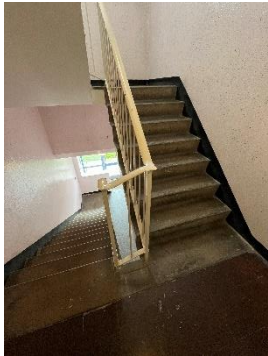
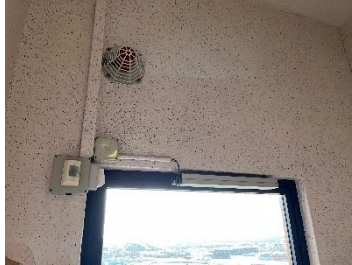
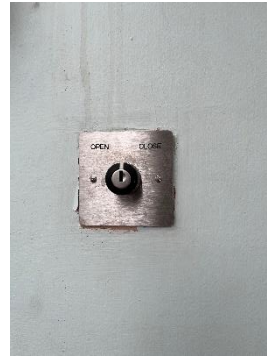
The block has a single concrete protected staircase. Automatic smoke vents (AOV) have been installed on the half landings of floors 16/15 and 8/7. The firefighter override switch is within the entrance lobby.

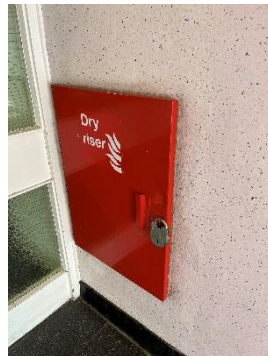
Dry riser outlets are in cupboards on all floors (except the top floor) within the flat lobbies. The dry riser inlet is in a cupboard in the ground floor lift lobby secured with a bin store padlock.

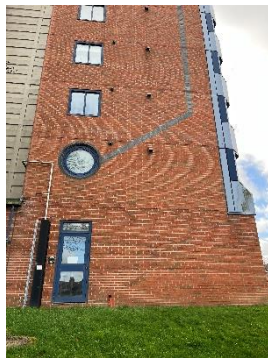
- 1) The external wall at St Mary's House has 4 separate areas of cladding. The external wall system was upgraded in 2007 and comprises of:
 - Brickwork, ground floor and side elevations. Fire classification A1.

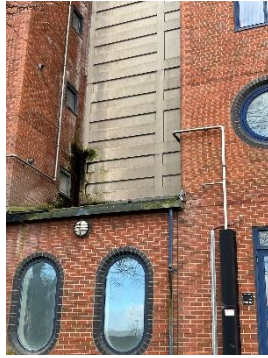
- Concrete panels, side elevations. Fire classification A1.

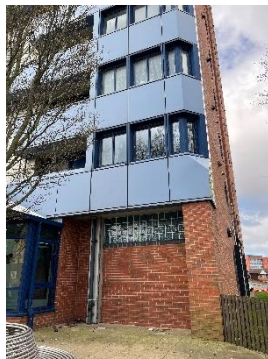
- Rain screen aluminium panels. Fire classification A1.

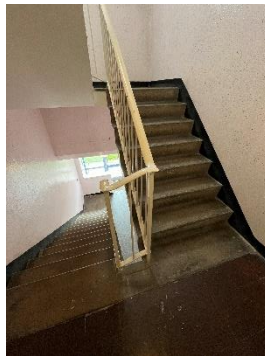
- 1) The building has a protected staircase that provides adequate means of escape.

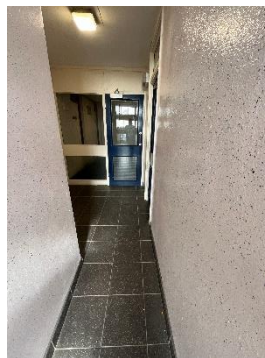
- 2) All corridors are of adequate width and will be maintained clear to that width as a minimum.

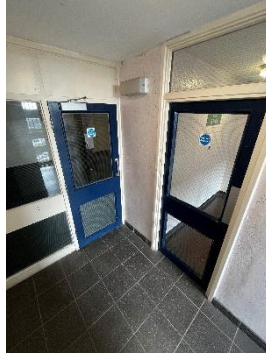
- 5) The communal landing / staircases are protected by use of notional FD30s fire doors with vision panels.

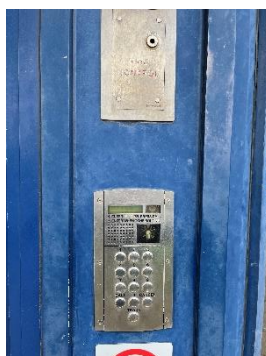
- 9) The final exit doors have door entry systems installed. These systems are designed to fail safe i.e. door unlocked in the event of a power failure. This prevents residents being locked in or out of the building.

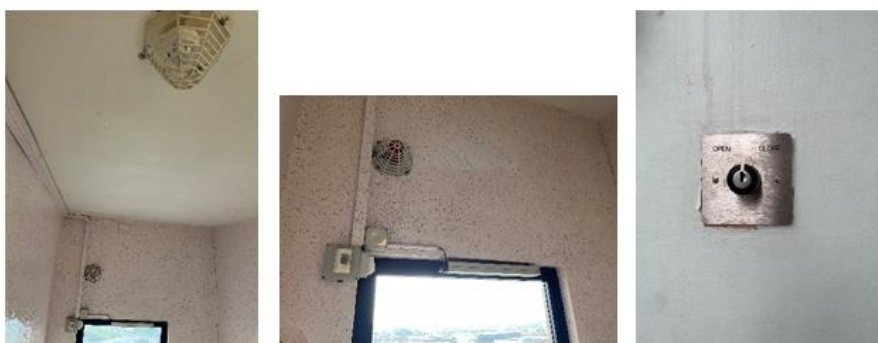
- 10) Automatic smoke vents (AOV) have been installed on the half landings of floors 7/8 and 15/16. The firefighter override switch is within the entrance lobby. This is tested, inspected, and maintained by a competent procured contractor in accordance with BS7346. The frequency for the maintenance checks is twice per year. (April and October).

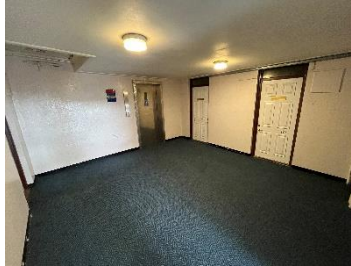
- 12) Emergency lighting is provided to communal lobbies and stairs. Checks are done monthly by Sandwell MBC in house electrical team or approved contractor.

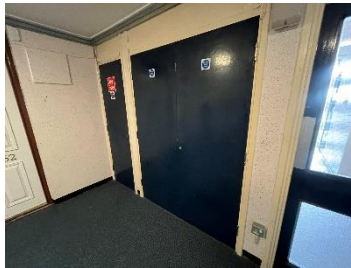
- 13) Residents' electrical meters are situated in the cupboards on all floors, protected with FD30s doors.

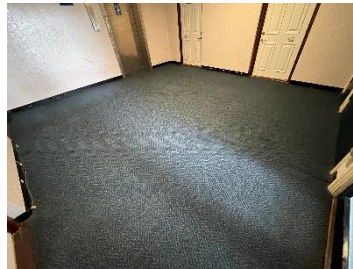
- 15) It was noted that landing floors are fitted with carpet. It is understood that carpets have been procured in accordance with BS 5287: 1988 specification for assessment and labelling of textile floor coverings and & BS 4790 Fire Test to Textile Floor Coverings. These carpets have been procured by SMBC utilising third party approved contractors. Therefore, it is understood that carpets fitted meet the approved standard.

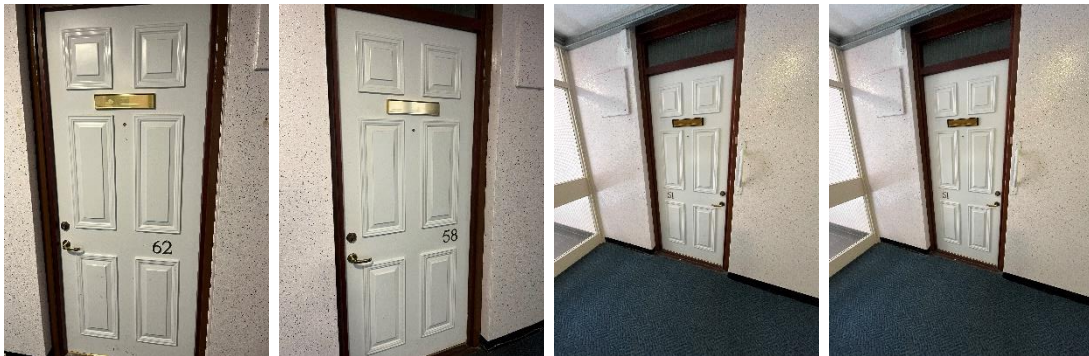
- 16) Individual flat entrance doors are predominately nominal FD30S rated composite fire doors.

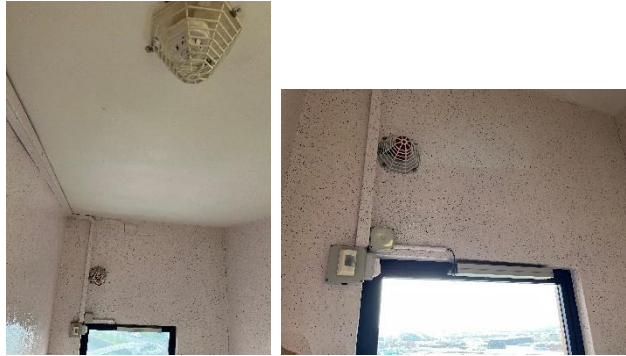
- 4) There is no means for detecting an outbreak of fire to the remaining communal areas. Automatic fire alarm systems are not usually required in the common areas of residential blocks as this can compromise the 'Stay Put' evacuation policy.
- 5) Smoke detectors linked to the automatic opening vents have been installed in the stairwell. The vents in the stairwells will automatically open when smoke has been detected.

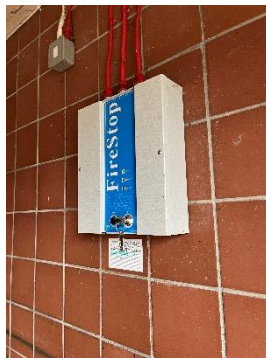
- 6) A deluge system is provided in the refuse chute bin store. Detectors for actuation and the control unit are sited within the bin store. An approved contractor maintains the system. The frequency for the maintenance checks is twice per year (April and October).

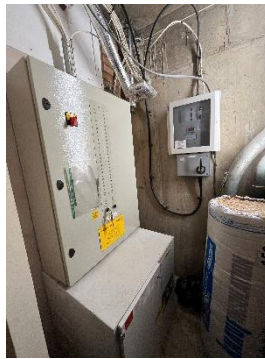
- 1) The premises has a sufficient emergency / escape lighting system in accordance with BS 5266. The emergency lighting is a central battery system. The central battery unit is situated in a cupboard in the corridor leading to the caretaker's area on the ground floor.

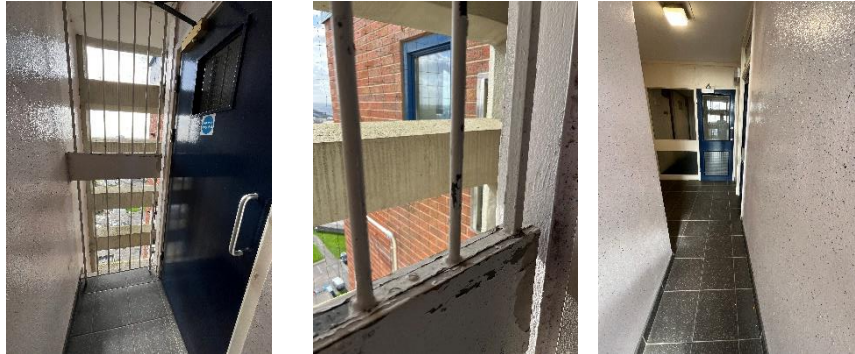
- 3) The design of the naturally ventilated shaft serving the single escape corridor presents a breach of compartmentation throughout the height of the building from the 1st floor up to the top floor. The potential therefore does exist for smoke logging on all floors within an escape route.

This situation is further affected by the proximity of flat windows to the ventilated shaft. Current measures are in place to help mitigate the risk such as the stay put policy, smoke detection within resident's flats, notional FD30s doors providing protection from the landing to the flat lobby and protected staircase.

The external wall next to shaft has a fire classification of Euro class A2 (non-combustible can be used above 18m). Previously, fire safety meetings have taken place to discuss this issue within a similar SMBC block, resulting in the opinion of the Fire Safety Manager and the Team Lead Building Safety stating the risk was low. It is the

opinion of the fire risk assessor that to reduce the risk even further, when future improvement works next take place, consideration should be given to improving fire stopping/ compartmentation at each floor level.

This could be by using fire rated door and frames to separate the open bin chute lobby from the landing/corridor area within the means of escape. See Observations.

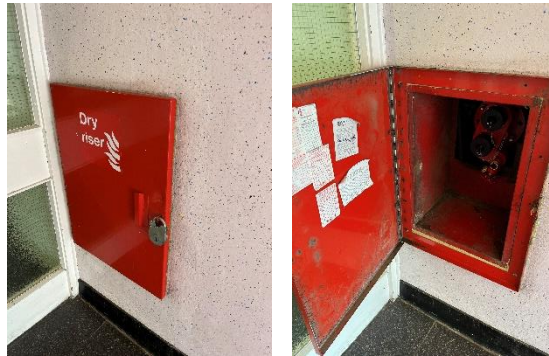
- 1) The dry riser inlet is internal, within a metal cabinet in the stairwell lobby on the ground floor.

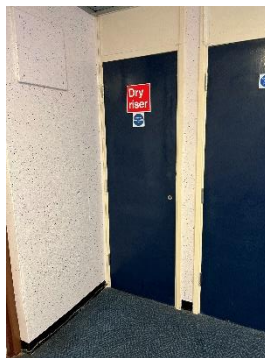
- 2) The dry riser outlets are located within cupboards on all floors above ground, secured with a type 54 suited mortice lock. The dry risers are checked regularly as part of the caretakers' duties.

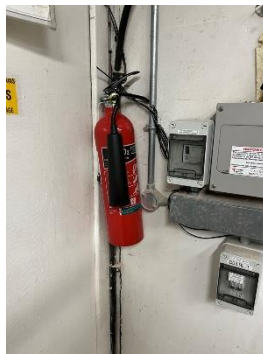
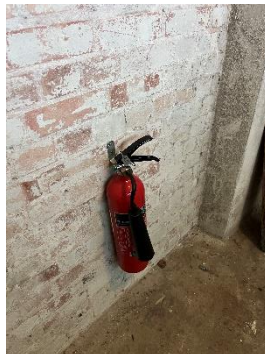
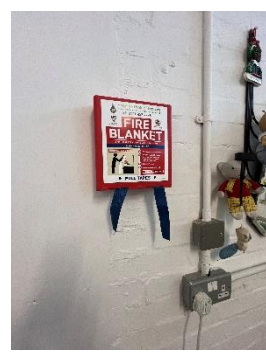
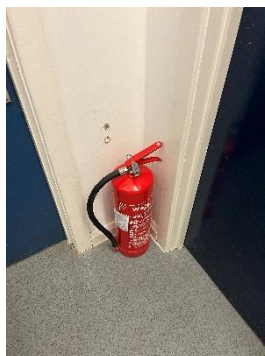
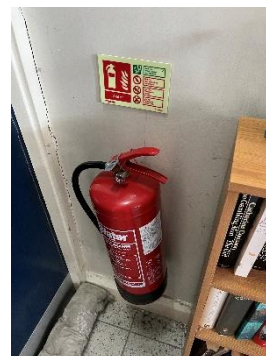
- 4) The frequency for the maintenance checks of fire extinguishers is once (October) each calendar year. The following portable fire extinguishers are provided in the block for use by suitably trained persons; There is no extinguisher information sign. A CO2 extinguisher information sign is required to be fitted. See action 11/4.

- Lift motor room; CO2
 - Pump room; CO2
 - Caretaker's room; Water and fire blanket
 - Communal Room; Water
- a. There is no extinguisher information sign for the lift room CO2 extinguisher, an information sign is required to be fitted. See action 11/4a.

- b. There is no extinguisher information sign for the pump room CO2 extinguisher, an information sign is required to be fitted. See action 11/4b.
- c. There is no extinguisher information sign or storage hook for the caretaker's water extinguisher, an information sign and storage hook is required to be fitted. See action 11/4c.

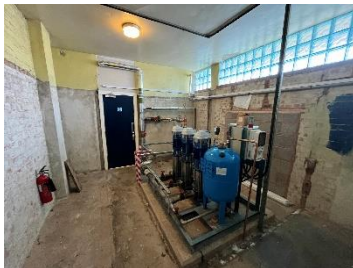
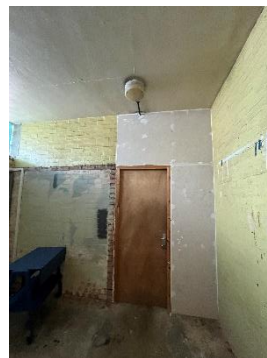
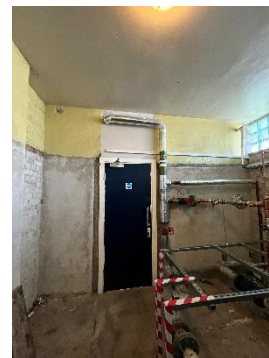
- 1) Fire doors display suitable signage where appropriate. However, there is no escape route signage from the pump room. Escape is possible in two directions, from either of the two doors. Escape signage is required to be fitted in the direction of the final fire escape on the right hand side of the building and in the direction of the caretaker's corridor. See action 12/1.

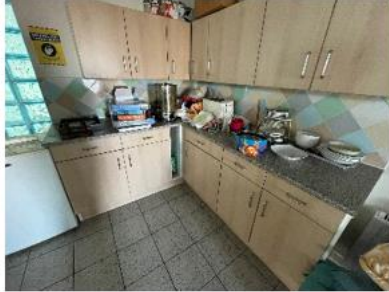
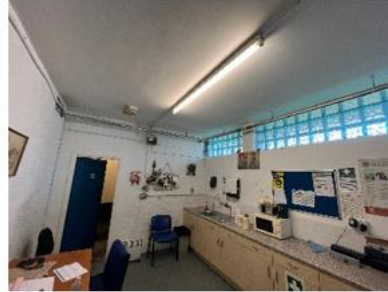
- 8) There is a small kitchenette within the communal room and another in the caretaker's room. Both kitchenettes are to be used for the reheating and cold preparation of food only.

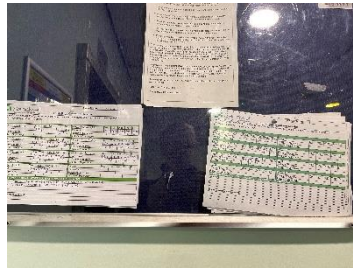
- 1) There is a regular cleaning service to the premises.

- 2) Refuse & recycling containers are emptied regularly. Refuse containers are in the bin store which is at the rear of the block. Recycling containers are kept away from the block.
 - 3) Regular checks by Caretakers minimise risk of waste accumulation.
 - 4) 'Out of Hours' service in place to remove bulk items.
-

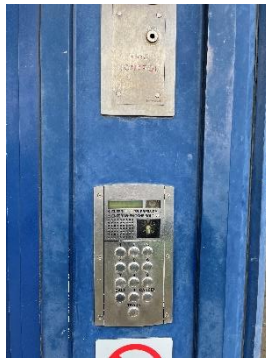
- 1) Regular checks are undertaken by Caretakers / Cleaning Team(s) 365 days per year which helps reduce the risk of arson.
- 2) Restricted access to the premises by means of a door entry system.

- 3) There is no current evidence of arson
 - 4) There have been no reported fire incidents since the previous FRA in March 2025.
-

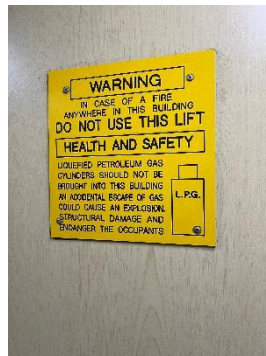
- 1) Residents are instructed not to bring L.P.G cylinders into the block.

- 2) The tenancy conditions, Section 7 – Condition 5.6 stipulates “If you live in a flat or maisonette, you, people living with you and any visitors to your property must not keep or use paraffin oil, petrol, bottled gas appliances or any other explosive, FLAMMABLE, or dangerous material in the property. This restriction also applies to any storage facility situated in or attached to the block, which has been provided for your use.”
- 3) No Flammable liquids are stored on site by Caretakers / cleaners.
- 4) There are no flammable liquids or gas cylinders stored on site.

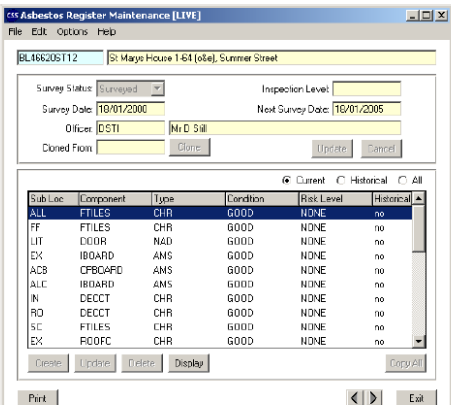
<p>Notes</p> <p>LIFT MOTOR ROOM HAS BEEN EXTERNALLY CLAD WITH BROWN PVC SHIPLAP. PREVIOUS SURVEY RECORDED ASBESTOS INSULATION BOARD IN THIS LOCATION – UNABLE TO ASCERTAIN IF THIS AIB IS STILL IN-SITU. ASBESTOS INSULATION BOARD IS STILL PRESENT TO INTERNAL WALL AROUND DOOR. EXTERNAL IS CLAD IN UPVC.</p> <p>REVISED BY G.CARRINGTON – 15/02/19</p> <p>MATERIAL SAMPLE REQUEST BY A.THOMPSON TO TOP FLOOR CEILING DUCT PANEL BENEATH METAL TRUNKING</p> <p>REVISED BY A.HACKWOOD – 22/01/2020</p> <p>**Survey revised 24/08/23 by John Davis following request by Andrew Kozlowski (KTL)**</p>
