Fire Risk Assessment

Heronville House

**Sedgley Rd East,
Tipton, DY4 7TX**

Date Completed: 13/12/2022

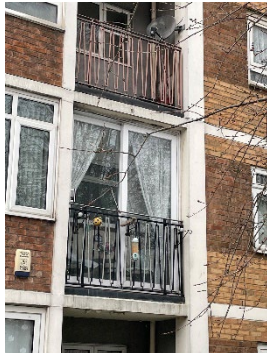
B. Flat 76 (2nd floor) has enclosed balcony with UPVC patio doors.

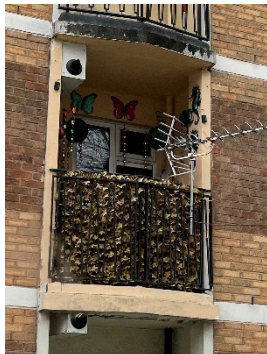
C. Flat 74 (2nd floor) has decorative screening to balcony which could potentially support the surface spread of fire.

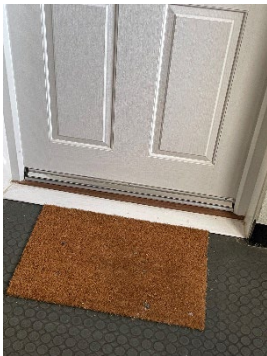
18) The fire rating of individual door mats outside flat entrance doors is unknown.

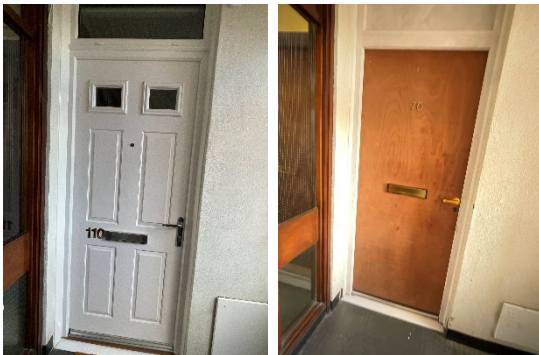
20) Individual flat doors are FD30s rated composite doors sets manufactured by IG Doors. Flat 70 has a timber flush FD30s rated entrance door.

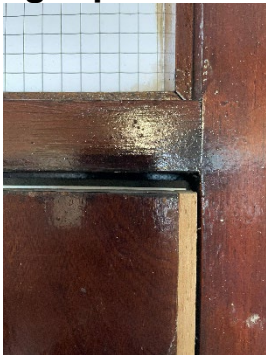
24) 5th floor by flat 118 - communal door has excessive gaps and light pass's through rebate.

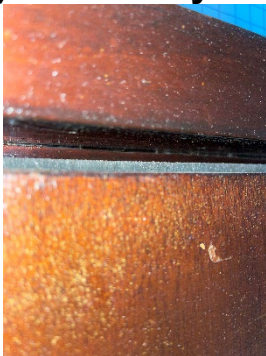
25) 5th floor by flat 110 - communal door has excessive gaps.

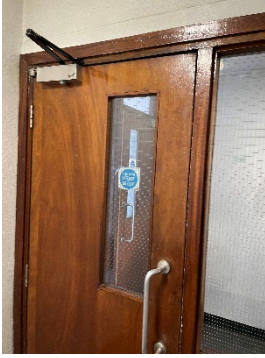
26) 5th floor communal door to stairs has excessive gap to head.

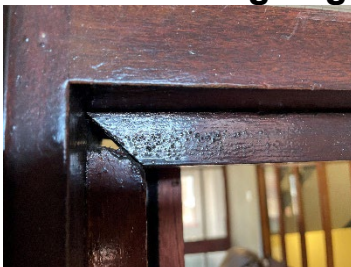
- 32) 3rd floor by flat 90 – communal door excessive gap / gap in rebate by self-closing device. Door is also slightly bowed bottom leading edge.

P2	Within 1 to 3 months of action plan date. Fire Rapid Response. JM:10622380	19/04/2023
07/32	3 rd floor by flat 90 - communal door has excessive gaps / door warped / gap in rebate. Adjustment / repair or possible replacement required.

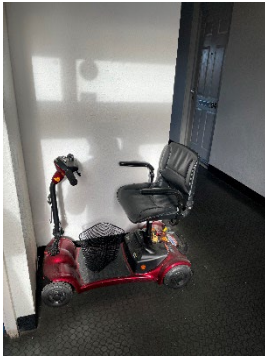
- 33) 3rd floor by flats 90, 92 & 94 – mobility scooter parked in communal lobby. 27/02/23 As a temporary solution the owner of the mobility scooter has agreed to reduce the risk by removing the battery to store within their flat whilst awaiting a permanent solution to be identified. This is a temporary measure only, if a permanent solution cannot be identified then the mobility scooter will have to be relocated from the communal lobby. A further meeting to be arranged by the housing officer.

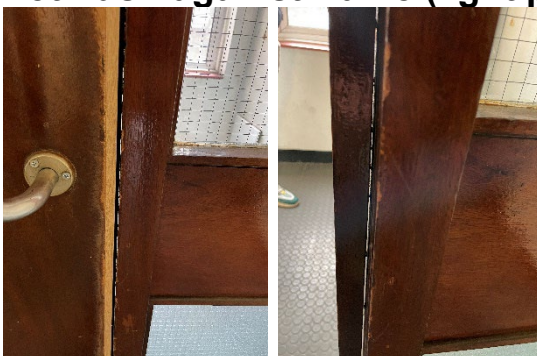
39) 1st floor by flat 78 – communal door excessive gap / rebate not flush against frame (light passes through)

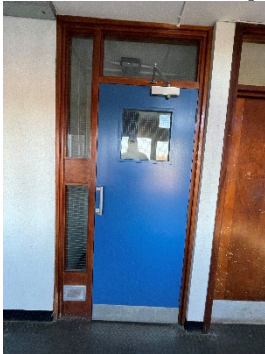
- 2) The doors to the chute rooms are FD30s and do not display “fire door keep shut” signage.

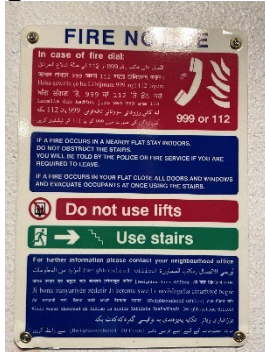
- 3) Fire Action Notices are displayed throughout the building; however these are currently under review to align with S.M.B.C current guidance of “stay put unless”

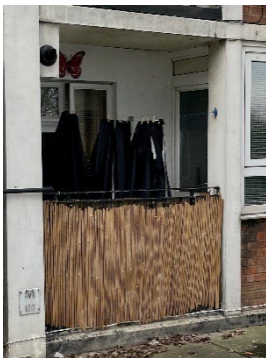
06/03a	Flat 62 – remove installed wicker screening from balcony.

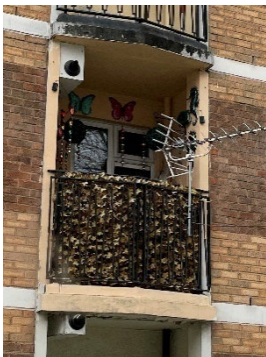
P2	Within 1 to 3 months of action plan date. Housing Manager	
06/03c	Flat 74 – remove installed decorative screening to balcony.

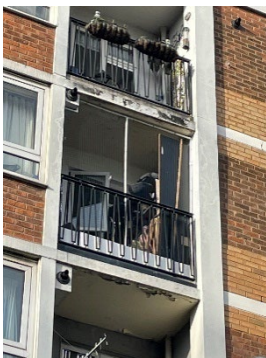
P2	Within 1 to 3 months of action plan date. Housing Manager	15/05/2023
06/03d	Flat 106 – remove installed netting/mesh & excessive combustible items on balcony.

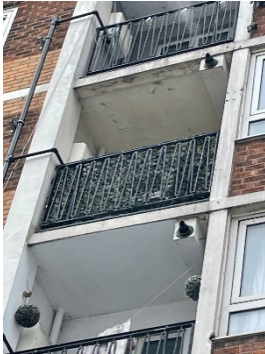
06/03e	Flat 102 – remove installed decorative screening to balcony.

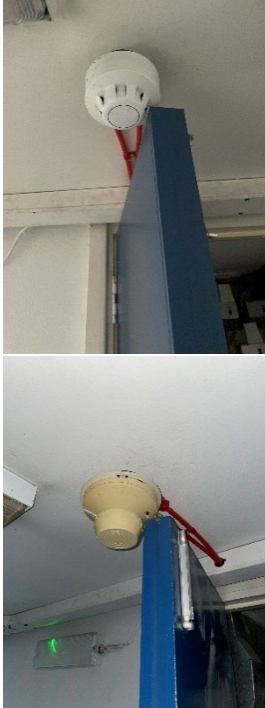
Section 7	<p>Means of Escape from Fire</p> <p>The block has a single staircase that provides a sufficient means of escape with 2 final exit doors at ground level.</p> <p>Service cupboard door to the 4th and 5th floor fouls on a detector head for the AOV. <i>(Resolved 02/01/23)</i></p> <p>Flat 74 entrance door requires adjustment as door doesn't reliably self-close fully into frame.</p> <p>Some communal doors have excessive gaps / require adjustment or repair.</p> <p>Exterior handle detached from roof access door.</p> <p>Mobility scooter stored in 3rd floor communal area. <i>27/02/23 Battery now stored within flat as a temporary solution.</i></p> <p>Artificial plants displayed in 1st floor lobby area.</p> <p>Intumescent strip to be replaced (loose) in 5th floor service cupboard.</p>	<p>Trivial</p>
Section 8	<p>Fire Detection and Alarm Systems</p> <p>Smoke detection within the block has been installed to the communal corridors and is linked to the automatic opening smoke ventilation system.</p> <p>Smoke / Fire detection to individual flats is to LD2 standard.</p>	<p>Trivial</p>

P2	Within 1 to 3 months of action plan date. Housing Manager	08/03/2023
07/10	4 th & 5 th floor by service cupboard, relocate detector heads to AOV to prevent fouling by service cupboard door.

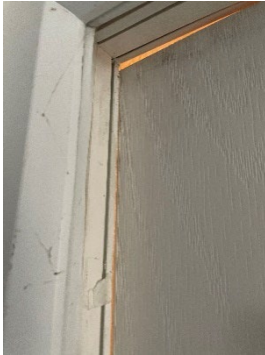
07/21	Flat 74 – entrance door requires adjustment doesn't reliable self-close into frame. Door binds on frame.

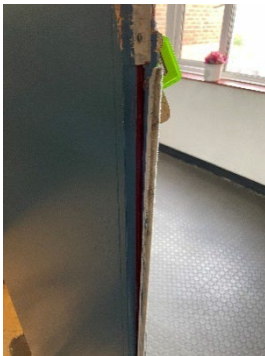
- 22) 5th floor service cupboard by flat 112 – Combined intumescent strip / cold smoke seal is loose and requires fixing within R/H door.**

P2	Within 1 to 3 months of action plan date. Fire Rapid Response. JM:10081185	12/01/2023
07/22	5 th floor by flat 112 – combined intumescent strip / cold smoke seal requires fixing to door / hangs loose.

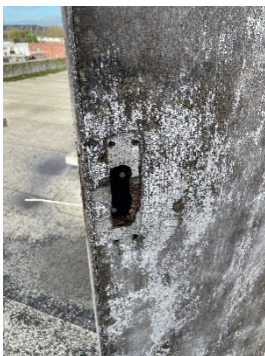
P2	Within 1 to 3 months of action plan date. Fire Rapid Response. JM:10081245	11/01/2022
07/23	Reinstate external handle to roof access door.

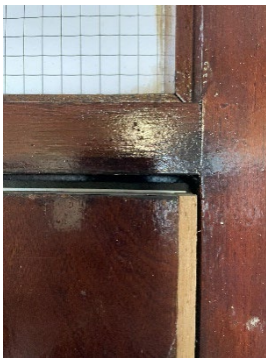
07/24	5 th floor by flat 118 – communal door has excessive gaps, adjustment or possible re-lipping required.

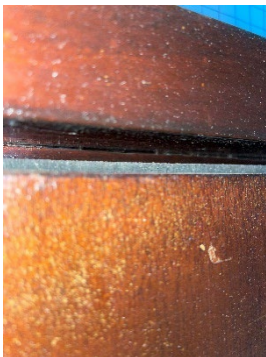
P2	Within 1 to 3 months of action plan date. Fire Rapid Response. JM:10123331 JM:10622083	18/04/2023
07/25	5 th floor by flat 110 – communal door has excessive gaps adjustment or possible re-lipping required.

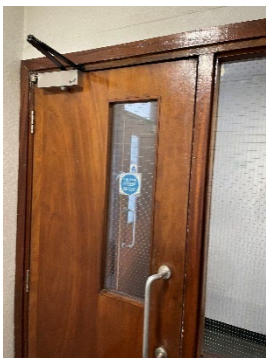
P2	Within 1 to 3 months of action plan date. Fire Rapid Response. JM:10622111	18/04/2023
07/26	5 th floor communal door to stairs excessive gap to head, adjustment or possible re-lipping required.

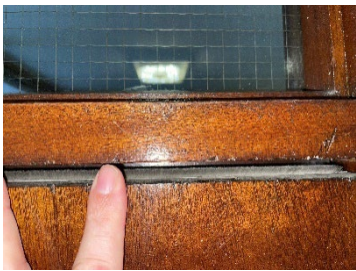
07/27	4 th floor communal door to stairs has excessive gaps adjustment or possible re-lipping required.

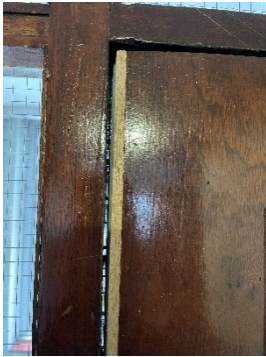
28) 4th floor by flat 100 - communal door has excessive gaps and screws missing from each hinge.

P2	Within 1 to 3 months of action plan date. Fire Rapid Response. JM:10622271	19/04/2023
07/28	4 th floor by flat 100 – communal door has excessive gaps adjustment or possible re-lipping required. Also replace missing screws to hinges.

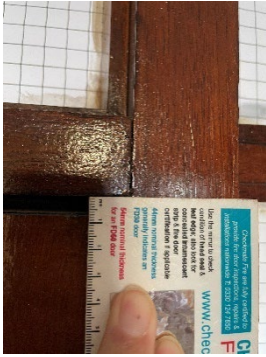
P2	Within 1 to 3 months of action plan date. Fire Rapid Response. JM:10622295	19/04/2023
07/29	4 th floor by flat 108 - communal door has excessive gaps adjustment or possible re-lipping required

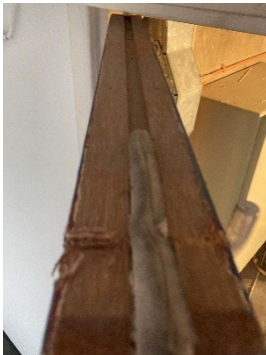
- 30) 4th floor by flat 104 – combined intumescent strip / cold smoke seal part missing from head on service cupboard head.

07/30	4 th floor by flat 104 – service cupboard door replace missing intumescent / cold smoke strip on head of door.

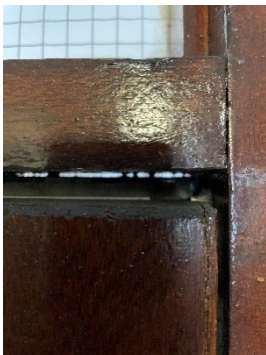
P2	Within 1 to 3 months of action plan date. Fire Rapid Response. JM:10081351	12/01/2023
07/31	3 rd floor by flat 98 – communal door has excessive gaps adjustment or possible re-lipping required

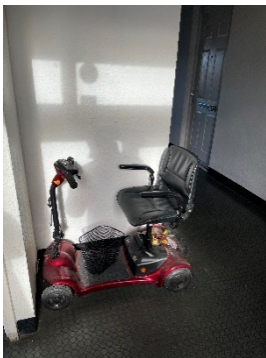
07/33	Mobility scooter in 3 rd floor communal corridor adjacent flats 90, 92 & 94 to be removed.

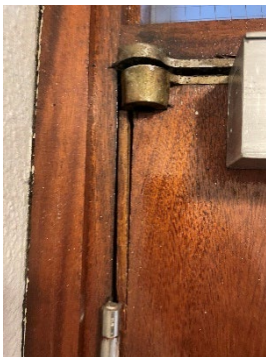
- 34) 2nd floor communal door to stairs has excessive gaps, also noted was a split within the timber.**

P2	Within 1 to 3 months of action plan date. Housing Manager	14/03/2023
07/34	2 nd floor communal door to stairs has excessive gaps and split above hinge, Adjustment / repair or possible replacement required

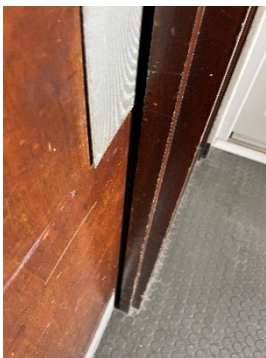
P2	Within 1 to 3 months of action plan date. Fire Rapid Response. JM:10081405 JM:10622425	12/01/2023
07/35	2 nd floor by flat 80 – communal door doesn't fully close into frame. Door requires adjustment / repair or replacement.

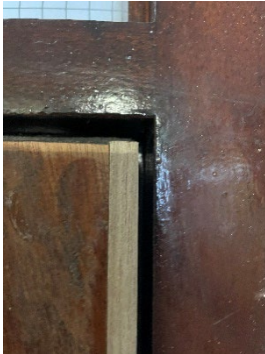
07/36	2 nd floor by flat 88 – communal door has excessive gaps adjustment or possible re-lipping required.

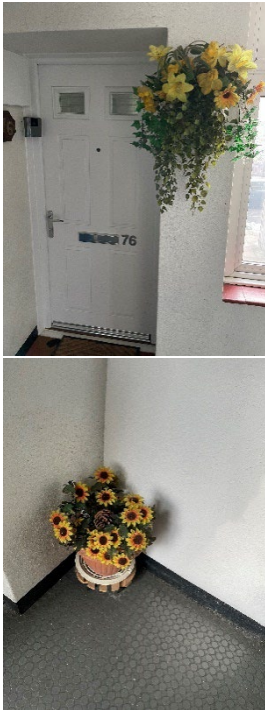
P2	Within 1 to 3 months of action plan date. Fire Rapid Response. JM:10622467	19/04/2023
07/37	All artificial plants to be removed from communal corridor outside flat 76

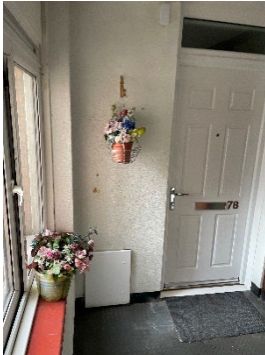
07/38	All artificial plants to be removed from communal corridor outside flat 78

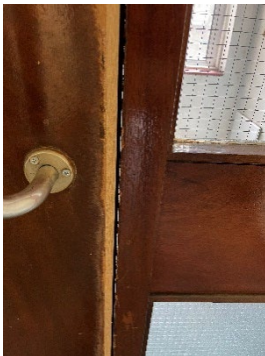
P2	Within 1 to 3 months of action plan date. Housing Manager	23/02/2023
07/39	1 st floor by flat 78 – communal door has excessive gaps adjustment required.

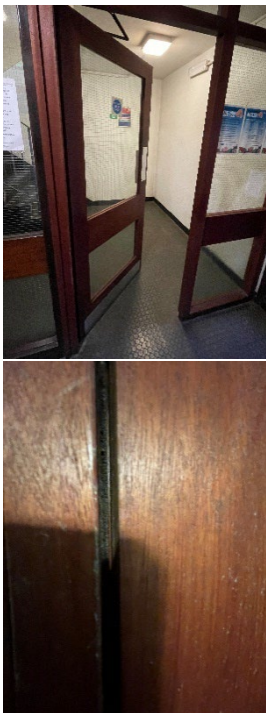
07/40	Ground floor communal door to stairs has excessive gaps and binds on floor. Adjustment or repair required

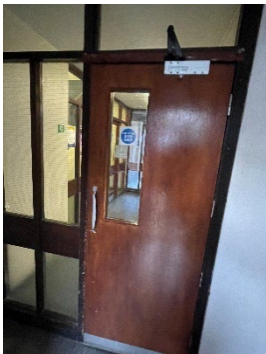
P2	Within 1 to 3 months of action plan date. Fire Rapid Response. JM:10081456	12/01/2023
07/41	Ground floor by flat 68 – communal door binds on leading edge / doesn't fully close into frame / adjustment required. Replace missing screw to hinge.

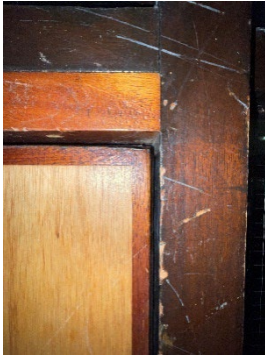
07/42	Ground floor by flat 60 – communal door has excessive gaps adjustment required.

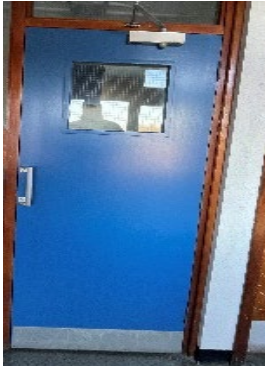
P2	Within 1 to 3 months of action plan date. Fire Rapid Response. JM:10081473	12/01/2023
12/02	Place fire door keep shut signage to chute room doors on floors 1 to 5 at approximately 1.5 metre high.
