Fire Risk Assessment

Heronville House

**Sedgley Rd East,
Tipton, DY4 7TX**

Date Completed: 23/06/2025

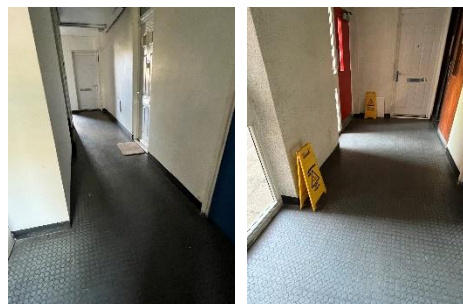
- 2) All corridors are of adequate width (at least 1050mm) and will be maintained clear to that width as a minimum.
- 3) Within the means of escape there is a single corridor that forms a dead end and is located on the ground floor. However, the corridor is protected with fire resisting construction, has natural ventilation via a louvre vent, is a place of relative safety and leads to a final exit door. The maximum travel distance along the corridor is approximately 12 metres (from flat 62 to the final exit) as per the guidance at the time 1962 - 71.

All doors within the corridor are notional FD30s with the flat entrance doors being FD30s rated composite door sets. Flats 66, 64 and 62 all have balconies that could be used as an alternative means of escape, flat 68 is immediately adjacent the final exit door (1m) and flat 60 is behind a notional FD30s communal fire door in proximity (1m) to a final exit door.

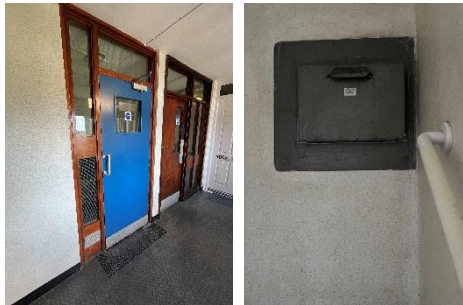
- 12) There is a hopper/chute for waste disposal on each floor. Each hopper has intumescent strips. The hoppers on the 1st to 5th floors are additionally protected by a notional FD30s door.

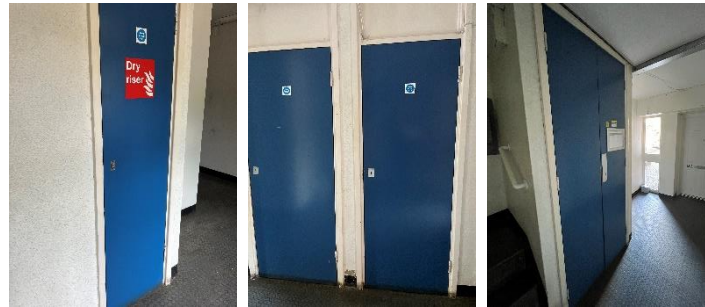
- 6) **Service cupboards consist of notional FD30s timber doors and are secured with suited cylinder locks. A key is stored within the Firefighters white box. Residents have been provided with a key for those service cupboards with double doors for access to their electricity meters. The ground floor main electrical service cupboard has an excessive gap between the door leaves and damage around the lock, requiring repair. See Action 10/06.**

P3	Fire Rapid Response 3 – 6 months.	
10/06	The ground floor main electrical service cupboard has an excessive gap between the door leaves and damage around the lock, requiring repair.

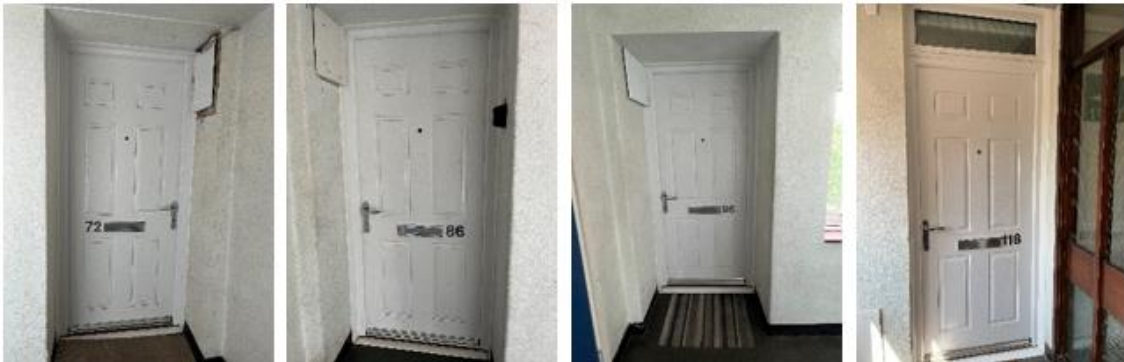
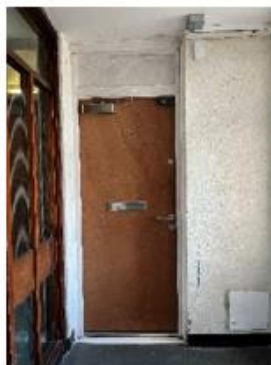
- 8) Individual flat doors are FD30s rated composite doors sets manufactured by IG Doors. Except Flat 70 which appears to be a nominal FD30s timber door.
