# Fire Risk Assessment

## Paget House

**Sedgley Rd East,  
Tipton, DY4 7TU**

**Date Completed: 06/01/23**

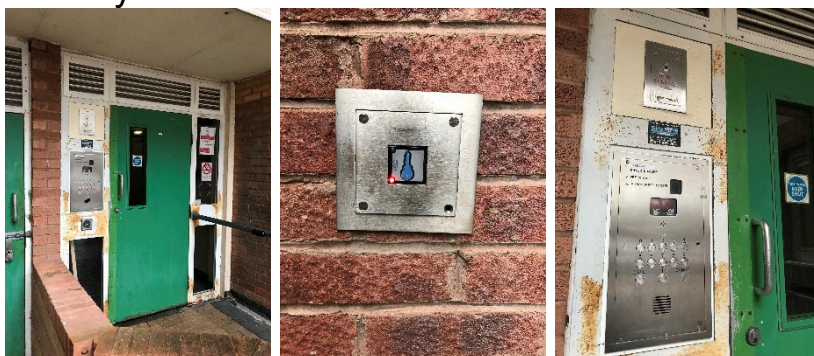
The block has a main entrance to the front elevation and an exit to the rear. Both entrances have a door entry system with fob reader access. The front entrance also has a firefighter override facility by use of a drop latch key.

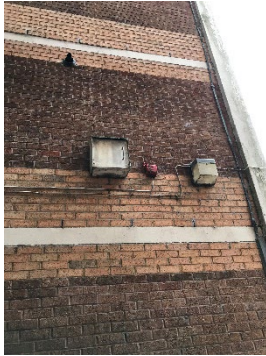
The fire fighters white box is located to the right-hand side of the front main entrance.

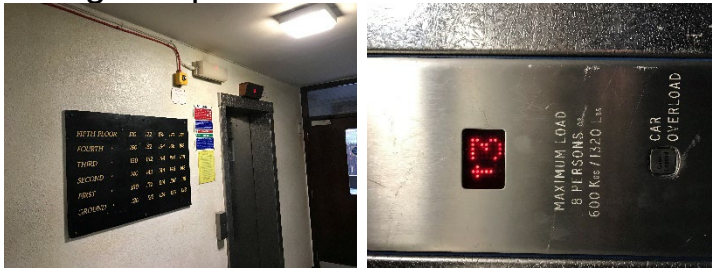
There is a single lift that serves all floors with a maximum capacity of 600kg or 8 persons.

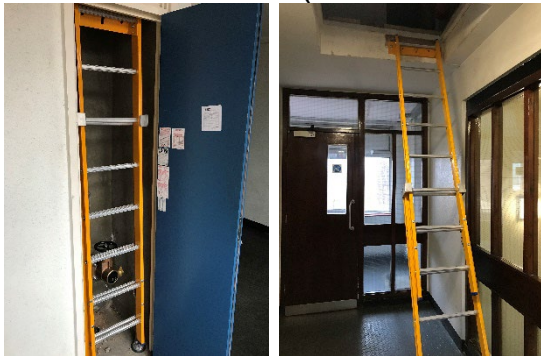
The lift motor room is located on the roof; access is obtained via an aluminium ladder (stored in the 5th floor dry riser cupboard)

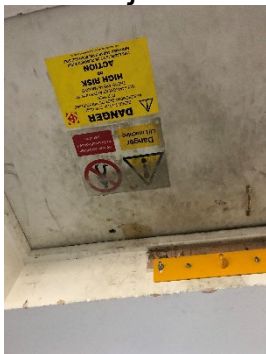
This allows access into the motor room through a trap door on the 5<sup>th</sup> floor adjacent the lift car.

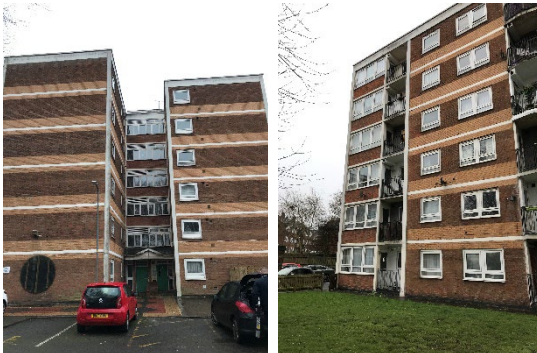
- 1) Ground to 5<sup>th</sup> floor on all facias is traditional brick.

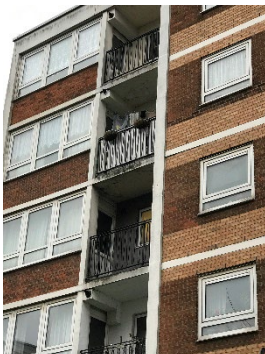
- 2) All windows are UPVC double glazed units.

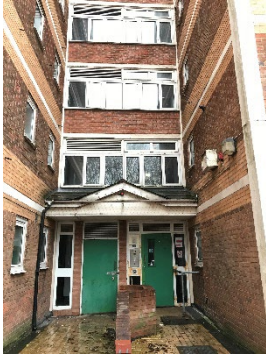
- 3) Bin room is located near the main front entrance door

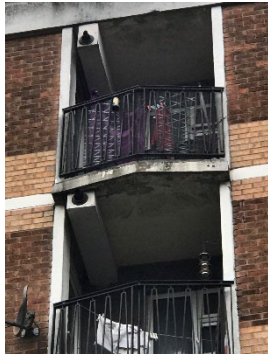
**f) Mesh and timber trellis attached to the 5<sup>th</sup> floor balcony of flat 174**

*Resolved 23/02/23*

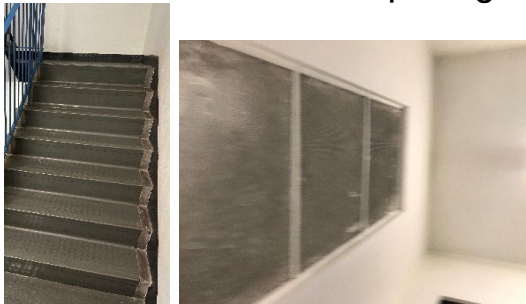
- 1) The site has a single staircase that provides a means of escape and is 1000mm in width. Each floor has signage within the communal staircase depicting what floor you are on.

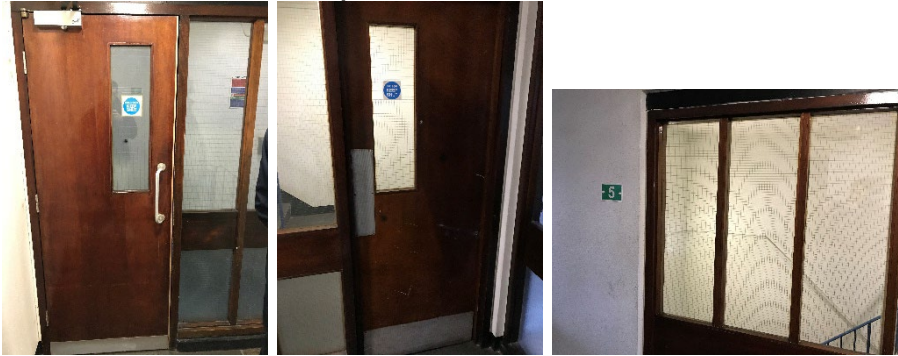
- 5) The communal landing / staircases are protected by use of FD30s fire doors with vision panels.

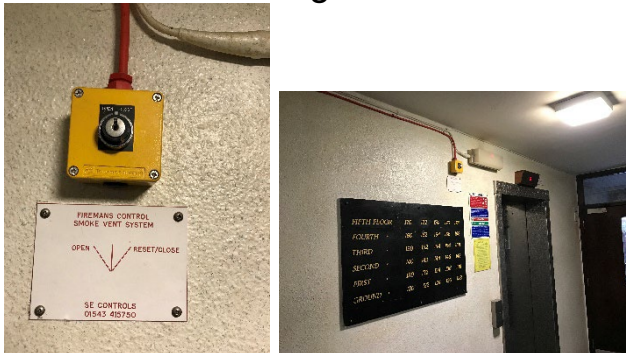
- 9) A Firefighter control switch is located within the ground floor lobby. The key for the control switch is outside within the Firefighter's White Box to the righthand side of the main entrance.

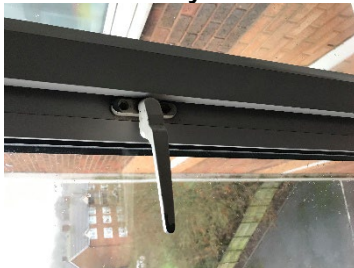
- 10) In addition to the windows controlled by the automatic smoke ventilation system, communal windows can be opened without the use of a key.

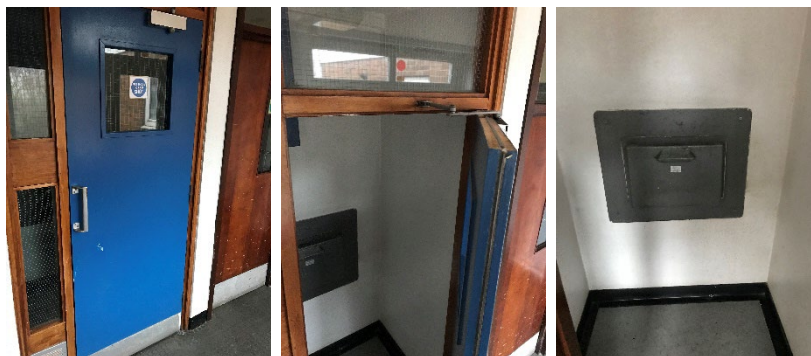
- 11) The chute room on each floor from the 1<sup>st</sup> to 5<sup>th</sup> is protected by an FD30s door.

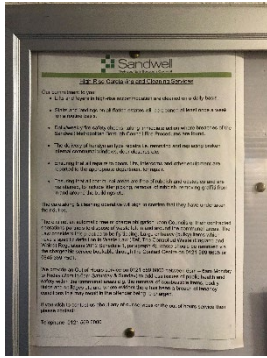
- 12) Communal areas are kept free of flammable items. The communal areas are checked on a regular basis by Caretaking / Cleaning teams 365 days per year and all items of rubbish are immediately removed. There is also an out of hour's service that allows combustible items of furniture / rubbish to be removed.
-

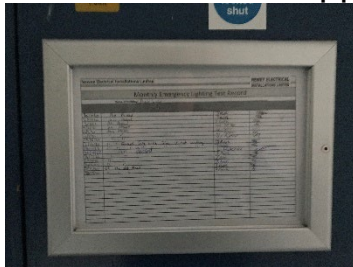
- 13)** Emergency lighting is provided to communal landings and stairs. Checks are done on a monthly basis by Sandwell MBC in house electrical team or approved contractor.

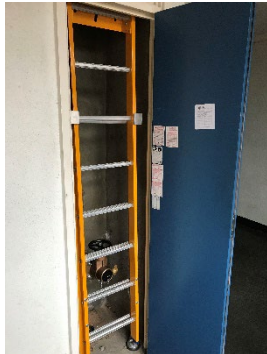
- 14)** Dry riser cupboard doors are FD30s rated, kept locked / secured with type 54 suited mortice lock(s). The 5<sup>th</sup> floor cupboard also houses an aluminium ladder which is utilised for access to the lift motor room and roof via the access hatch on the 5th floor lobby.

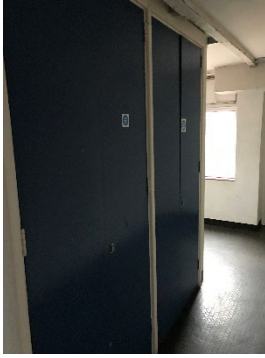
- 15)** Service cupboards are FD30s rated and secured with suited cylinder locks. A key is stored within the Firefighters white box. Also, residents have been provided with a key for access to their electricity meters

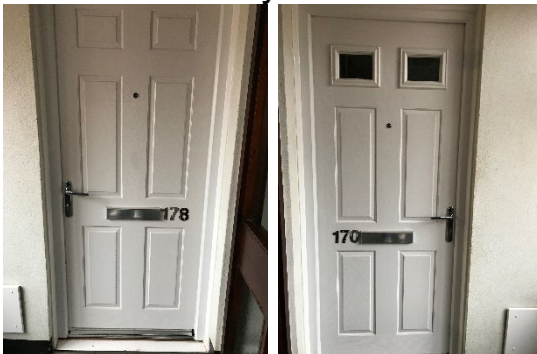
**19)** Individual flat doors are FD30s rated composite doors sets manufactured by IG Doors

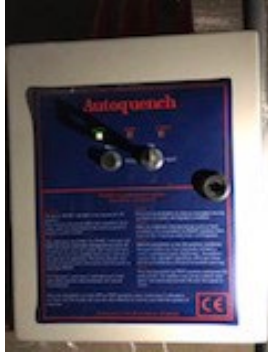
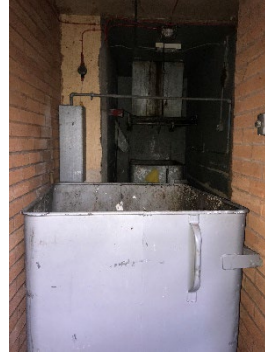
- 4) A sprinkler system is provided to the refuse chute bin store. An approved contractor maintains the system. The frequency for the maintenance checks are twice per year (April and October) of each calendar year. The control panel is located in the ground floor service cupboard.

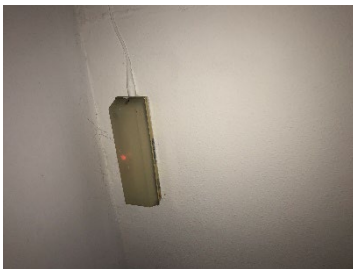
- 1) The premises have a sufficient emergency / escape lighting system in accordance with BS 5266 and has test points strategically located.
- 2) The self-contained units are provided to the communal landings, stairs and lift motor room.

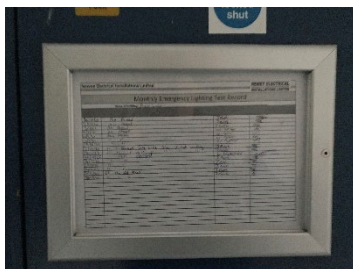
- 3) All installed equipment is checked and tested on a monthly basis by Sandwell MBC in house electrical team or approved contractor, in accordance with current standards.

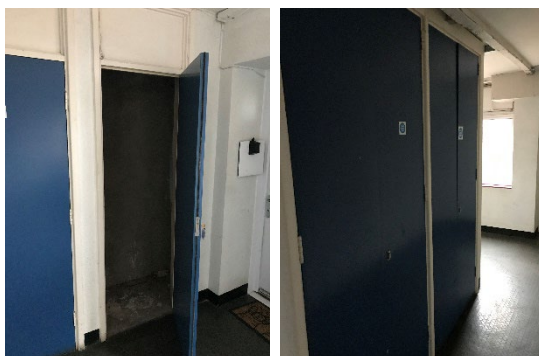
- 4) All service cupboards and storage cupboards to communal landings are lockable. Keys are held centrally unless containing resident's meters.

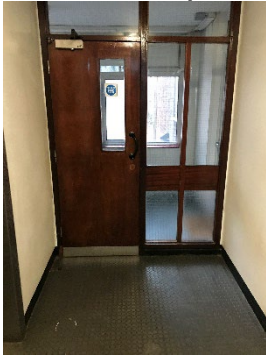
- 7) The corridors / staircases are protected by use of FD30s fire doors with vision panels.

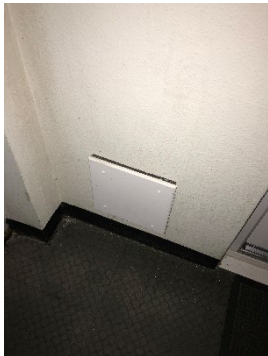
- 8) Access panels to stop taps are fixed to masonry and bedded on Intumescent material.

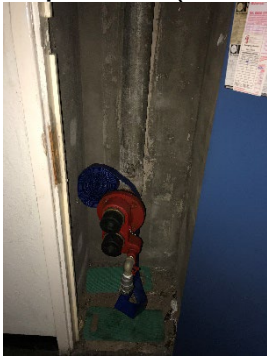
- 1) The dry riser inlet cabinet is located in the ground floor dry riser cupboard (twin valve) secured with a suited cylinder lock.

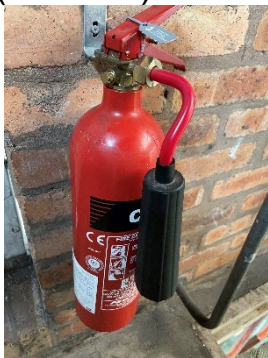
- 2) The outlets are contained within the dry riser cupboard on floors 1 – 5 that is secured with suited cylinder lock.
- 3) The dry riser is checked regularly as part of the Caretakers duties.
- 4) Maintenance contracts in place to service the valves twice per year (April and October) with a hydraulic test undertaken annually (October) to comply with the requirements of BS9990.
- 5) Portable fire extinguisher (CO2) is provided to the lift motor room. Maintenance contracts in place for maintenance of the extinguisher. The frequency for the maintenance checks are once (October) of each calendar year.

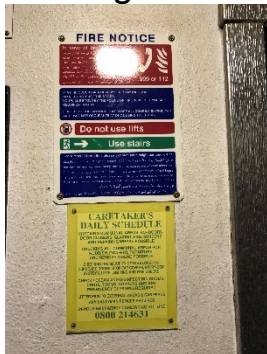
- 2) Fire Action Notices are displayed throughout the building; however, these are currently under review to align with S.M.B.C current guidance of “stay put unless”

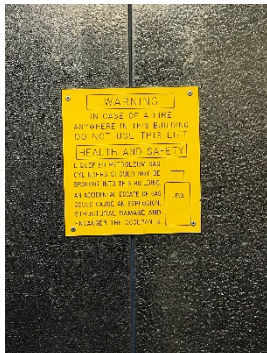
- 3) Yellow LPG warning signs are displayed within the lift cars.

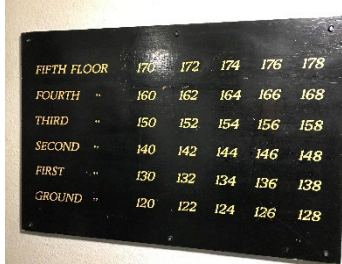
- 4) Signage depicting the floor location of each flat is fitted to the ground floor lobby wall.

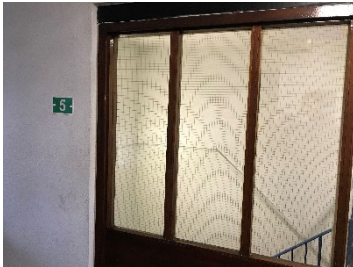
- 5) Signage depicting floor level is fitted to the wall opposite the lift car on each floor.

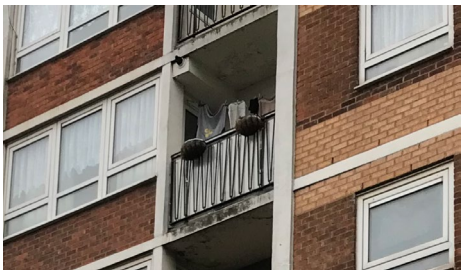
06/04e	Remove plastic screen attached to 4 <sup>th</sup> floor balcony flat 166

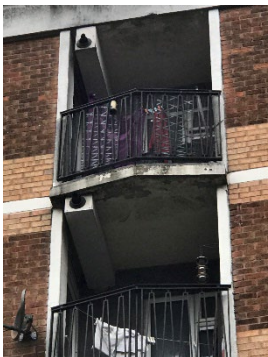
P2	1-3 months Housing Manager	23/02/2023
06/04f	Remove mesh and timber trellis attached to the 5 <sup>th</sup> floor balcony flat 174

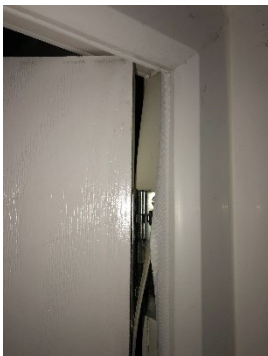
P2	1-3 months Housing Manager	23/02/2023
07/20b	Repair damage to door seal and ensure door closes correctly into frame flat 136

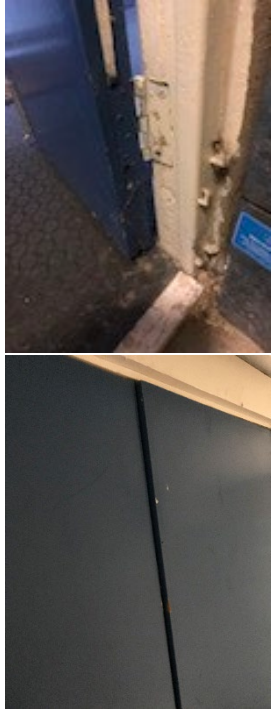
- 21) 5th floor service cupboard does not align properly with the service cupboard door next to it is also missing small portion of cold smoke seal at the bottom edge of the door.**

07/21	5 <sup>th</sup> floor service cupboard needs properly aligning and replace small portion of missing intumescent strip and cold smoke seal from bottom edge of floor

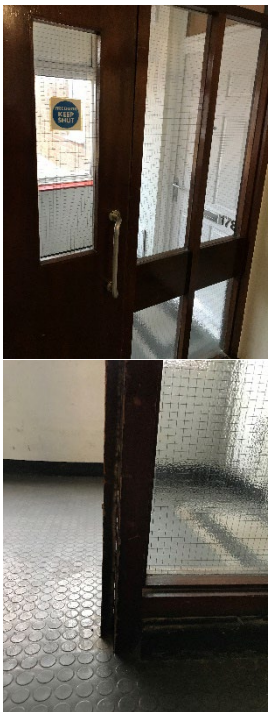
- 22) There are excessive gaps around the edges of the door and frame on the 5<sup>th</sup> floor communal door closest to flat 178 light is also visible through frame of the door, and the door handle is loosened.**

07/22	<p>5<sup>th</sup> floor communal door nearest flat 178 has excessive gaps where adjustment required</p> <p>Also, adjust Gap in frame where light is visible through, and tighten loose door handle</p>

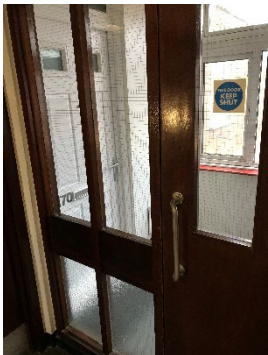
- 23) There are excessive gaps around the edges of the door and frame on the 5<sup>th</sup> floor communal door closest to flat 170 light is also visible through frame of the door, and the door handle is loosened.**

P2	<p>1-3 months Fire Rapid Response JM10627733</p>	19/04/2023
07/23	<p>5<sup>th</sup> floor communal door nearest flat 170 has excessive gaps where adjustment is required</p> <p>Also adjust frame where light is visible and tighten loose door handle</p>

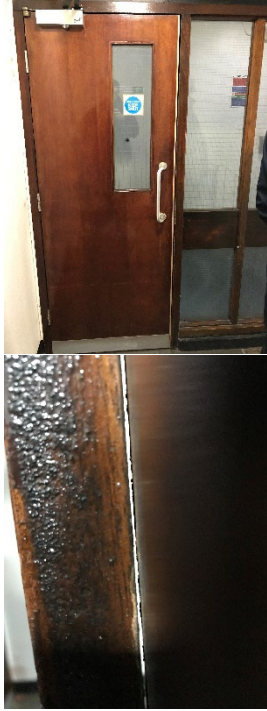
07/24	4 <sup>th</sup> floor communal door adjust gaps around frame where light is visible through frame.

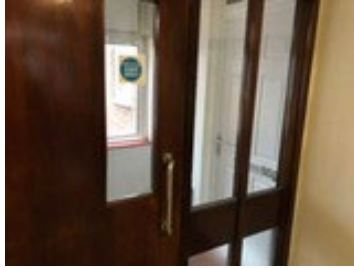
- 25) There are excessive gaps the frame on the 4<sup>th</sup> floor communal door closest to flat 168 light is also visible through frame of the door, and the door handle is loosened.**

P2	1-3 months Fire Rapid Response JM10627757	19/04/2023
07/25	4 <sup>th</sup> floor communal door nearest flat 168 adjust frame of door where light is visible and tighten loose door handle

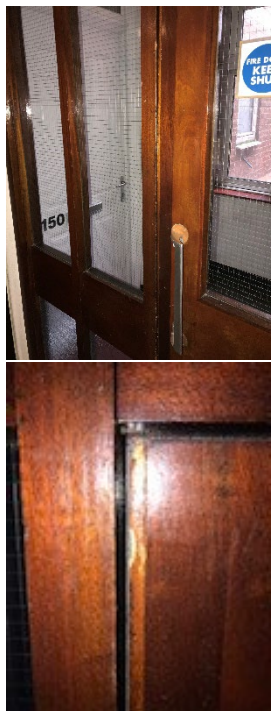
07/27	3 <sup>rd</sup> floor communal door nearest flat 150 adjustment needed between door and frame

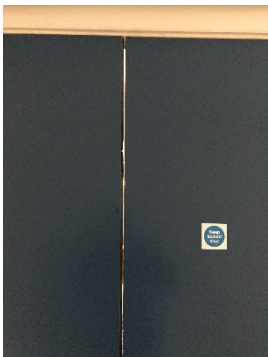
- 29) large gaps between service cupboard doors on the 2<sup>nd</sup> floor light is visible through double doors these doors cannot be secured due to damage around the lock**

07/29	2 <sup>nd</sup> floor service cupboards large gaps between doors to be adjusted

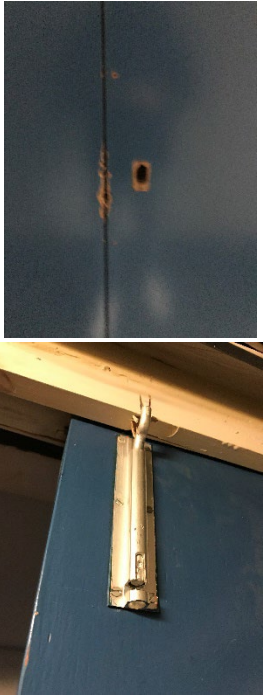
**32) lock is missing to service cupboard doors on the first floor nearest flat 132. Secure bolt lock is also broken to the left-hand side of the service cupboard doors**

07/32	1 <sup>st</sup> floor service cupboard doors nearest flat 132 lock missing and needs replacing also bolt lock to the left-hand side of the cupboard doors is broken and in need of replacement

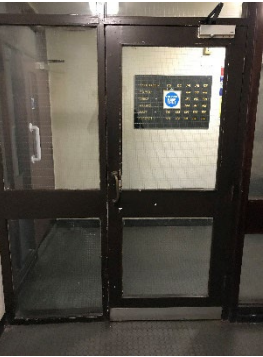
P2	1-3 months Fire Rapid Response JM10627899	19/04/2023
07/33	Excessive gaps to communal door entering stairwell on the ground floor

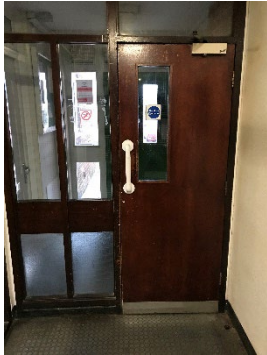
07/34	Excessive gaps on the ground floor communal door entering the lobby area (door with white handle)

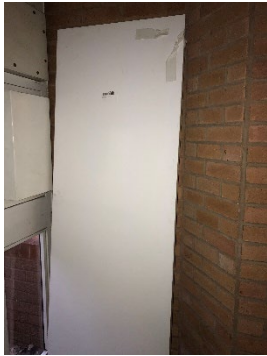
P2	1-3 months Fire Rapid Response JM10627917	19/04/2023
07/35	Remove Door to flat 178 left on ground floor
