Fire Risk Assessment

Paget House

**Sedgley Rd East,
Tipton, DY4 7TU**

Date Completed: 16/06/2025

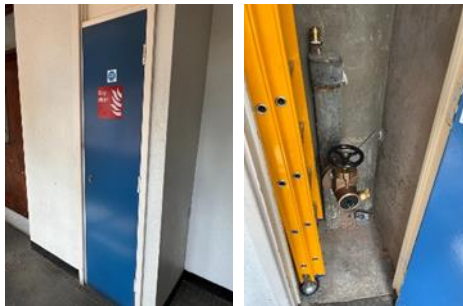
- 14) Dry riser cupboard doors are notional FD30s timber doors, kept locked / secured. The 5th floor cupboard also houses an aluminium ladder which is utilised for access to the lift motor room and roof via the access hatch in the 5th floor lift lobby.

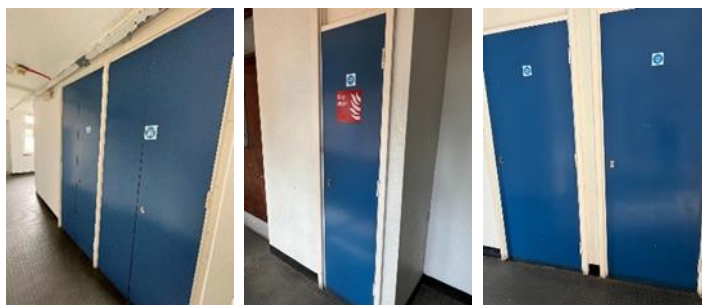
- 4) All service, riser and storage cupboards to communal landings are lockable. Keys are held centrally unless containing resident's meters.

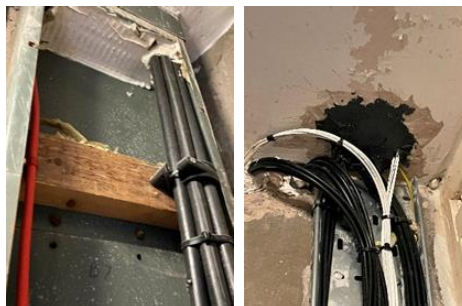
- 5) Service cupboards consist of notional FD30s timber doors and are secured with suited cylinder locks. A key is stored within the Firefighters white box. Residents have been provided with a key for those service cupboards with double doors for access to their electricity meters. The following service cupboards have deficiencies requiring repair; See actions 10/5 a, b, c, and d.
- a) 4th floor electrical cupboard near flat 164 has an excessive gap between the door leaves.
 - b) 2nd floor electrical cupboard near flat 144 has an excessive gap between the door leaves and damage.
 - c) 1st floor electrical cupboard near flat 144 has damage around the lock.
 - d) Ground floor electrical cupboard near flat 122 has damage around the lock.

P3	Fire Rapid Response 3 – 6 months.	
10/5 b.	The 2nd floor electrical cupboard near flat 144 has an excessive gap and damage between the door leaves, requiring repair and adjustment.

10/5 c.	The 1st floor electrical cupboard near flat 134 has damage between the door leaves around the lock, requiring repair.

P3	Fire Rapid Response 3 – 6 months.	
10/5 d.	The ground floor electrical cupboard near flat 122 has damage between the door leaves around the lock, requiring repair.

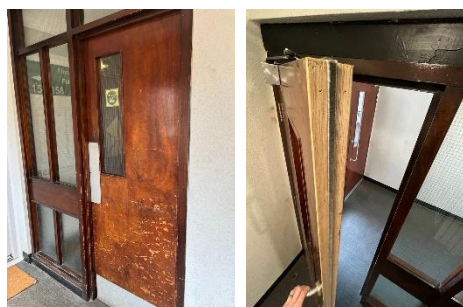
- 8) The communal corridors, landing & staircases are protected by use of notional self-closing 44mm 30-minute timber fire doors with vision panels & 25mm stops, along with 30-minute notional hardwood fire screens with GWPP glazing (stairwell). It is recognised that these doors do not meet today's benchmark of a certified FD30s fire door /screen install however, because they were installed at the time of the building's construction and to the standard of that time they are deemed as acceptable so long as the doors /screens are free of damage and function as they were intended to do so. It has been recognised that all the landing / staircase notional doors in this block have been upgraded with combined intumescent strips & cold smoke seals to enhance their original design and minimise departures from today's standards. Where minor shortcomings have previously been identified, actions have been created for corrective works for example, some doors have been re-lipped with hardwood.

- 9) It was noted that the notional hardwood fire screens with Georgian wired glazing that protect staircases only provided 30 mins fire resistance. When any future refurbishments take place, this should be upgraded to a minimum of 60 mins.

Observations	
Some notional communal landing doors show signs of wear and tear due to age. Consideration should be given to upgrade with certified FD30s door sets, combination frames / screens as part of any future refurbishment works.

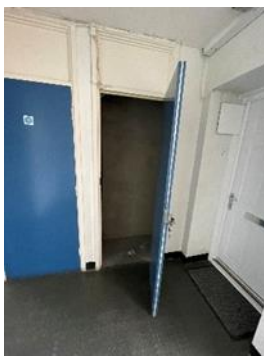
- 1) Residents instructed not to bring L.P.G cylinders into block.
- 2) The tenancy conditions, Section 7 – Condition 5.6 stipulates “If you live in a flat or maisonette, you, people living with you and any visitors to your property must not keep or use paraffin oil, petrol, bottled gas appliances or any other explosive, FLAMMABLE, or dangerous material in the property. This restriction also applies to any storage facility situated in or attached to the block, which has been provided for your use.”
- 3) No Flammable liquids stored on site by Caretakers / cleaners.
- 4) There are no flammable liquids or gas cylinders stored on site.
- 5) There are 2 cupboards within the lobby on each floor. Cleaners’ products are stored within the ground floor cupboards whilst the remainder on the sampled floors are empty.
