Fire Risk Assessment

Wallace House

Badsey Rd, Oldbury,
B69 1ER

Date Completed: 12/05/2025.

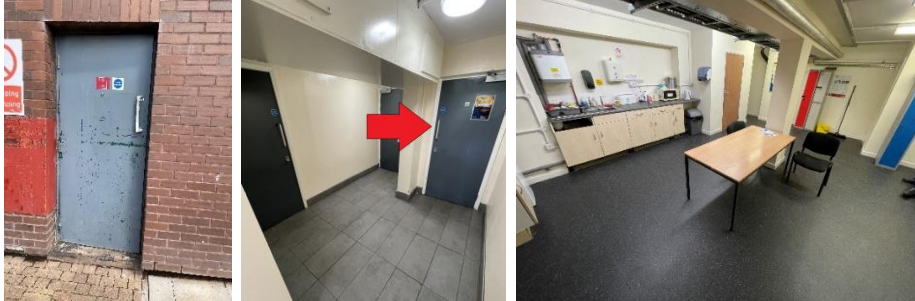
There is a Caretakers / Cleaners Welfare Office located on the ground floor; access is obtained both internally and externally room utilising the suited 54 lock key. There are three secured storage cupboards within this room.

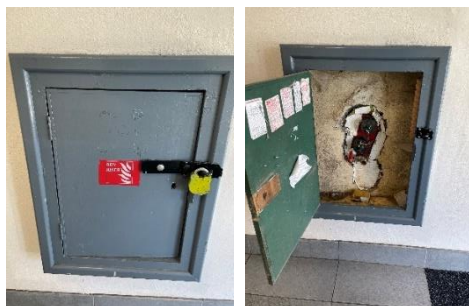
There is a dry riser system at Wallace House. The riser inlet is to the right-hand side in the main entrance foyer and is secured with a fire service bridge door padlock.

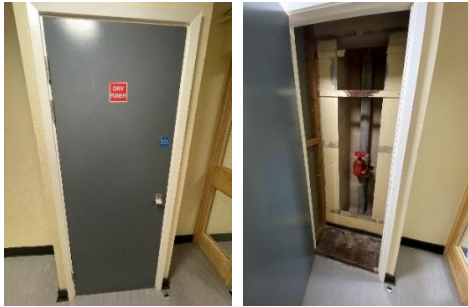
Dry riser outlets are available on each floor above ground opposite the stairwell door / in lift the lobby. The outlets are contained within a dry riser cupboard that is secured with a type 54 suited mortice lock.

In some cases, it was noted that Dry Risers outlets had been secured so that access to operate could be difficult in an emergency. When any maintenance or servicing is carried out consideration should be given to rectifying this so that emergency service access and operation is simplified.

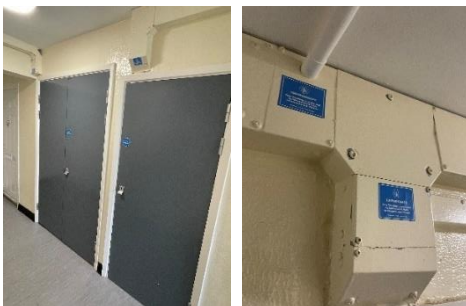
- 4) All communal fire doors are subject to a 12-week check by the Fire Safety Rapid Response Team.
- 5) All service cupboards to communal corridors are nominal timber FD60s, locked with suited keys. It was noted that cabling is run through metal trunking protected by intumescent pads or pillows.

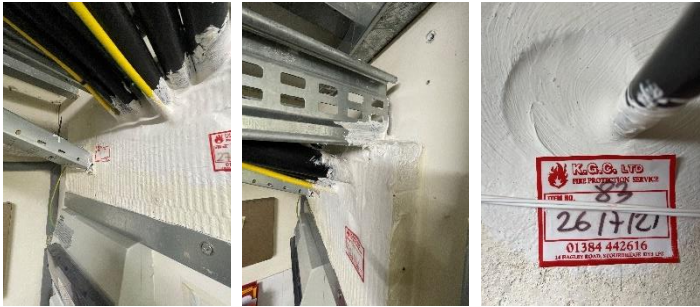
- 6) A variety of methods / materials have been used to achieve fire-stopping including Rockwool, intumescent collars and intumescent fire batts.

- 7) **On the 10th floor, outside flat 62, some fire stopping is required in the electrical cupboard. This is where there have been cable penetrations through the wall.**
- 8) **On the 8th floor, outside flat 50, some fire stopping is required in the electrical cupboard. This is where there have been cable penetrations through the wall.**
- 9) The fire stopping / compartmentation is subject to a 12-week check by the Fire Safety Rapid Response Team.
- 10) Any remedial works arising from the fire stopping / compartmentation check(s) will be actioned immediately by the Fire Safety Rapid Response Team.
- 9) Individual flat doors are nominal FD30s composite fire door sets manufactured by IG doors.
- 10) The communal corridor and staircase doors are nominal FD30s timber fire doors with vision panels.

10/07	On the 10 th floor, outside flat 62, some fire stopping is required in the electrical cupboard. This is where there have been cable penetrations through the wall.	N/A.	P2	Fire Rapid Response Within 1-3 months	
10/08	On the 8 th floor, outside flat 50, some fire stopping is required in the electrical cupboard. This is where there have been cable penetrations through walls.	N/A.	P2	Fire Rapid Response Within 1-3 months	
10/15	The caretakers room door that leads to fresh air (By the main entrance) is missing a spy hole leaving insulation exposed, this should be rectified as soon as possible.

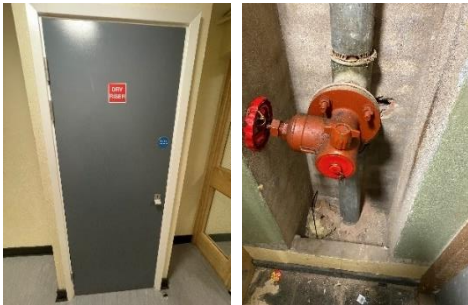
- 2) The Dry riser outlets are available in cupboards on each floor above ground adjacent the stairwell door. The cupboards are secured with a suited type 54 key mortice lock.

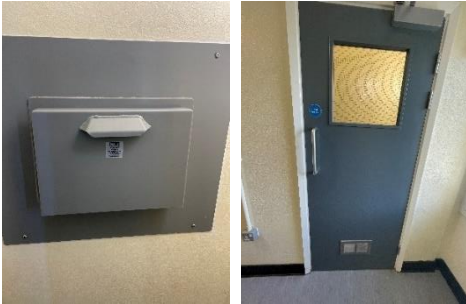
- 1) There is a regular Cleaning Service to the premises.
- 2) Refuse hoppers are accessed in each floor within the chute rooms.

- 4) When any refurbishments of the building are carried out consideration should be given to upgrading the manual waste chute closure plate to an appropriate automatic operating system.
 - 5) Regular checks by Caretakers minimise risk of waste accumulation.
 - 6) 'Out of Hours' service in place to remove bulk items.
-

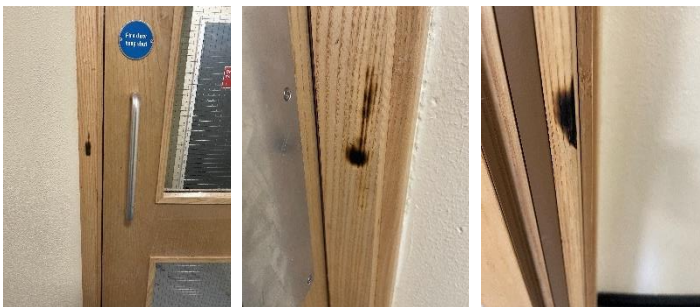
- 3) CCTV is in operation covering the ground floors, lifts and external areas and surrounding areas. The system is monitored 365 days per year by the centralised CCTV control room located at the Sandwell MBC Operations and Development Centre, Roway Lane, Oldbury, B693ES.
- 4) There is evidence of Arson on the 9th floor are no signs of arson, these are in the form of scorch marks on the staircase and lobby area. (Email has been sent to housing).
