Fire Risk Assessment

Wallace House

**Badsey Rd, Oldbury,
B69 1ER**

Date Completed: 06/05/2026

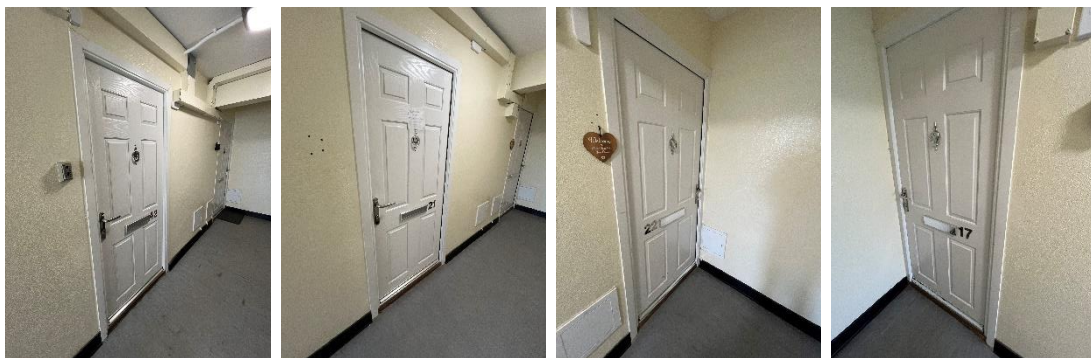
- 16) Flat 70 flat front door has a damaged letterbox opening. This letterbox is required to be repaired. See action 7/16.

Question/ Ref No	Required Action	Supporting photograph	Priority	Timescale and Person Responsible	Date Completed
7/16	Flat 70 flat front door has a damaged letterbox opening. This letterbox is required to be repaired.

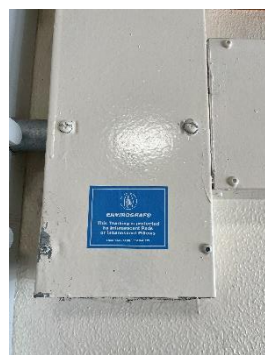
- 5) **Fire stopping around the dry riser inlet is of a poor standard and requires renewing. See action 10/5.**

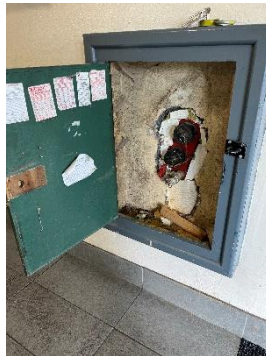
- 1) The riser inlet is located within the ground floor lobby, inside a dry riser cabinet and is secured with a firefighter's suited bridge door padlock.

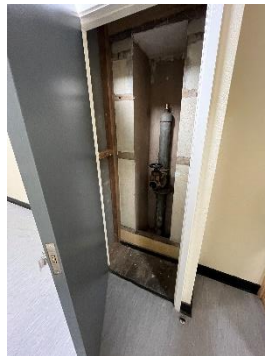
- 2) The dry riser outlets are available in cupboards on each floor above ground in the lift lobbies. The cupboards are secured with a suited type 54 key mortice lock.

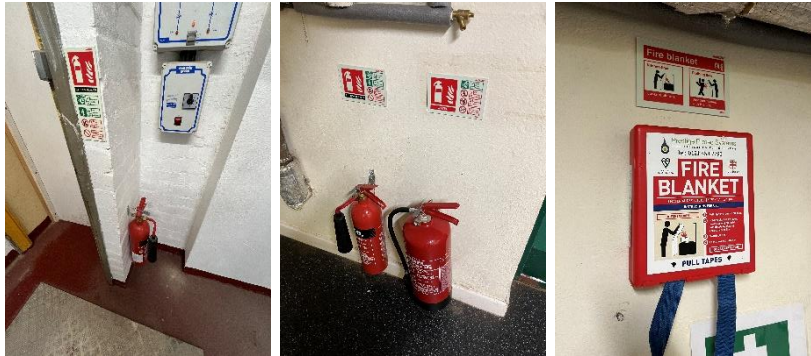
- 4) The frequency for the maintenance checks of fire extinguishers is once (October) each calendar year. Portable fire extinguishers are provided to the lift motor room (CO₂) and caretakers room (CO₂ and Water and a fire blanket).

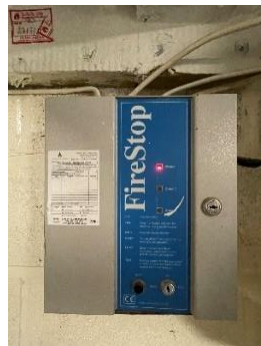
- 5) The bin store is protected by a fire suppression system and serviced 6-monthly. The control panels are located on the wall within the bin store.

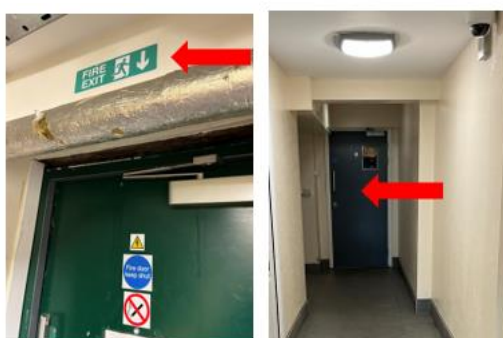
- 1) Fire doors display suitable signage where appropriate. However, a 'Fire Escape Keep Clear' sign is required to be fitted on the foyer side of the fire escape door from the caretaker's room and the fire exit signs removed from the green exit door in the caretaker's office. See action 12/1 and 7/17.
