Fire Risk Assessment

Wallace House

**Badsey Road, Oldbury,
B69 1ER**

Date Completed: 4th October 2022

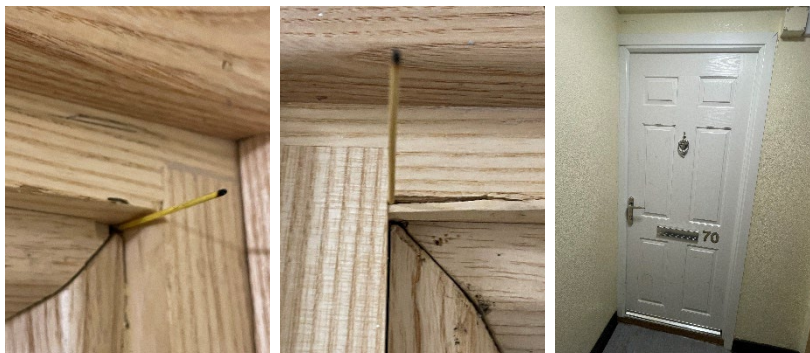
23) Incense sticks have been previously lit and wedged into crevices on the 12th floor lobby leading to flat 70. Resolved 28/04/23

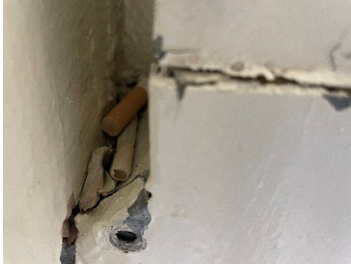
- 27) 8th floor near flats 45, 46 & 47 used cigarettes have been discarded in corner between wall and cable trunking adjacent communal window. Residents should be reminded of the No Smoking Policy that exists within any communal area of the building and the associated risks from the inappropriately discarding of smoking materials. *Resolved 28/04/23*

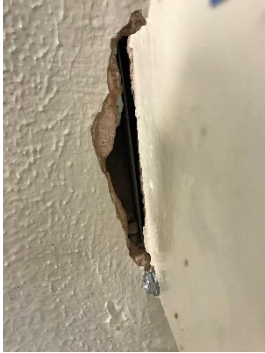
- 30) 4th floor adjacent flat 21 by communal window there is a hole in the wall where cables penetrate the wall. Hole requires fire stopping. *Resolved 17/10/22*

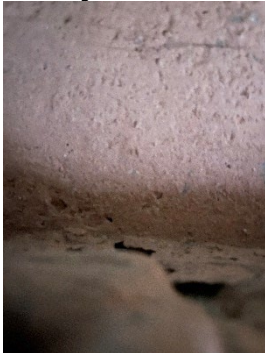
- 9) There is a small gap above the internal face of the server room doors. A camera was inserted into the gap to ensure the cavity couldn't facilitate smoke travel beyond the server room. The small cavity was found sufficiently enclosed with concrete.

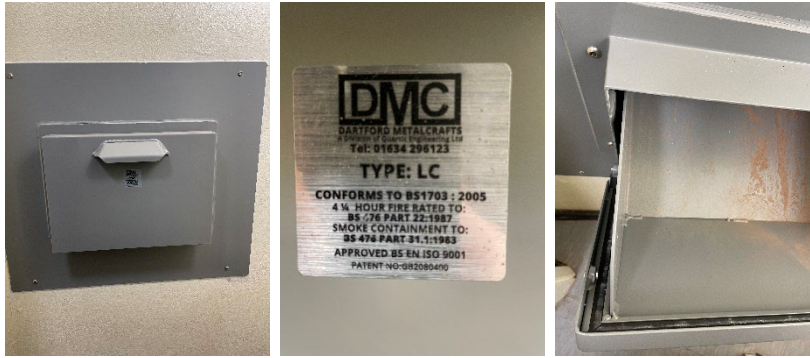
- 10) 23/02/23 - Refuse hoppers to all floors have been replaced with Dartford Metalcrafts Type LC – Conforming to BS1703: 2005

4 ¼ Hours fire rated to BS476 part 22: 1987

Smoke containment to BS476 part 31.1: 1983.

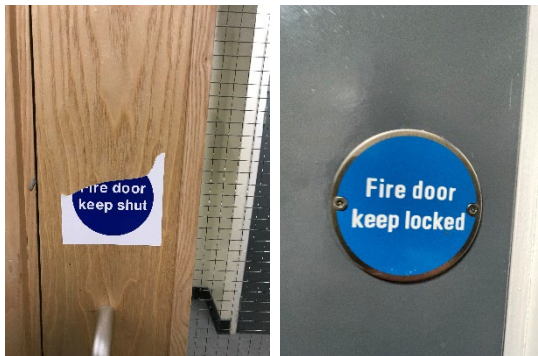
- 1) All fire doors display "Fire Door Keep Shut" where appropriate. **3rd floor communal door to stairwell "fire door keep shut" sign is torn.** *Resolved 13/10/22*

| 12/01 | Replace torn Fire Door Keep Shut sticker on 3 rd floor door to stairwell. | | P2 | Within 1 – 3 months of action plan date. Caretakers | 13/10/2022 |

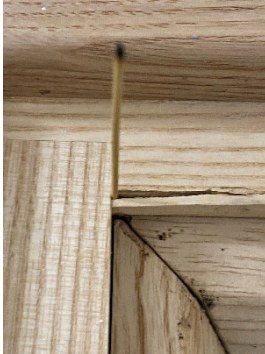
| 07/23 | Incense sticks have been lit and wedged in crevices by flat 70 12 th floor. | | P2 | Within 1 – 3 months of action plan date. Housing Manager | 28/04/2023 |

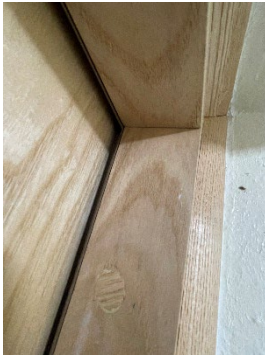
| 07/31 | 4 TH floor communal door to stairwell requires adjustment / doesn't fully close into frame top corner leading edge. | | P2 | Within 1 – 3 months of action plan date. Fire Rapid Response JM9708603 | 17/10/2022 |

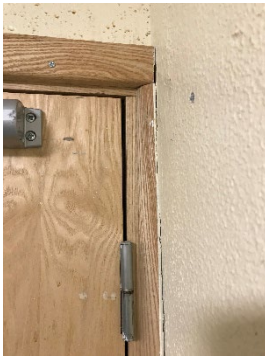
- 32) 2nd floor communal door to stairwell, excessive gap above top hinge and door binds on leading edge (fixings to frame may be loose / hinge side). *Resolved 18/10/22*

| 07/32 | 2 nd floor communal door to stairwell requires adjustment, excessive gap above top hinge / door binds on leading edge. | | P2 | Within 1 – 3 months of action plan date. Fire Rapid Response JM9712439 | 18/10/2022 |
