Fire Risk Assessment

Wyrley House

**Sedgley Rd East,
Tipton, DY4 7TT**

Date Completed: 02/06/2025

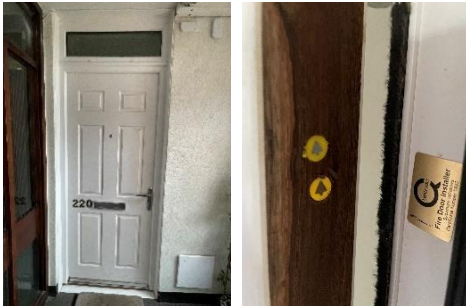
- 21) Individual flat doors are FD30s rated composite doors sets manufactured by IG Doors. BM-Trada fire door identification plugs were noted.

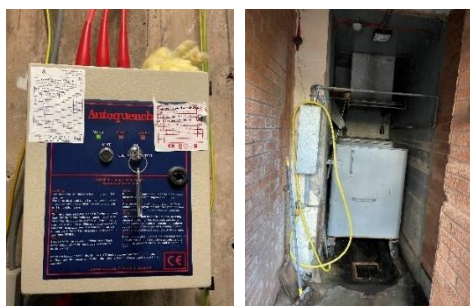
- 3) There is no effective means for detecting an outbreak of fire to communal areas. The reason for this are:
 - I. Such systems may get vandalised.
 - II. False alarms would occur.
 - III. A Stay Put - Unless policy is in place.
- 4) A fire suppression system is provided to the refuse chute bin store. An approved contractor maintains the system. The frequency for the maintenance checks are twice per year (April and October) of each calendar year. The control panel is located in the ground floor service cupboard.

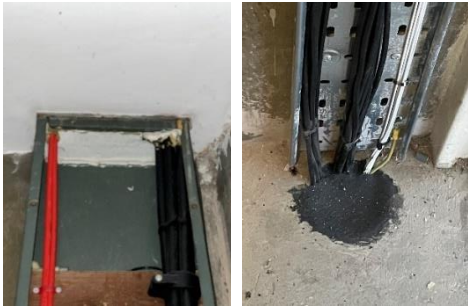
- 5) A variety of methods / materials have been used to achieve fire-stopping including Rockwool and intumescent pillows.

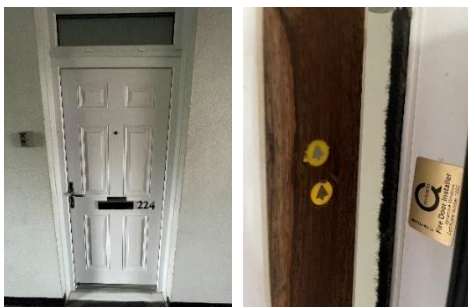
- 7) Individual flat doors are FD30s rated composite doors sets manufactured by IG Doors. BM-Trada fire door identification plugs were noted.

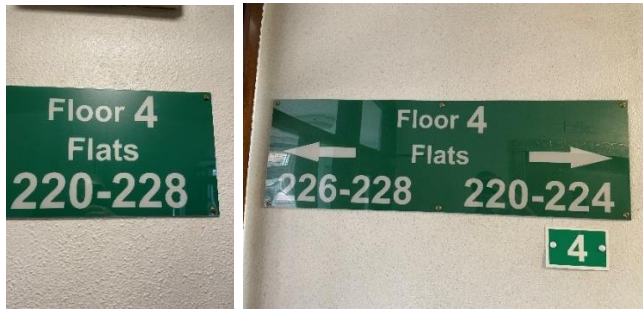
- 6) Photoluminescent wayfinding signage depicting floor level and flat numbers are fitted to the walls on all floors and to the wall of each landing on the communal staircase. Signage that meets the requirement of ADB and Fire Safety (England) Regulations 2022.

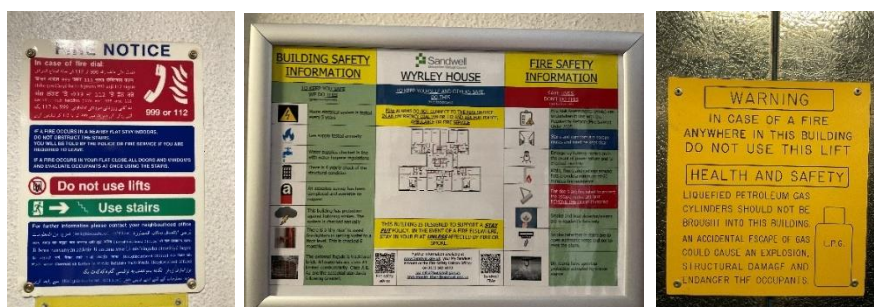
- 1) All Caretaking / Cleaning Employees have undertaken fire safety training. This includes use of bespoke 'Fire Safety in High / Low Rise Flatted Accommodation' Video.
- 2) All employees are encouraged to complete 'In the line of fire' training on an annual basis.
- 3) Caretaking Teams are not currently trained in the effective use of fire extinguishers. The only extinguishers are located within the lift motor room. Caretaking Teams are not expected to tackle fires in this area.
- 4) Building safety and evacuation notices are displayed in common areas and lift cars.

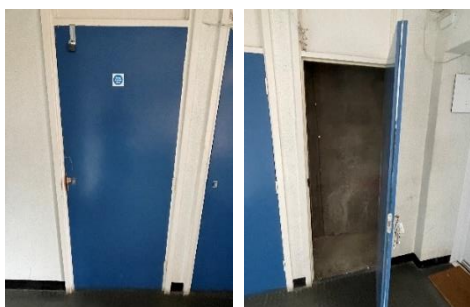
- 1) Residents instructed not to bring L.P.G cylinders into block.
- 2) The tenancy conditions, Section 7 – Condition 5.6 stipulates “If you live in a flat or maisonette, you, people living with you and any visitors to your property must not keep or use paraffin oil, petrol, bottled gas appliances or any other explosive, FLAMMABLE, or dangerous material in the property. This restriction also applies to any storage facility situated in or attached to the block, which has been provided for your use.”
- 3) No Flammable liquids stored on site by Caretakers / cleaners.
- 4) There are no flammable liquids or gas cylinders stored on site.
- 5) There are 2 cupboards within the lobby on each floor. Cleaners products are stored within the ground floor cupboards whilst the remainder on the floors below are empty.

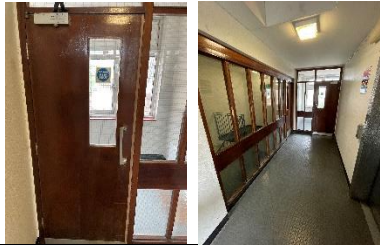
| Observations | | |
|---|---|--|
| Some notional communal landing doors show signs of wear and tear due to age. Consideration should be given to upgrade with certified FD30s door sets, combination frames / screens as part of any future refurbishment works. | | |
