Fire Risk Assessment

Wyrley House

**Sedgley Rd East,
Tipton, DY4 7TT**

Date Completed: 04/01/23

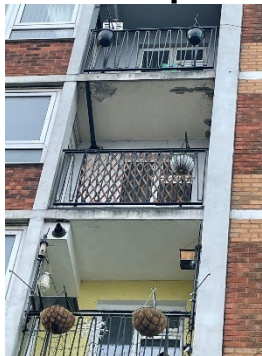
B. Flat 226 (4th floor) has timber trellis installed to balcony railings which could potentially support the external surface spread of fire.

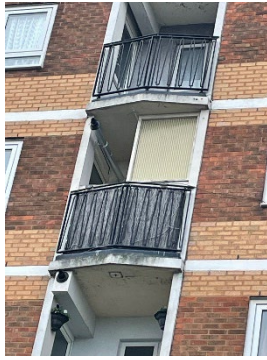
C. Flat 224 (4th floor) has timber / willow screening installed to balcony railings. There balcony has also been partially enclosed with what appears to be a UPVC framed unit. It would appear that this unit has been glazed with an acrylic perspex panel. Further enquiries at the time of the FRA where not possible due to the occupier not being home. The modifications to this balcony could potentially support the external surface spread of fire. *Resolved 22/03/23*

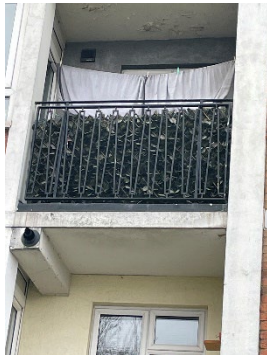
- D. Flat 206 (2nd floor) has decorative screening installed to balcony railings which could potentially support the external surface spread of fire. *Resolved 27/03/23***

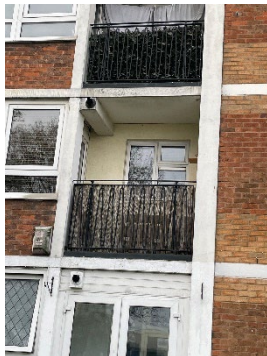
- E. Flat 196 (1st floor) has timber / willow screening installed to balcony railings which could potentially support the external surface spread of fire. *Removed 15/03/23***

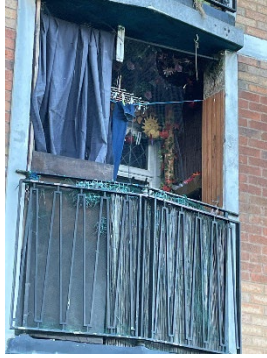
- F. Flat 194 (1st floor) has screening and netting installed to balcony railings and a what appears to be a plastic sheet utilised as a curtain over a pole. It appears that there is also a timber panel and a sheet of ply board against the railings. The presence excessive combustible items could support the external surface spread of flame.**

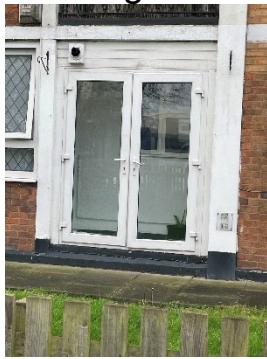
- G.** Flat 186 (ground floor) There are UPVC doors installed to the balcony with a section of UPVC shiplap cladding above. A request has been processed to cover each side of the cladding with a fire retardant paint.

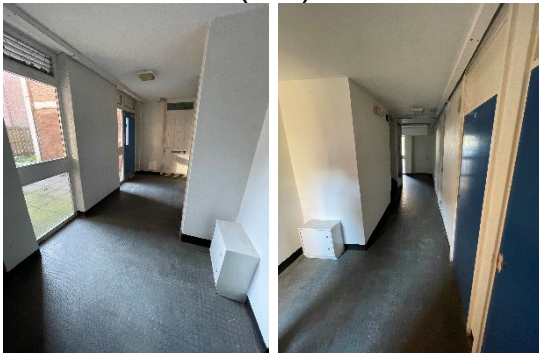
- 2) All corridors are of adequate width (at least 1050mm) and will be maintained clear to that width as a minimum.
- 3) Within the means of escape there is a single corridor that forms a dead end and is located on the ground floor. However, the corridor is protected with fire resisting construction, has natural ventilation via a louvre vent, is a place of relative safety and leads to a final exit door. The maximum travel distance along the corridor is 13 metres (from flat 182 to the final exit) as per the guidance at the time 1962 - 71. All doors within the corridor are FD30s rated with the flat entrance doors being FD30s rated composite door sets. Flats 182, 184, 186 all have balconies that could be used as an alternative means of escape, flat 188 is immediately adjacent the final exit door (1m).

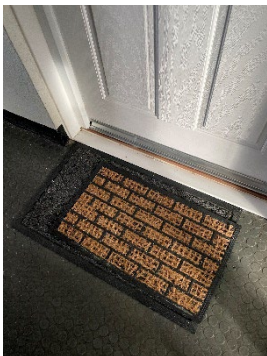
- 17) The fire rating of individual door mats outside flat entrance doors is unknown.

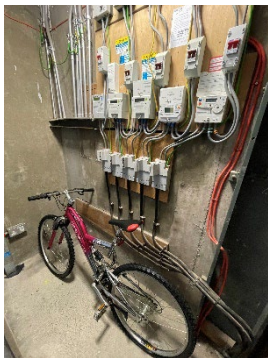
- 21) The 5th floor service cupboard containing residents electricity meters contained a bicycle which should be removed. Flats on this floor are 230, 232, 234, 236, 238. Resolved 27/02/23**

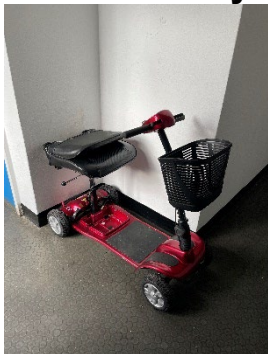
- 22) There is a mobility scooter parked on the 5th floor lobby adjacent the dry riser cupboard and flat 236. Discussions between the resident, housing officer and fire safety officer have been held. It has been agreed that the scooter will remain in situ when not in use, subject to the battery being removed and stored within flat, whilst a request for an access ramp into the flat is processed. This is a temporary arrangement only and should the request for an access ramp be unsuccessful then the scooter must be removed from the 5th floor lobby.**

07/22	Mobility scooter to be removed from 5 th floor communal corridor outside flat 236.	 	P2	Within 1 to 3 months of action plan date. Housing Manager. 16/01/23 Referral sent to repairs from housing officer for a ramp to be installed improving access to flat.	Resolved 29/06/2023
07/23	5 th floor communal door to stairs – excessive gaps to door and between stop and frame, adjustment / repair required.	 	P2	Within 1 to 3 months of action plan date. Fire Rapid Response JM:10630191	20/04/2023

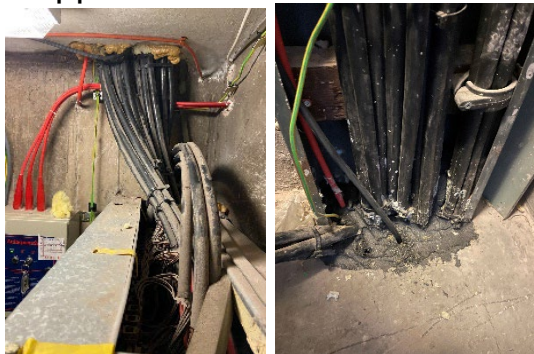
- 6) There is a minimal amount of foam present where power cables penetrate through the slab from the service cupboard to the service cupboard above (ground to 1st floor). This has not been removed due to the close proximity of live terminals within the mains distribution board. Where the cables enter the 1st floor service cupboard above the penetration has been suitably fire stopped with intumescent mastic.

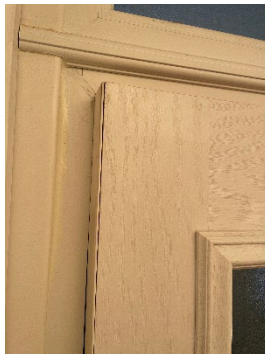
B. 2nd floor flat 200 door binds top corner lock side

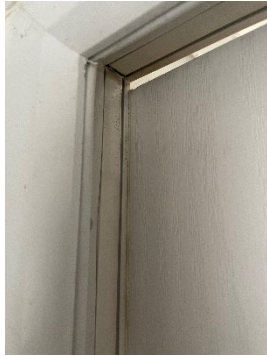
C. 1st floor flat 196 door binds slightly on top corner lock side.

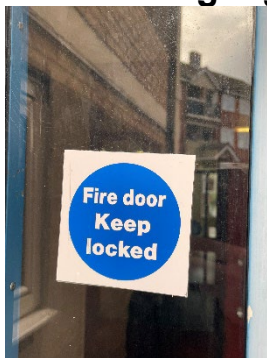
- 1) Fire doors display “Fire Door Keep Shut” where appropriate.
- 2) The front and rear final exit doors display “Fire Door Keep Locked” signage which is incorrect and should be removed.

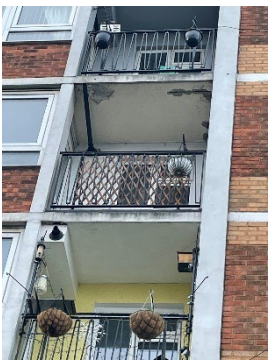
06/03b	Flat 226 – Remove timber trellis installed to balcony railings.

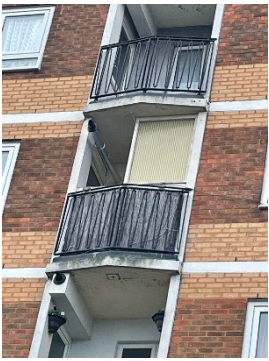
P2	Within 1 to 3 months of action plan date. Housing Manager	Resolved 29/06/2023
06/03c	Flat 224 – Remove installed acrylic perspex panel, willow screening to balcony.

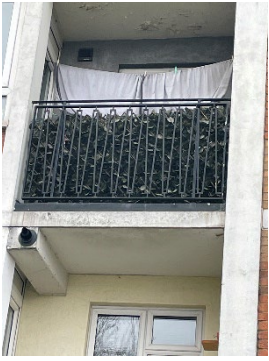
P2	Within 1 to 3 months of action plan date. Housing Manager	Resolved 22/03/2023
06/03/d	Flat 206 – Remove decorative screening installed to balcony.

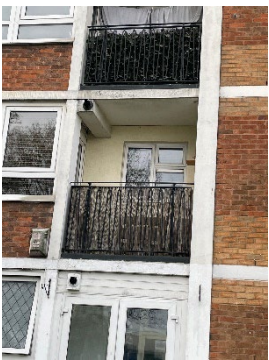
06/03e	Flat 196 – Remove willow screening installed to balcony.

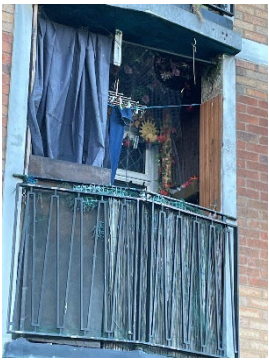
P2	Within 1 to 3 months of action plan date. Housing Manager	Items removed 13/03/2023
06/03f	Flat 194 – Remove all screening / netting, curtain, ply board and timber panel from balcony.

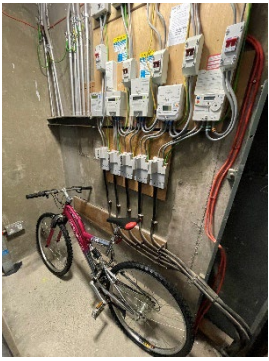
P2	Within 1 to 3 months of action plan date. Housing Manager	Items Removed 29/06/2023
07/21	Bicycle to be removed from the 5 th floor electrical service cupboard. (flats 230, 232, 234, 236, 238)

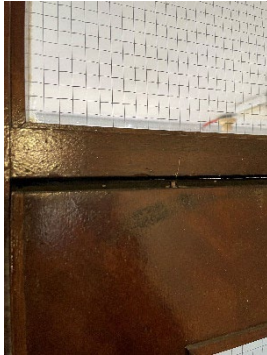
07/24	5 th floor communal door by flat 230 – excessive gaps adjustment / repair required.

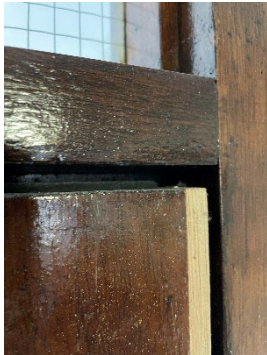
P2	Within 1 to 3 months of action plan date. Fire Rapid Response JM10631596	20/04/2023
07/25	5 th floor fd30s communal door by flat 238 – excessive gaps adjustment / repair required.

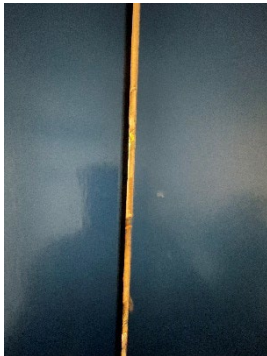
P2	Within 1 to 3 months of action plan date. Fire Rapid Response JM:10631605	20/04/2023
07/26	5 th floor fd30s left side electrical service cupboard doors by flat 234 excessive gap between doors adjustment / required.

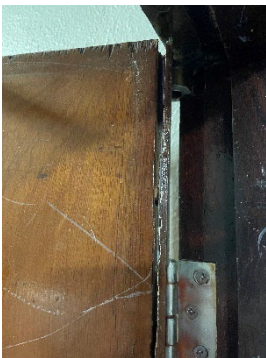
07/27	4 th floor communal door to stairs excessive gaps and door split along edge on hinge side, adjustment / repair required.

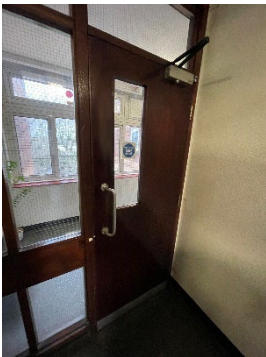
P2	Within 1 to 3 months of action plan date. Fire Rapid Response JM10631632	20/04/2023
07/28	4 th floor communal door by flat 220 has excessive gaps adjustment / repair required.

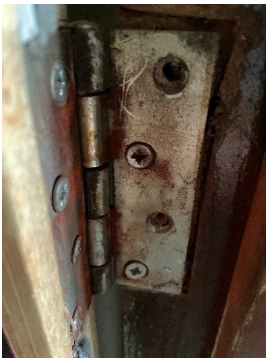
- 29) 4th floor communal door by flat 228 has 3 missing screws from 2 hinges.**

P2	Within 1 to 3 months of action plan date. Fire Rapid Response JM10631644	20/04/2023
07/29	4 th floor communal door by flat 228 replace missing screws to 2 hinges.

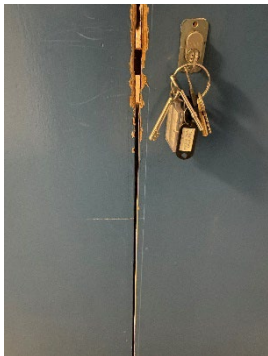
- 30) 4th floor service cupboards (electrical) opposite flat 224 – left hand cupboard has a defective lock (can't unlock) and excessive gap between doors, cold smoke seal doesn't meet opposite edge.**

07/30	4 th floor opposite flat 224 left side electrical service cupboard has excessive gaps between doors / require adjustment. Defective lock / unable to unlock requires attention / replacement.

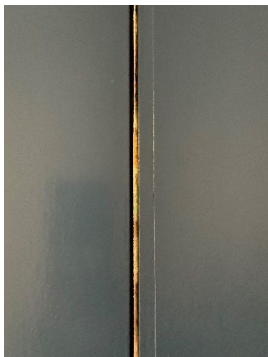
P2	Within 1 to 3 months of action plan date. Fire Rapid Response JM:10631671	20/04/2023
07/31	4 th floor opposite flat 224 right side electrical service cupboard has excessive between doors / requires adjustment.

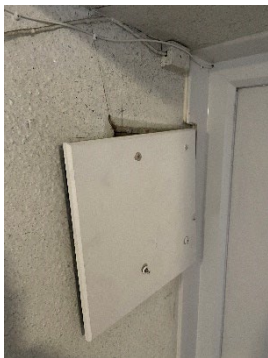
- 32) Access panel to stop tap adjacent flat 226 is hanging loose and requires re-fixing to masonry to maintain compartmentation.**

P2	Within 1 to 3 months of action plan date. Fire Rapid Response JM:10631680	20/04/2023
07/32	4 th floor by flat 226 access panel to stop tap requires re-fixing to wall

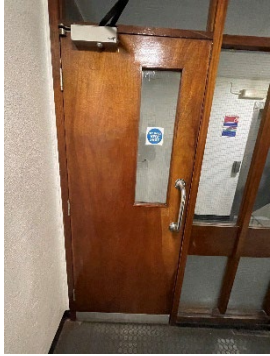
JM:10631690	
07/33	3 rd floor by communal door to stairs has excessive gaps and gap between stop and frame handle side / adjustment / repair required.

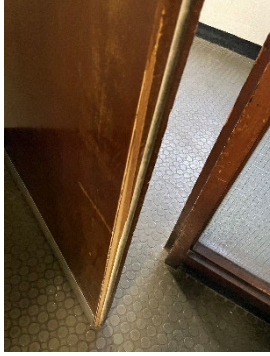
- 34) 3rd floor communal door by flat 218 excessive gaps and damage to re-lipped edge on leading edge.**

P2	Within 1 to 3 months of action plan date. Fire Rapid Response JM:10631774	20/04/2023
07/34	3 rd floor by flat 218 communal door has excessive gaps and damage to re-lipped edge, adjustment / repair required.

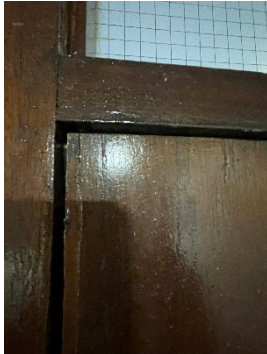
07/35	3 rd floor communal door by flat 210 has excessive gaps adjustment / repair required.

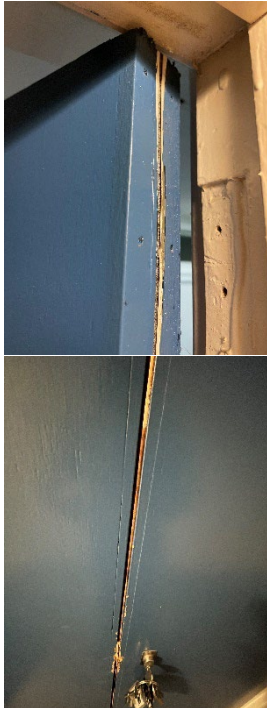
- 36) 3rd floor by flat 214 service cupboard doors (electrical) have excessive gaps between both sets of doors. Smoke seal is partially missing from the left-hand door of the left-hand set.**

P2	Within 1 to 3 months of action plan date. Fire Rapid Response JM:10631824	20/04/2023
07/36	3 rd floor by flat 214 electrical service cupboard has excessive gaps between both sets of doors, adjustment required. Also replace cold smoke seal that is partially missing from left hand door (left side cupboard).

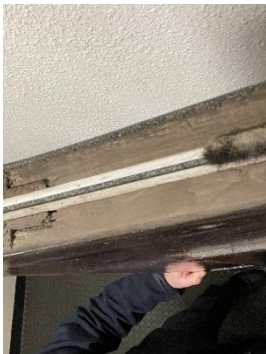
- 37) 2nd floor communal door to stairs smoke seal is partially missing from head. Also, excessive gaps towards bottom of door on leading edge.**

07/37	2 nd floor communal door to stairs has excessive gaps towards bottom on leading edge adjustment / repairs required. Replace cold smoke seal to head.

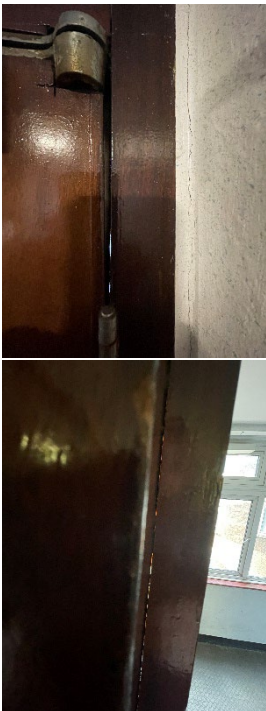
P2	Within 1 to 3 months of action plan date. Fire Rapid Response JM:10631855	20/04/2023
07/38	2 nd floor by flat 200 excessive gaps (each side) between stop and frame require adjustment.

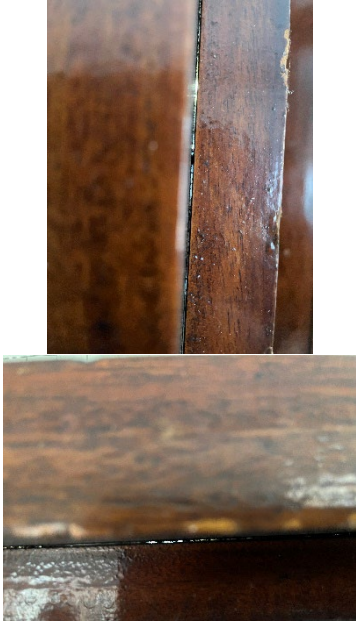
07/39	2 nd floor by flat 208 communal door gaps between stop and frame handle side and head require adjustment

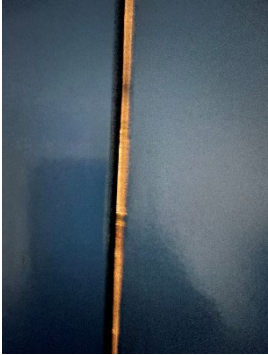
P2	Within 1 to 3 months of action plan date. Fire Rapid Response JM:10631868	20/04/2023
07/40	2 nd floor electrical service cupboards excessive gaps between both sets of doors require adjustment.

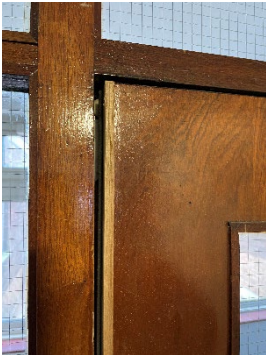
07/42	1 st floor by flat 190 communal door excessive gap to leading edge and gap between stop and frame on same side, adjustment / repair required.

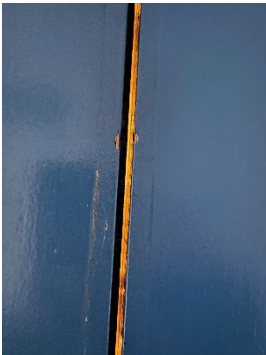
P2	Within 1 to 3 months of action plan date. Fire Rapid Response JM:10631892	20/04/2023
07/43	1 st floor chute room door requires replacement screw to lower hinge	No Photo	P2	Within 1 to 3 months of action plan date. Fire Rapid Response JM:10631937	20/04/2023
07/44	1 st floor electrical service cupboard excessive gap between both sets of doors and on right door / hinge side, adjustments required.

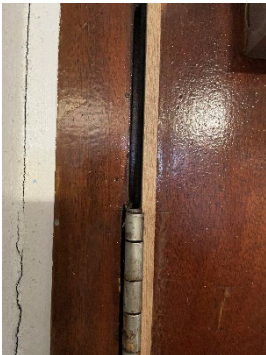
07/45	1 st floor by flat 198 communal door has excessive gaps hinge side and head adjustment / repairs required.

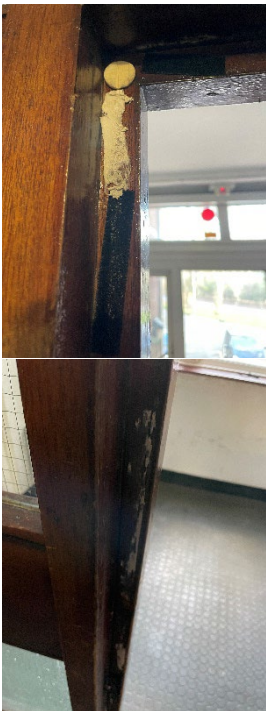
P2	Within 1 to 3 months of action plan date. Fire Rapid Response JM:10632038	20/04/2023
07/46	1 st floor communal doors leading to flat 190 had sticky pads and Velcro applied to the door stops to prevent banging. Housing officer to contact all flats on this floor to inform that interference with fire doors will significantly increase the risk to all in the event of a fire.

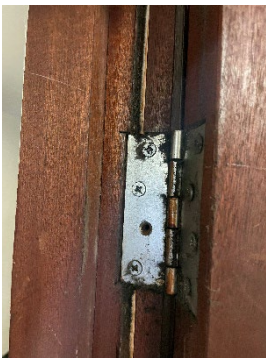
- 47) Ground floor communal door to stairs has a screw missing from top hinge.**

07/47	Ground floor communal door to stairs / replace missing screw to top hinge

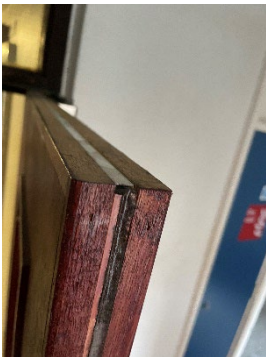
P2	Within 1 to 3 months of action plan date. Fire Rapid Response JM:10632071	20/04/2023
07/48	Ground floor by flat 188 communal door doesn't reliably fully self-close adjustment required, also requires cold smoke seal to head.

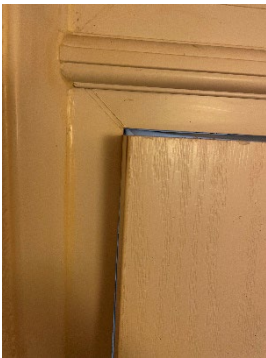
P2	Within 1 to 3 months of action plan date. Fire Rapid Response JM:10632417	20/04/2023
10/08a	4 th floor flat 220 door requires adjustment to ensure it reliably fully self-closes into frame.

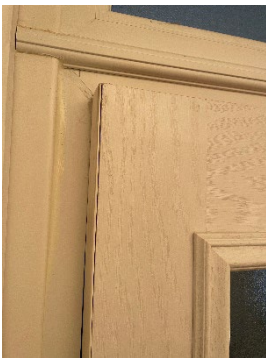
10/08b	2 nd floor flat 200 door requires adjustment to ensure it reliably fully self-closes into frame.

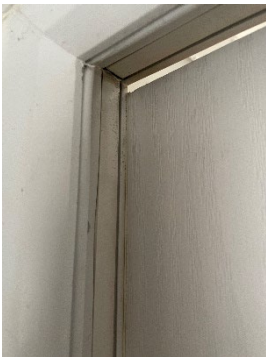
P2	Within 1 to 3 months of action plan date. Fire Rapid Response JM:10632440	20/04/2023
10/08c	1 st floor flat 196 door requires adjustment to ensure it reliably fully self-closes into frame.

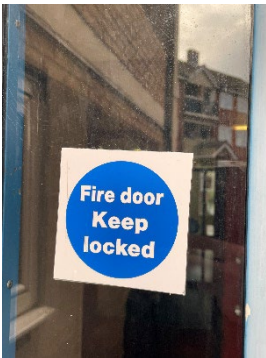
P2	Within 1 to 3 months of action plan date. Fire Rapid Response JM:10632460	20/04/2023
12/02	Remove “fire door keep locked” signage from both final exit doors.
