Fire Risk Assessment

Wesley Court

**Southbank Rd,
Cradley Heath, B64 6LQ**

Date Completed: 11/07/2025

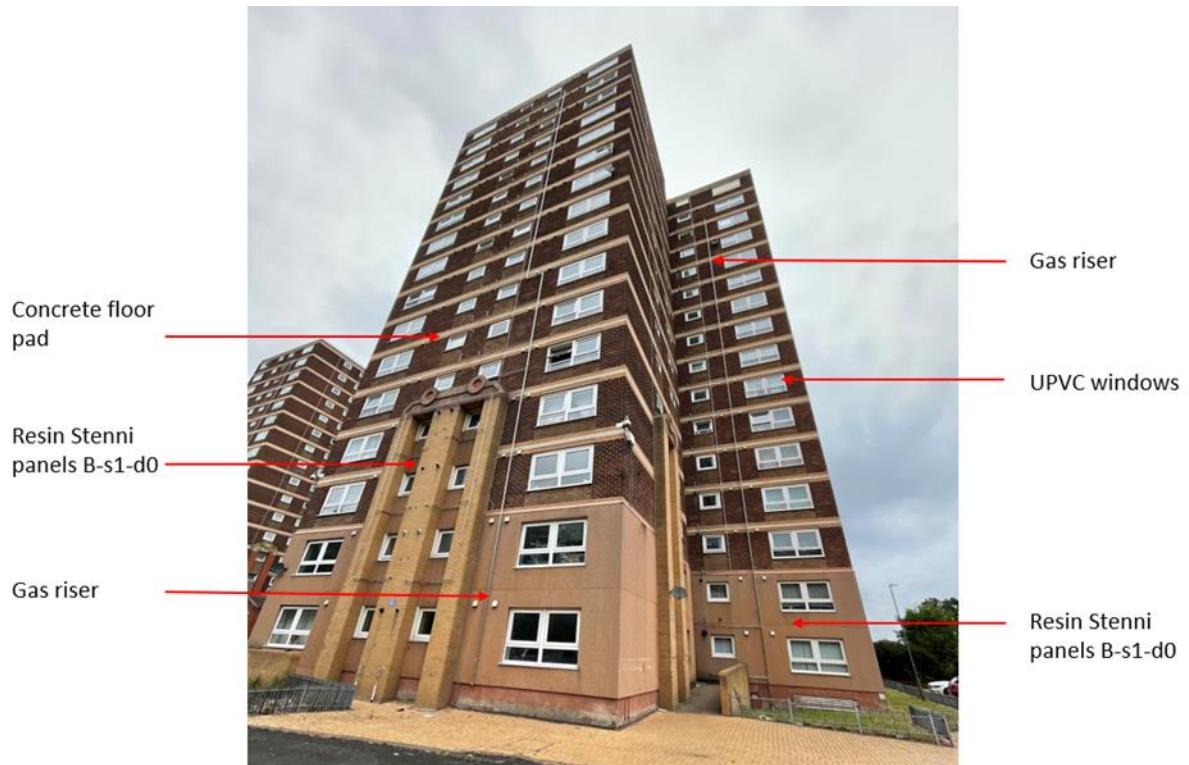
1. Ground to 1st floor - Resin-Stenni panels, fire classification B-s1-d0. Also, small areas to 2nd and 3rd floor.

5. Cladding was found to be damaged near the bin store entrance. This damage should be repaired. See observations.

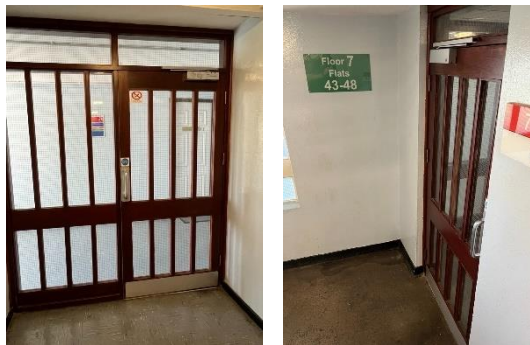
- 4) None of the corridors that form part of the means of escape are dead ends.
- 5) The means of escape are protected to prevent the spread of fire and smoke.
- 6) The communal landing / staircases are protected by use of notional FD30s fire doors with vision panels. It was noted that some communal doors have been replaced with nominal FD30s fire doors.

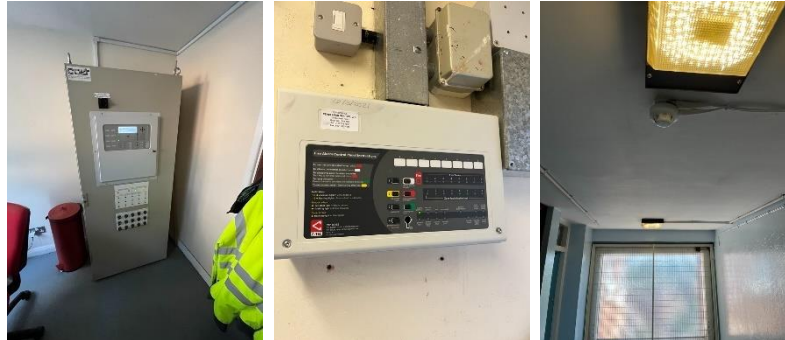
- 9) Automatic smoke ventilation is employed. This is tested, inspected and maintained by a competent procured contractor in accordance with BS7346. The frequency for the maintenance checks are twice per year (April and October) of each calendar year. The main control panel is located in the caretaker's office (ground floor superintendent's office) with repeater panels in the service cupboards on each floor. These service cupboards are secured with 138 suited mortice locks.

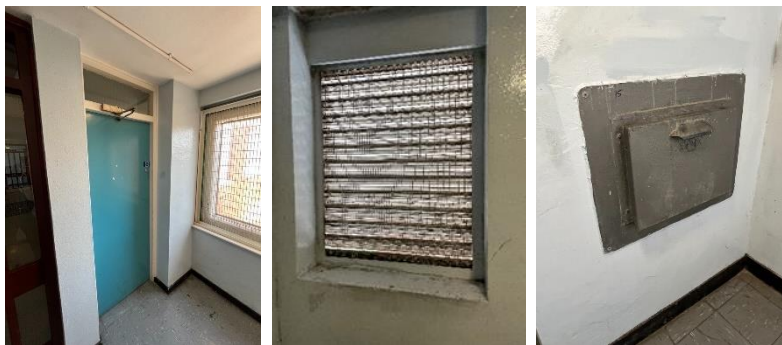
- 10) The chute rooms on each floor have a louvre vent and notional upgraded FD30s timber door.

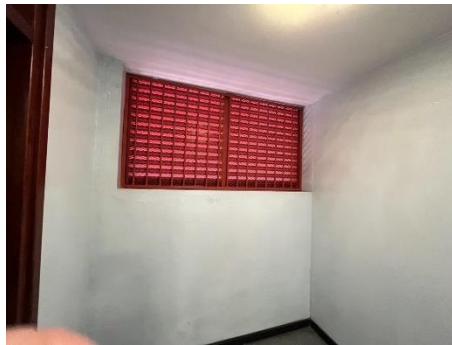
- 13) The 15th floor corridor is vented by means of a louvre vent.

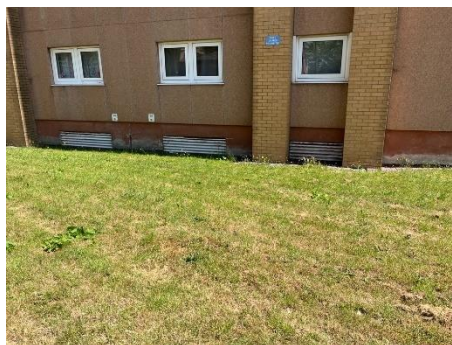
- 14) The basement is ventilated by means of louvre vents.

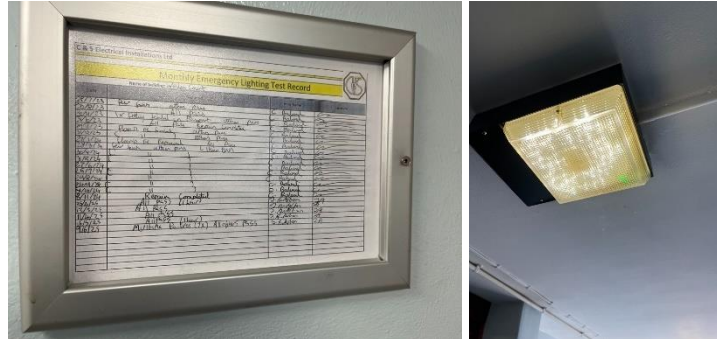
- 16) Emergency lighting is provided to communal landings, stairs and community rooms and basement. Checks are done monthly by Sandwell MBC in house electrical team or approved contractor.

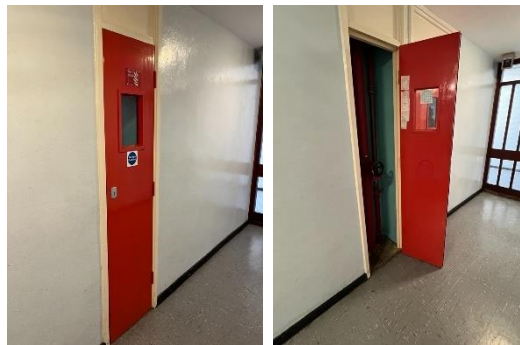
- 17) Dry riser cupboard doors are notional FD30s, kept locked / secured with type 54 suited mortice locks.

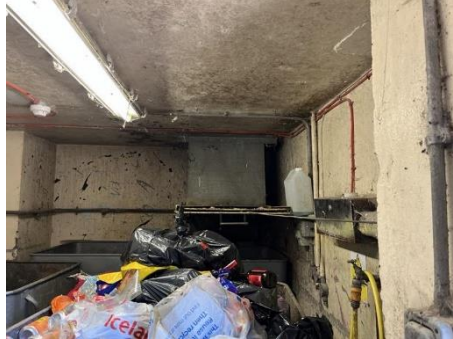
- 4) A fire suppression system is provided to the refuse chute bin store. An approved contractor maintains the system. The frequency for the maintenance checks is twice per year (April and October) of each calendar year.

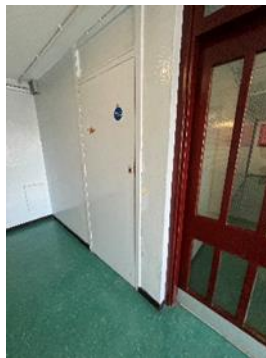
- 9) **The 13th floor electrical service cupboard has damage around the lock area, requiring repair. See Action 10/09.**

P3	Fire Rapid Response 3 – 6 months.	
10/09	The 13 th floor electrical service cupboard has damage around the lock area, requiring repair.

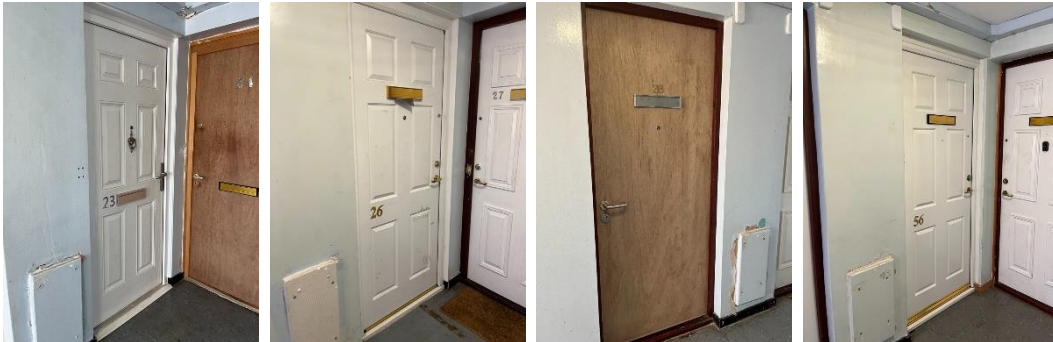
- 10) Individual flat doors are a mixture of nominal FD30s composite doors sets and FD30s rated composite door sets and timber flush nominal FD30s doors.
