# Fire Risk Assessment

## St Giles Court

**Reservoir Road,  
Rowley Regis  
B65 9PE**

**Date Completed: 21/07/2025**

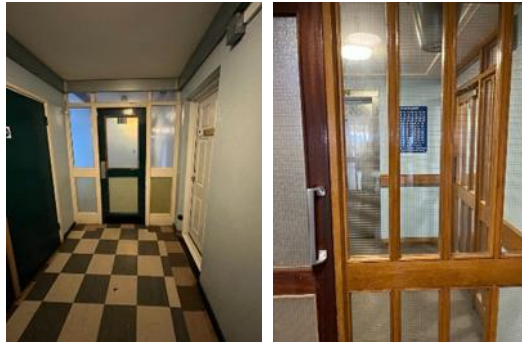
- 6) The communal landing / staircases are protected by use of notional FD30s fire doors with vision panels. It was noted that some communal doors have been replaced with nominal FD30s fire doors.

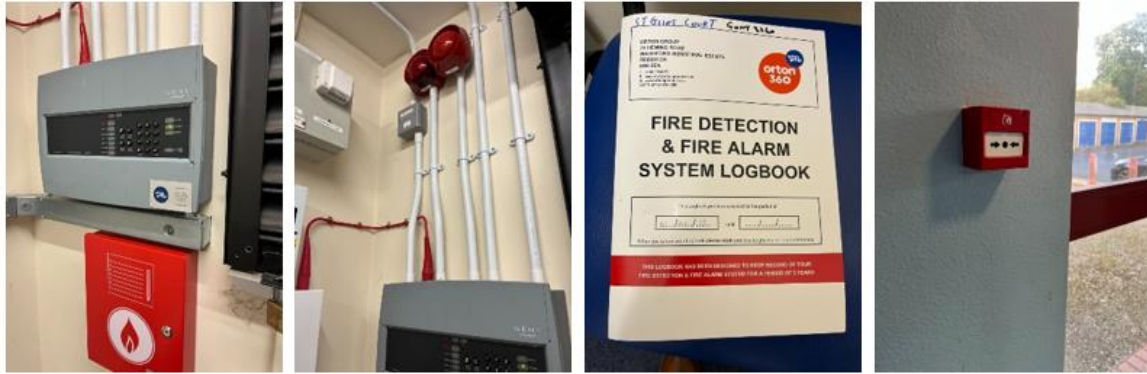
- 3) There is no effective means for detecting an outbreak of fire to the remaining communal areas. Automatic fire alarm systems are not normally required in the common areas of residential blocks.
  - 4) There is a fire alarm system that covers the ground floor communal areas and office/community rooms etc only. The system is subject to a cyclical test. There are manual call points in the ground floor common area for these AFA systems. These MCPs should be removed from all but the communal areas and office/community rooms exits, at the proposed block refurbishment, to avoid confusion to residents who may actuate these call points following evacuation from a fire in their own flat.
-

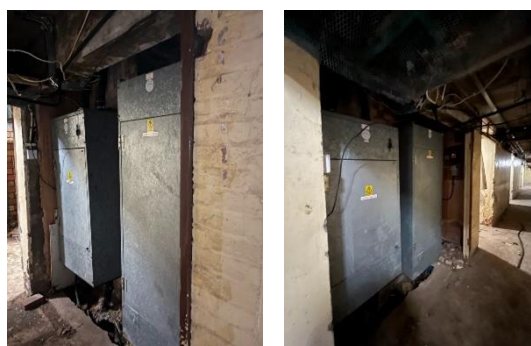
- 1) The building is designed to provide as a minimum 1-hour vertical fire resistance and 1-hour horizontal fire resistance around flats stairwells and lift shafts. All doors are 30-minute fire resistant with cold smoke seals, including those in 1-hour rated walls.
- 2) The premise has sufficient compartmentation to limit the travel and effect of smoke and flame in event of a fire. Whilst the existing fire stopping is fit for purpose, there is a cyclical programme to ensure fire stopping as not been compromised by third parties and where applicable enhance the fire stopping.
- 3) **The lower ground floor contains a brick-built compartment for the main incoming electrical supply. This compartment has no fire doors and is open to the lower ground floor. A double FD30s fire door set is required to be fitted. See Action 10/03**

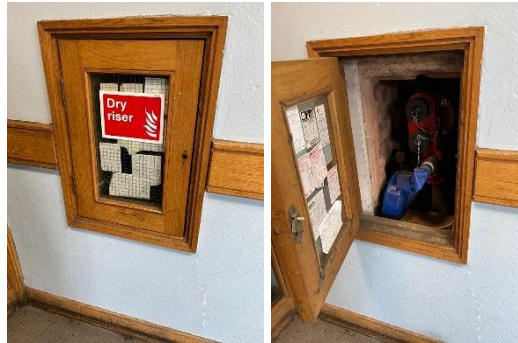
- 1) The dry riser inlet is located within the ground floor lobby, inside a cupboard secured with a budget lock.

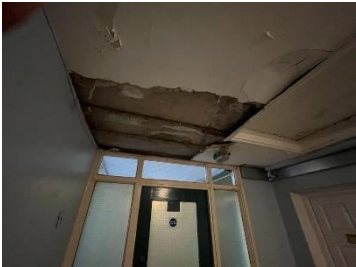
P3	Fire Rapid Response 3 – 6 months.	
10/08	The lift lobby ceiling for flats 80-82 on the 13 <sup>th</sup> floor is damaged, potentially affecting compartmentation. This damage should be repaired.

- 8) **The lift lobby ceiling for flats 80-82 on the 13<sup>th</sup> floor is damaged, potentially affecting compartmentation. This damage should be repaired. See Action 10/08.**

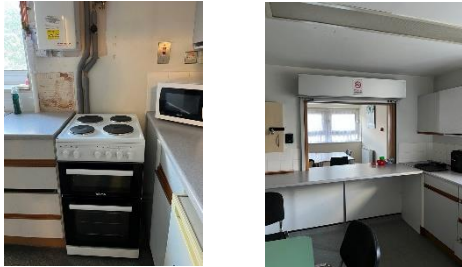
<p>There is an electric cooker in the communal kitchen. Information given to the assessor stated that residents of the block are not allowed to use the kitchen facilities unsupervised by SMBC staff and that the electric cooker is not used by staff.</p> <p>All SMBC should be made aware that the kitchen shutter and kitchen door should be closed if the cooker is used. The cooker should not be used for fat frying.</p> <p>Consideration should be given to removing the cooker and designating the kitchen for the cold preparation and re-heating of food only.</p>
