Fire Risk Assessment

Addenbrooke Court

**Southbank Rd,
Cradley Heath, B64 6LJ**

Date Completed: 01/07/2025

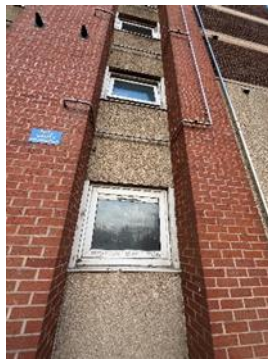
4. Windows that form part of the AOV system are powder coated aluminium units.

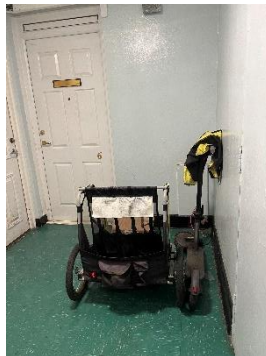
- 4) None of the corridors that form part of the means of escape are dead ends.
- 5) The means of escape are protected to prevent the spread of fire and smoke.
- 6) At the time of the assessment, items were seen in the corridor outside of Flats 4, 5, and 6. An email was sent to the Housing Officer requiring removal of these items.

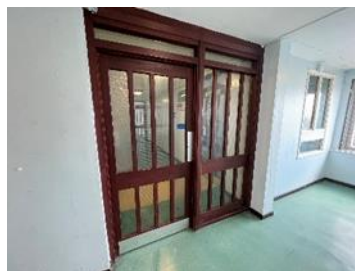
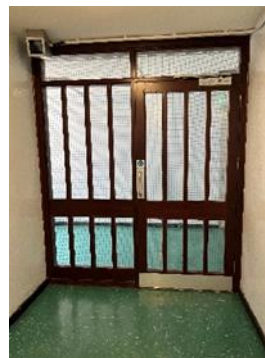
- 8) The corridor fire door from the main entrance foyer into the lift lobby requires adjustment to close into its frame correctly. See Action 07/08.

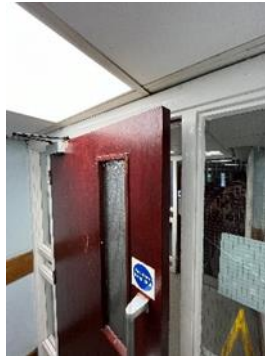
- 9) On the 10th floor, the corridor fire door from the staircase into the lift lobby requires adjustment to close into its frame correctly. See Action 07/09.

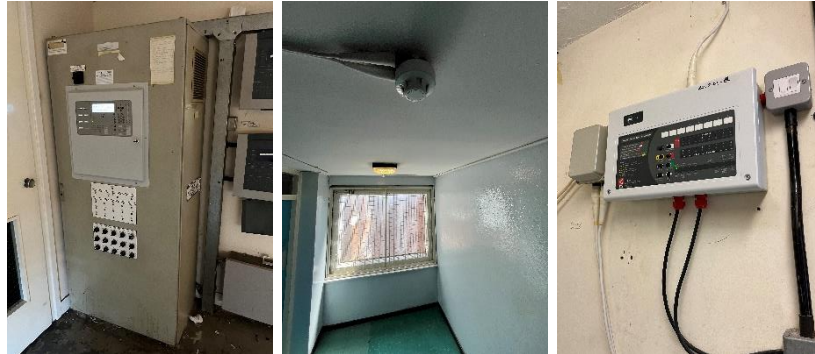
- 13) The AOV to the first-floor lobby by flats 10, 11, 12 is defective and stuck in the open position due to a failed actuator. The assessor has been informed that a replacement actuator is on order from the contractor. An email was sent to the Team Leader Fire Safety and Facilities, the reply (08.07.25.) stated that a replacement actuator has been fitted by the contractor and the AOV is working correctly.

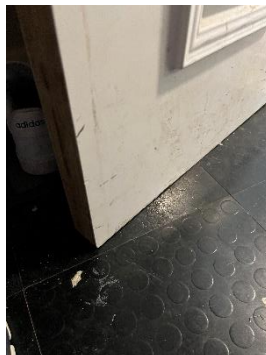
- g) Flat 32 – Door has excessive head gap, requiring adjustment. See Action 07/26g.**

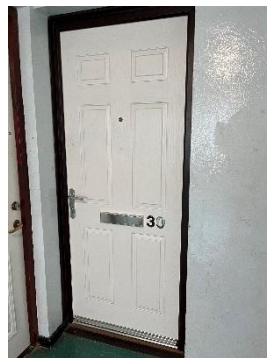
- i) Flat 45 - Door has no self-closing device fitted. There is an excessive head gap. A self-closing device is required to be fitted, and the excessive head gap requires adjustment. See Action 07/26i.**

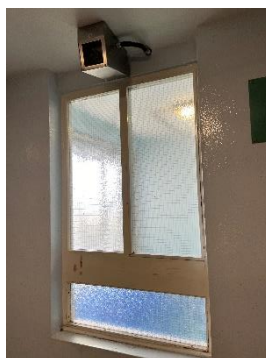
- 17) It was noted that the notional hardwood fire screens with Georgian wired glazing that protect staircases may only provide 30 mins fire resistance. When any future refurbishments take place, this should be upgraded to a minimum of 60 mins.

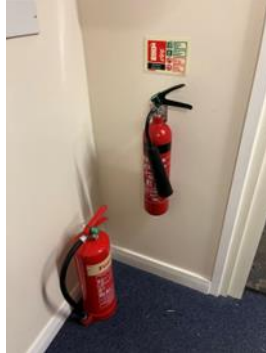
- 7) The foam extinguisher in the server room should be removed. A foam extinguisher is not suitable for an electrical fire. An email has been sent to the Team Leader of Fire and Safety Facilities to request removal of this extinguisher.

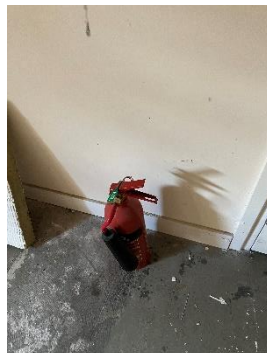
- 8) The portable fire extinguisher (CO2) in the AOV control room is required to be fitted to a stand or hook and a 'how to use' sign fitted. An email has been sent to the Team Leader Fire of and safety Facilities to request suitable storage and signage.

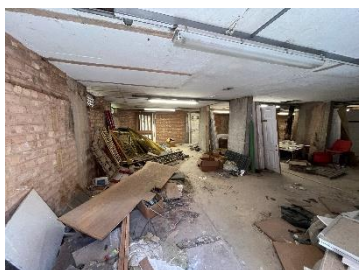
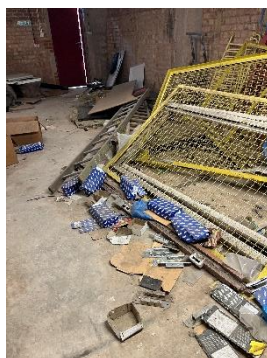
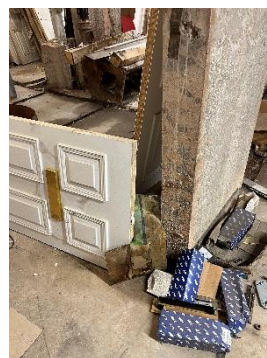
- 3) No Flammable liquids stored on site by Caretakers / cleaners.
- 4) There are no flammable liquids or gas cylinders stored on site.
- 5) **The basement appears to have become an area where surplus SMBC materials and items are being stored. The basement has poor housekeeping and excessive storage of combustible items. Housekeeping should be improved, and combustible waste should be removed. See Action 18/05.**

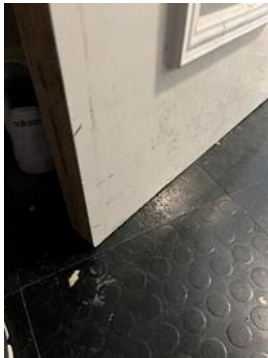
P2	Fire Rapid Response 1 – 3 months.	
07/26f	Flat 40 – Door leaf binds on flooring, preventing proper self-closure, adjustment required

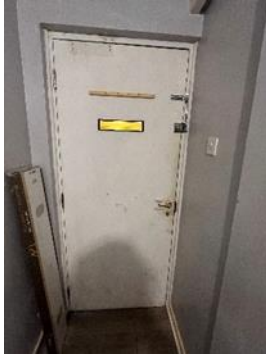
P2	Fire Rapid Response 1 – 3 months.	
07/26i	Flat 45 – Door has no self-closing device fitted. There is an excessive head gap. A self-closing device is required to be fitted, and the excessive head gap requires adjustment.

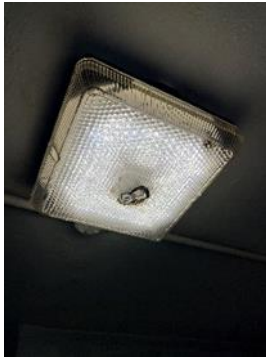
- 3) **The emergency light fitting in the bin chute room on the 14th Floor has been damaged and requires repair. See Action 09/03.**

P2	Fire Rapid Response 1 – 3 months.	
09/03	The emergency light fitting in the bin chute room on the 14 th Floor has been damaged and requires repair.

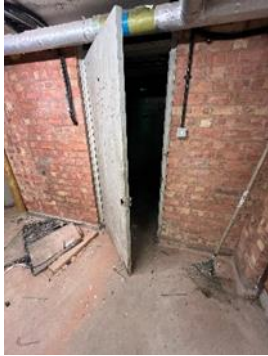
- 4) **The basement contains a brick-built compartment for the main incoming electrical supply. The door to this compartment is damaged and unsuitable, the door should be replaced with a FD30s fire door. See Action 10/04**

P3	Fire Rapid Response 3 – 6 months.	
10/04	<p>The door to the main incoming electrical supply in the basement is damaged. The door is required to be replaced with a FD30s fire door.</p>

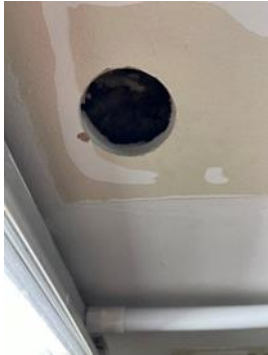
10/06	There are minor holes in the ceiling of the AOV room that require filling with a fire-resistant material.

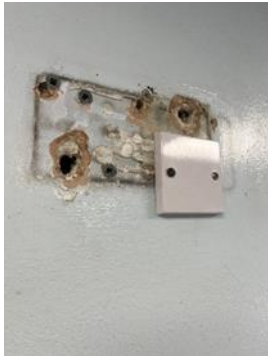
P3	Fire Rapid Response 3 – 6 months.	
10/07	There are minor holes in the entrance foyer walls, requiring filling with fire resistant material.

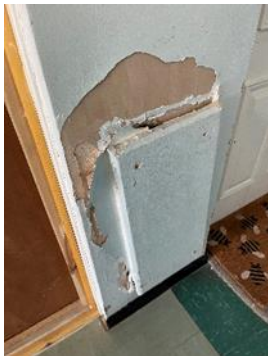
- 8) **Access panels to stop taps are fixed to masonry adjacent flat entrance doors and bedded on intumescent material. The access panel outside flat 82 is damaged. The panel should be repaired. See action 10/08.**

P3	Fire Rapid Response 3 – 6 months.	
10/08	The service access panel outside flat 82 is damaged. The panel should be repaired.

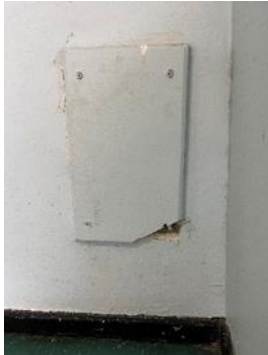
- 9) **Access panel to stop tap outside flat 66 is damaged. The panel should be repaired. See action 10/09.**

10/09	The service access panel outside flat 66 is damaged. The panel should be repaired.

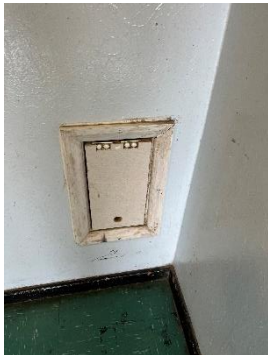
P3	Fire Rapid Response 3 – 6 months.	
10/10	The access panel to stop tap outside flat 21 has not been upgraded as per all other service access panels in the block. The panel should be upgraded to offer sufficient fire and smoke resistance.

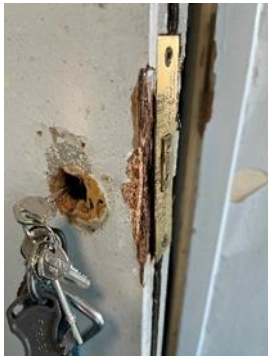
- 13) **The 15th floor electrical service cupboard has damage around the lock area, requiring repair. See Action 10/13.**

P3	Fire Rapid Response 3 – 6 months.	
10/13	The 15 th floor electrical service cupboard has damage around the lock the damage is required to be repaired.
