Fire Risk Assessment

Moorlands Court

**Reservoir Road,
Rowley Regis
B65 9PB**

Date Completed: 29/07/2025

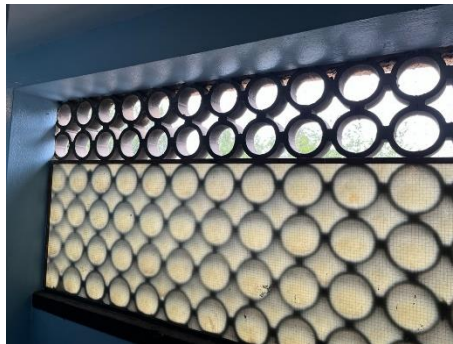
- 17) The chute room area on each floor has natural ventilation by means of block work.

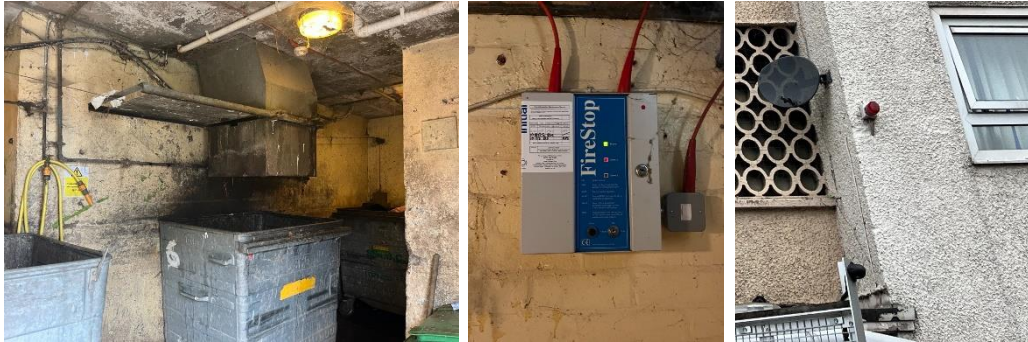
- 4) A fire suppression system is provided in the refuse chute bin store. The control panel is located within the lower ground floor. There is a warning beacon on the outside of the building, monitored by cctv. An approved contractor maintains the system. The frequency for the maintenance checks is twice per year (April and October) of each calendar year.

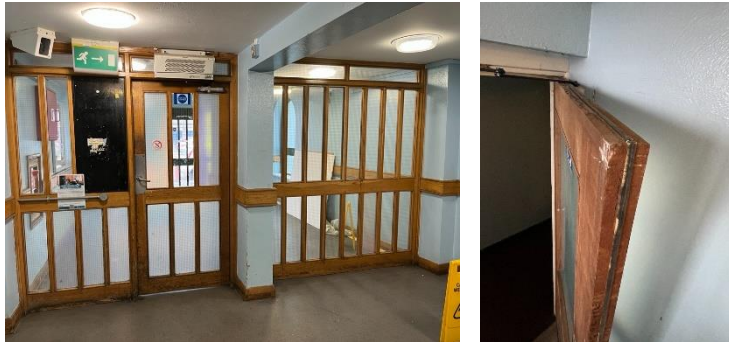
- 12) The communal corridors, landing & staircases are protected by use of notional self-closing 44mm 30-minute timber fire doors with vision panels & 25mm stops, along with 30-minute notional hardwood fire screens with GWPP glazing. It is recognised that these doors do not meet today's benchmark of a certified FD30s fire door /screen install however, because they were installed at the time of the building's construction and to the standard of that time they are deemed as acceptable so long as the doors /screens are free of damage and function as they were intended to do so. It has been recognised that some landing / staircase notional doors in this block have been upgraded with combined intumescent strips & cold smoke seals to enhance their original design and minimise departures from today's standards. Where minor shortcomings have previously been identified, actions have been created for corrective works for example, some doors have been re-lipped with hardwood.

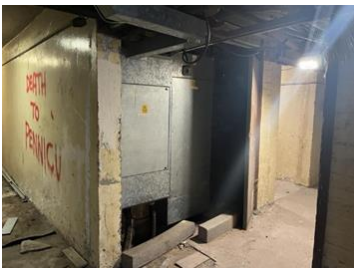
P2	Fire Rapid Response 1 – 3 months.	
10/03	The lower ground floor contains a brick-built compartment for the main incoming electrical supply. This compartment has no fire doors and is open to the lower ground floor. A double FD30s fire door set is required to be fitted.
