# Fire Risk Assessment

**Falcon Place,  
1-12,  
Tividale,  
Oldbury,  
B69 1PD.**

**Date Completed: 05/05/2026**

**Officer: C. Hudson Fire Risk Assessor**

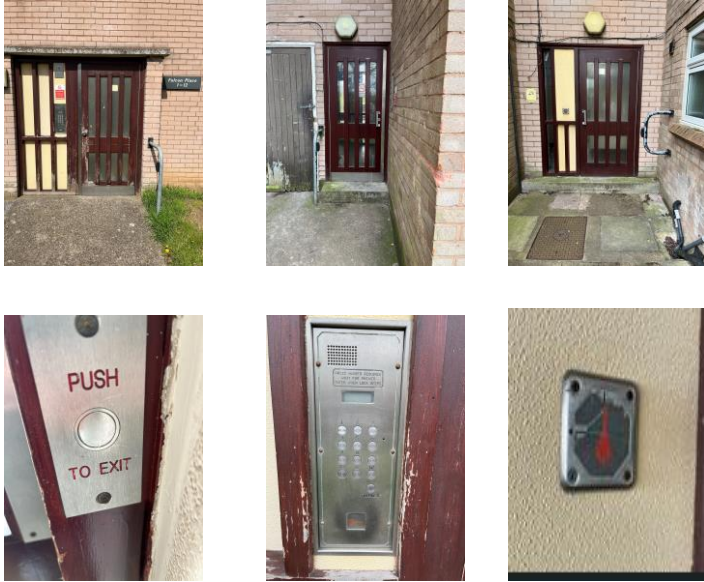
The main entrance is on the front elevation with a further 2 exits located on the rear elevation, a door entry system using a fob reader is installed. The escape routes lead to an ultimate place of safety. The front final exit door has a firefighter override switch operated by drop-latch key. The door entry system is designed to fail safe and unlock in the event of a power failure.

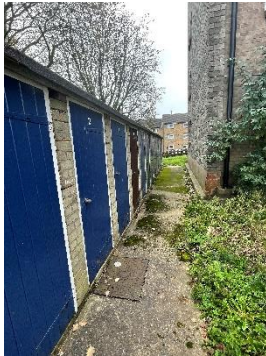
Storage cupboards located externally. These are kept secure and tenants have the keys; no access was gained to the storage cupboards whilst carrying out this FRA.
