Fire Risk Assessment

19-24 Falcon Place

Tividale, B69 1PD

Date Completed: 13th May 2026

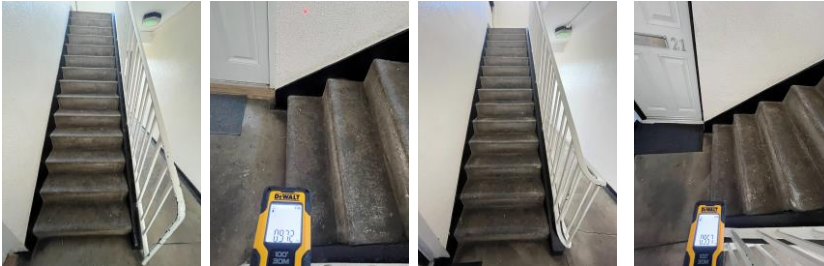
Ground to 1st & 2nd floor staircase.

5) 19-24 Falcon Place consists of a single staircase that provides sufficient means of escape, this is located as you enter each block. The width of the staircases has been measured from handrail to the wall at a measurement of 972 mm and 957 mm. These stairs are kept clear to maintain safe means of escape.

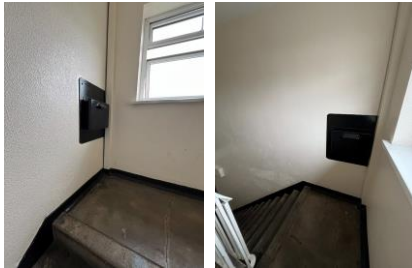
8) On both 1st floor and 2nd floor landings, there are bin chute hoppers within the means of escape, they do not present any obstruction in the event of safe evacuation.

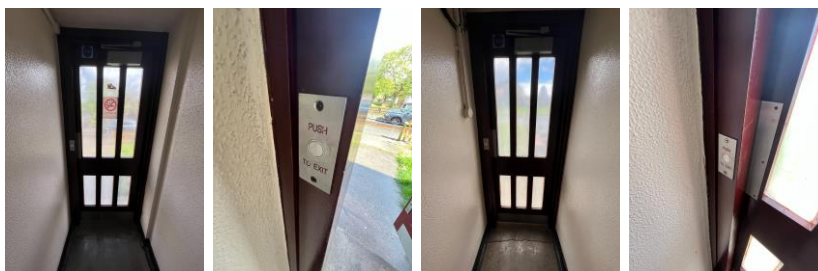
Front final & Rear final exit

10) There is a clear and safe exit out of the building via the two-ground floor exits. The front final exit door is accessed using a push button, this will fail safe in an emergency, the rear final exit door accessed by a levered handled.

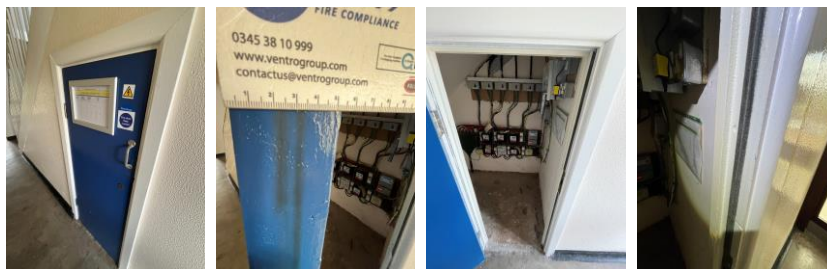
- 3) Electrical Service cupboard on the ground floor which accommodates the residents' electrical meters and other electrical apparatus is secured by a FD60s door and accessed using a 138 key.

- 4) **Electrical cupboard does have brush smoke seals installed to the door frame, however the brush seal on the hinge side has been fouled by paint reducing its performance.**

Question/ Ref No	Required Action	Supporting photograph	Priority	Timescale and Person Responsible	Date Completed
10/4	Ground floor electrical cupboard, brush smoke seal on the hinge side have been fouled by paint. Damaged seal to be replaced by new seal.

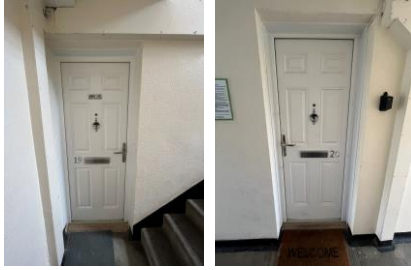
Ground floor flats 19,20

- 7) **All individual flats are installed with composite FD30s rated doors. Reasonable attempts were made to access flats to check for the function of self-closing devices and the condition of smoke and intumescent seals; this was not possible due to residents not being present at the flats or not answering.**

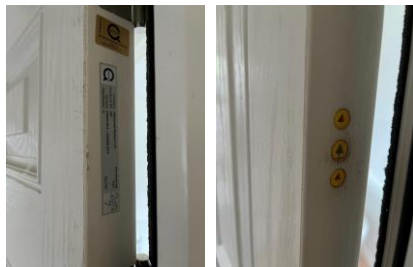
Access was gained to flats 20 and 23 to assess the operation of the self-closing device, the condition of the fire and smoke seals to the flat entrance door and smoke detection, Flat 20 self-closing device requires adjustment to allow the door to close automatically into the frame.

8) Flat 20 was checked for confirmation of a certified FD30S fire rated door.

- 9) Flat 20 self-closing device does not allow the door to self-close into the frame.

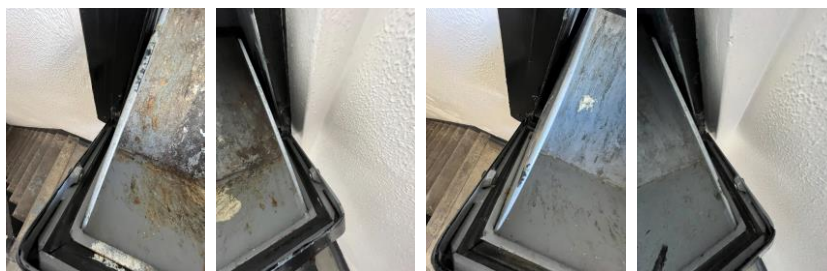
- 11) Intumescent seals have been installed within the chute hoppers on the 1st and 2nd landing

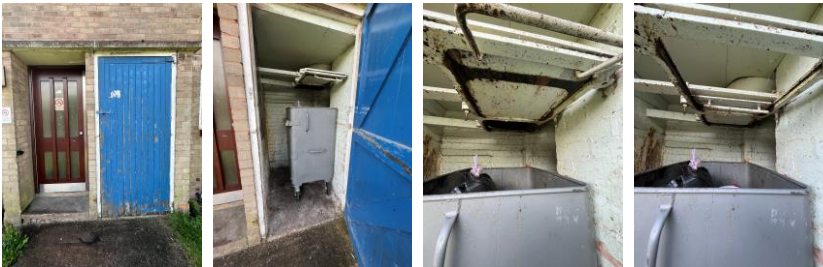
- 2) Refuse bin is stored in a secured bin room that is located next to the front entrance of the building. The refuse bin store has been installed with a manual bin closer plate; this was tested to see if it is functioning and not seized. The bin storage cupboard is kept secure by a means of a latch type mechanism. Bins Are regularly emptied by site services.

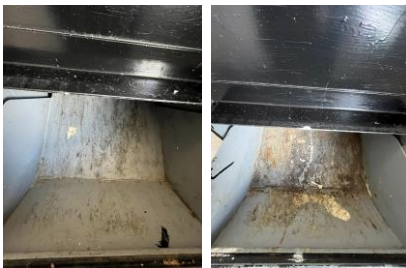
- 3) 1st 2nd floor internal refuse chutes are clear of any rubbish.
