Fire Risk Assessment

Bishops Close 8 -12

Bishops Close, Smethwick B66 2RD

Date Completed: May 2026

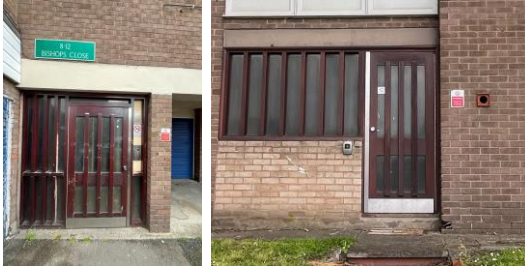
Front and rear entrances to block

Main entrance to the building is through a timber door, with both the front and rear doors accessed via fob reader, trades and visitors use an intercom system. For emergency access there is a firefighter manual override switch located above the door intercom panel.

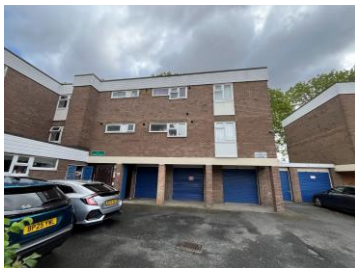
Front Elevation

- 1) The exterior of the building is predominately traditional brick construction with a flat roof design with UPVC fascia boards under the roof line and a bitumen and felt roof. Front and rear entrances are through timber doors with glazing in the inserts of the doors alongside the timber panelling to the side.

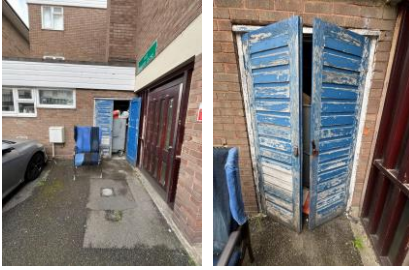
- 2) Adjacent to the front entrance is the refuse bin store, which is enclosed by a timber door.
-

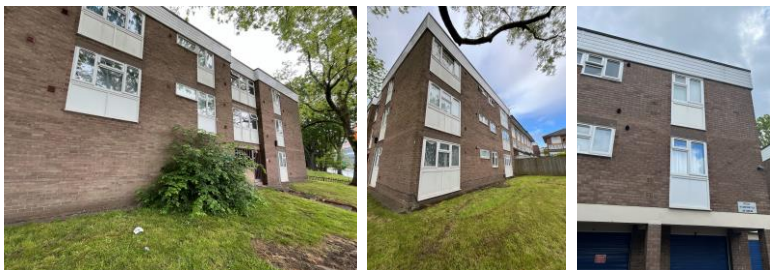
- 3) UPVC double glazed window units have been installed for each flat and communal areas within the block.

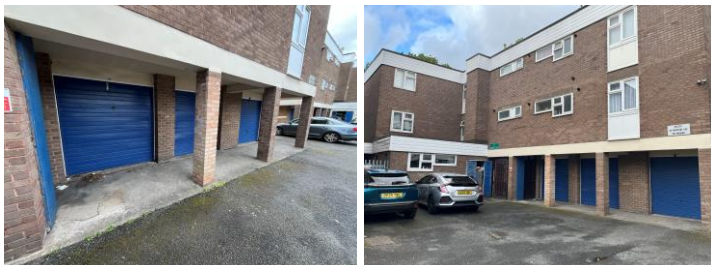
- 4) Front elevation of the building has resident garages which are slightly set back from being in line with the front elevation of the building and not directly under the flats above.

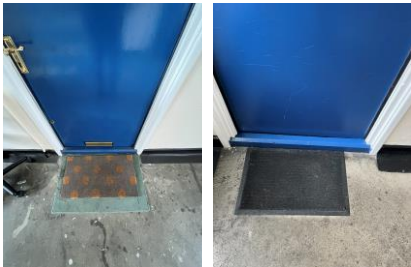
- 1) Each flat is equipped with, as a minimum LD3 fire detection to facilitate means of escape and provide sufficient response time.
- 2) Flat entrances have door mats placed within communal corridors, the fire rating is not known, however the condition and the size of these mats are acceptable.

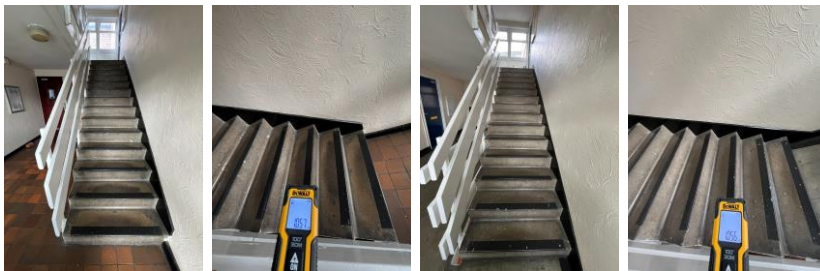
Ground to 1st & 2nd floor staircase.

- 6) 8 -12 Bishops Close consists of a single staircase that provides sufficient means of escape, this is located at the rear of the block. The width of the staircases has been measured from handrail to the wall at a measurement of 1057mm and 1056mm These stairs are kept clear to maintain safe means of escape.

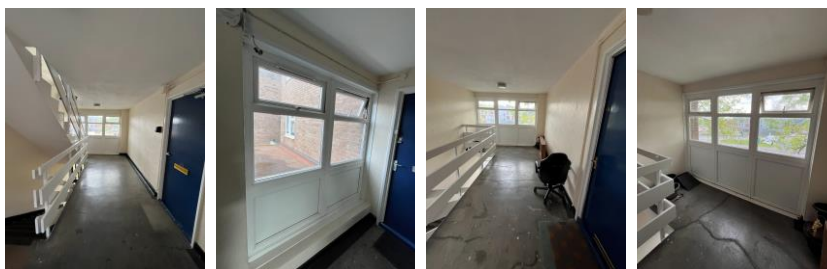
1st and 2nd floor landing

- 7) UPVC windows units have been installed on the staircase landing and within the corridors to the flats, these windows can be opened without the use of a key to allow sufficient airflow into the corridor and stairwell. There is no automatic smoke ventilation system installed in this premises.

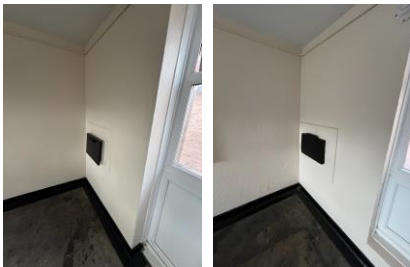
10) On both 1st floor and 2nd floor landings, there are bin chute hoppers within the means of escape, they do not present any obstruction in the event of safe evacuation.

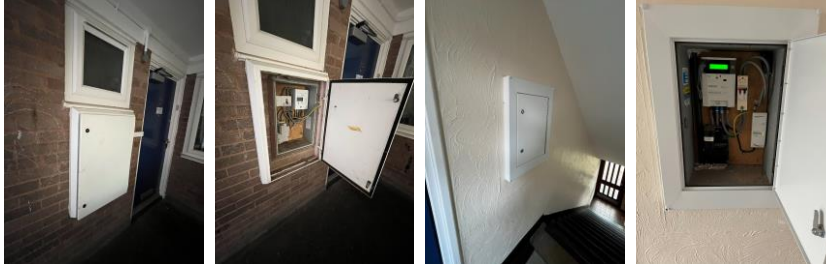
- 11) The residential electricity meters are installed within durable metal enclosures situated in the communal corridors adjacent to the flat entrance doors. Access control to these service boxes is maintained via standard budget lock mechanisms.

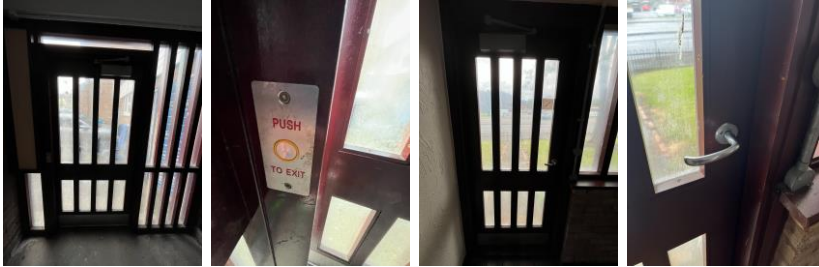
Front final & Rear final exits.

15) There is a clear and safe exit out of the building via the two-ground floor exits. The front final exit door is accessed using a push button, this will fail safe in an emergency, the rear final exit door accessed by a levered handle.

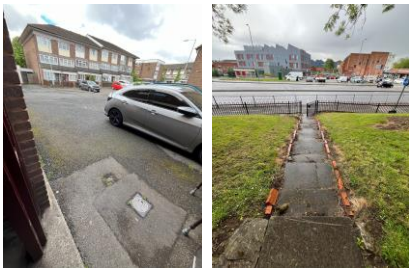
Front and rear final exit routes

16) The route out the block to ultimate safety is clear from both final exit doors.

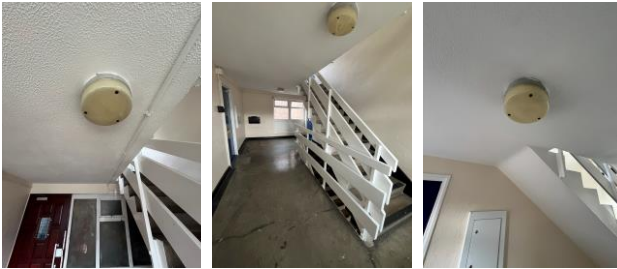
Communal corridors on ground, 1st and 2nd floors

- 1) Emergency lighting is not present within the blocks
- 2) Conventional lighting has been installed to the communal landings and stairs.

<p>illumination to the communal escape routes and with the block being of non-complex design, this can be seen as acceptable. <i>Recommended that on any future refurbishment of the block that these lights be upgraded.</i></p>	
<p>Recommended that all timber FD30S flat entrance doors are to be upgraded to Composite certified FD30S fire doors on any future upgrade to the block.</p>

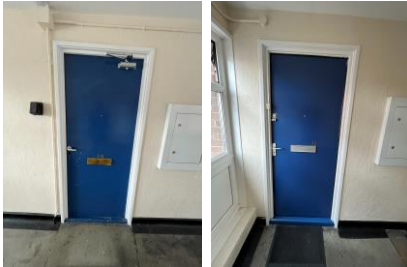
1st floor flats 10,11

- 6) All individual flats are installed with timber FD30s doors.
Recommendation on any future refurbishment of the block the doors be upgraded to certified FD30s rated fire doors.

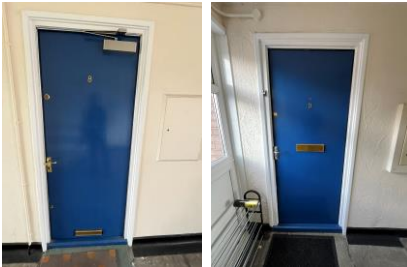
2nd floor flats 8,9

- 7) Flat 8 checked for function of door closing device, this functioned as it should and from the recommended 15 degree angle test. Smoke seals checked, no issue found.

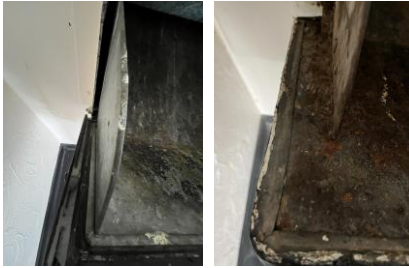
- 8) Intumescent seals have been installed within the chute hoppers on the 1st and 2nd landing

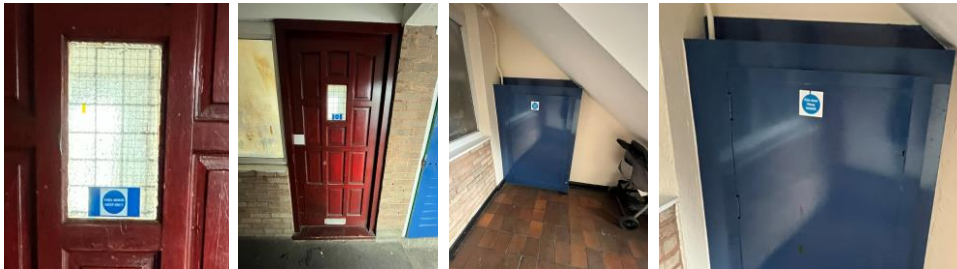
Fire signage on electrical cupboard

- 1) Fire door keep shut signs are displayed where appropriate, on external electrical cupboard and communal fire doors display Fire Door Keep Shut/Locked” sign.

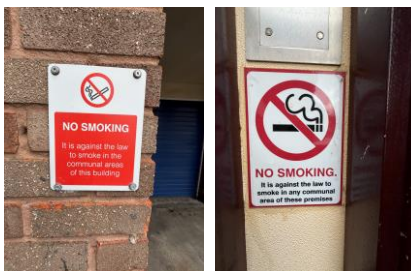
- 2) Yellow LPG warning signs are not displayed within the block. [refer to section 18](#).
- 3) Smoking is prohibited within any communal parts of the building in line with Smoke Free England legislation. Signage is also displayed in the external refuse cupboard located next to the entrance doors.

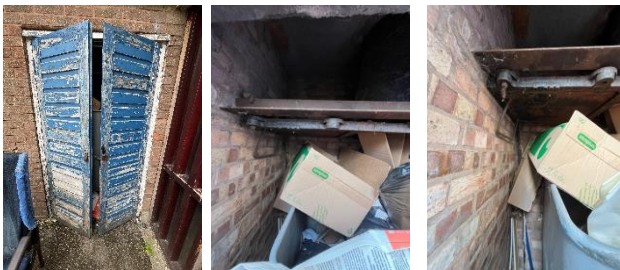
- 2) Refuse bin is stored in a secured bin room that is located next to the main entrance of the building. This is kept secure by a means of a pulldown handle latch. There is a manual bin closer plate installed on the refuse chute. Bins Are regularly emptied by site services on a weekly basis.

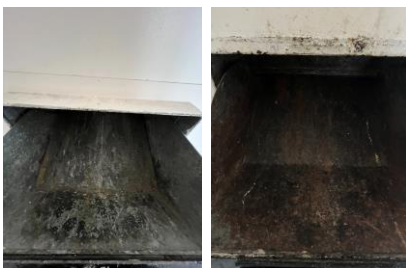
- 3) Both 1st and 2nd floor internal refuse chutes are clear of any rubbish.

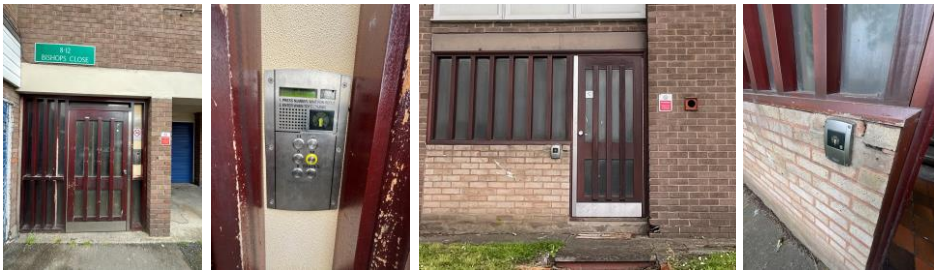
Front and rear entrance doors with access system.

- 1) Regular checks are undertaken by Caretakers / Cleaning Team(s) 365 days per year which helps reduce the risk of arson.
- 2) Both blocks have restricted access, this is via a key lock, each resident has their own fob to gain access. There is an intercom system that can allow visitors and contractors in.
