Fire Risk Assessment

25-30

**Blue Rock Place,
Tividale,
B69 1PB**

Date Completed: 18/05/2026

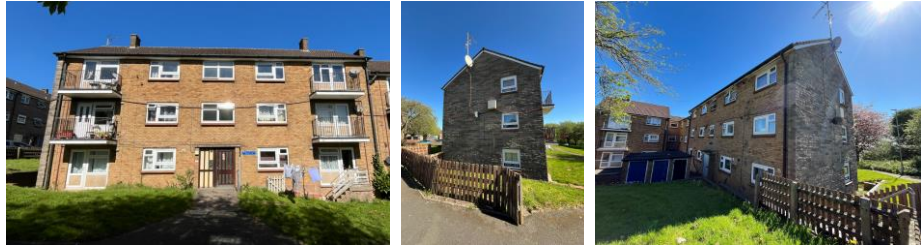
The low-rise, consists of 3 storeys (inclusive of the ground floor) constructed in 1965 using traditional brick cavity and concrete construction. The roofs are pitched and finished with concrete interlocking tiles. Around the roof line uPVC fascia boards are fitted with asbestos cement underclanking soffit boards. Each of the floors contains 2 dwellings, total of 6 within the block.

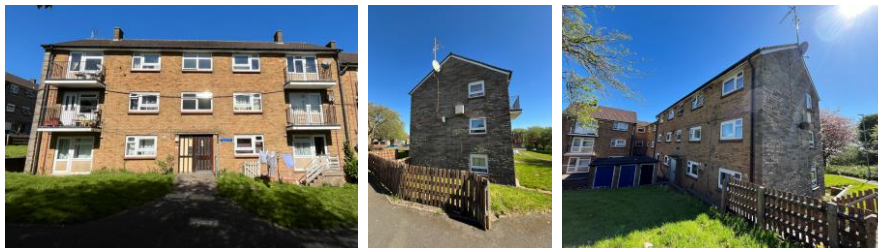
- 1) The external surface of the building is predominantly brick structure with uPVC soffits and fascia. The roof is pitched and fitted with concrete interlocking roof tiles are fitted on the roof.

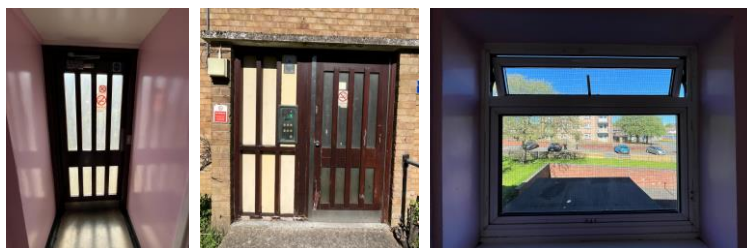
- 2) uPVC double glazed units have been installed to each flat and communal stairway. Communal windows are Georgian wired glazed. Entrance doors (x2) are mainly timber and glass units, with one door having a small section of spandrel panelling within the side frame.

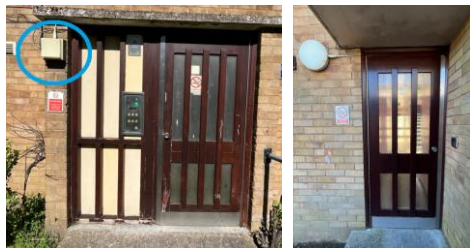
- 4) Externally, lighting units are fitted near the entrance doorways. These provide illumination for resident access and contribute to overall safety and security during hours of darkness.
